POTAKE LAKE DAM

ROCKLAND COUNTY, NEW YORK
INVENTORY NO. N.Y. 970

PHASE I INSPECTION REPORT
NATIONAL DAM SAFETY PROGRAM

AUGUST 1981

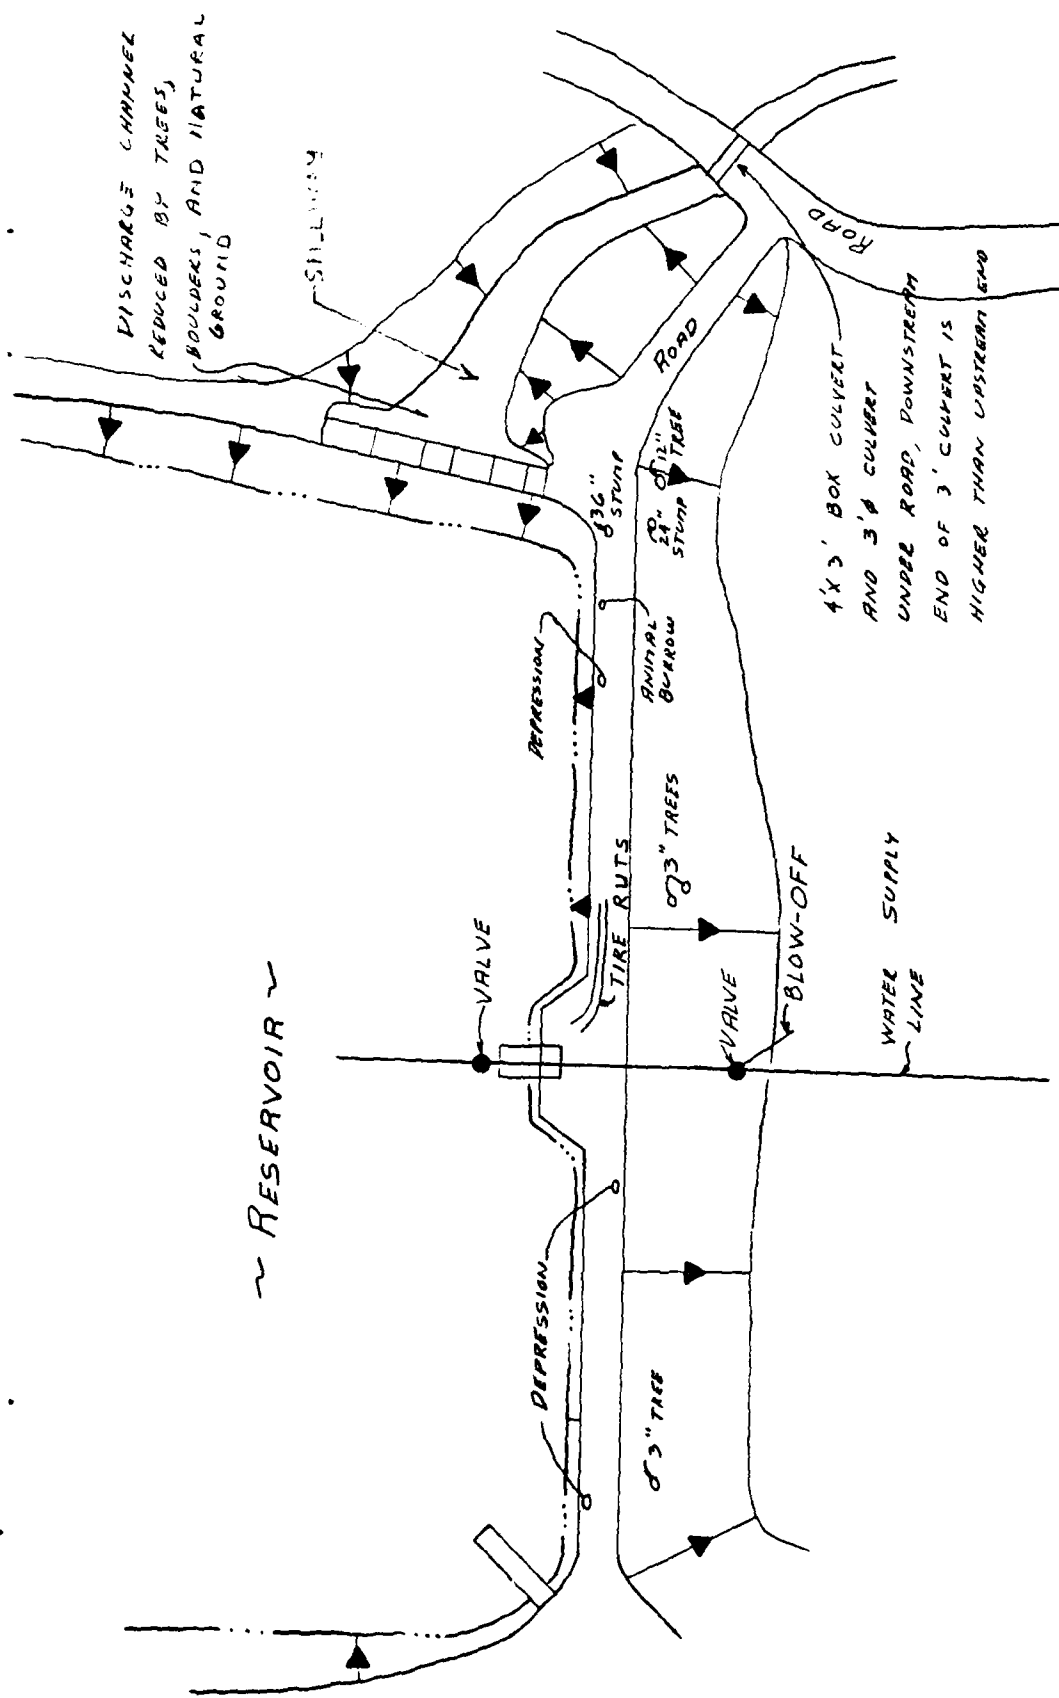
PLATE I
POTAKE LAKE DAM
FIELD SKETCH

1. One animal burrow and three depressions were found on the crest of the dam (see Field Sketch Appendix E).
2. Tire tracks 0.4 feet deep were found along the crest on the left side of dam.
3. On the downstream face of the embankment are three 3-inch diameter trees, a 12-inch diameter tree, and a 24-inch diameter stump. Near the
