WESTCOTT RESERVOIR
ONONDAGA COUNTY
NEW YORK

INVENTORY No. NY 1471

PHASE I INSPECTION REPORT
NATIONAL DAM SAFETY PROGRAM

MAY 1981

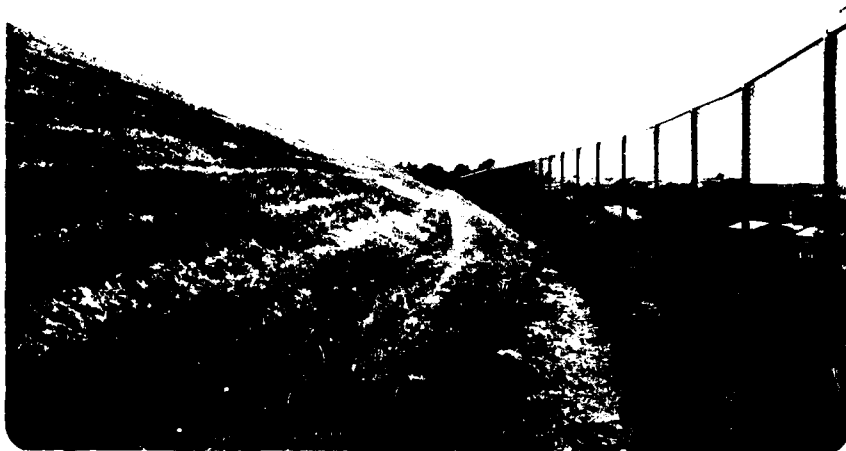
4. Easterly slope of embankment.

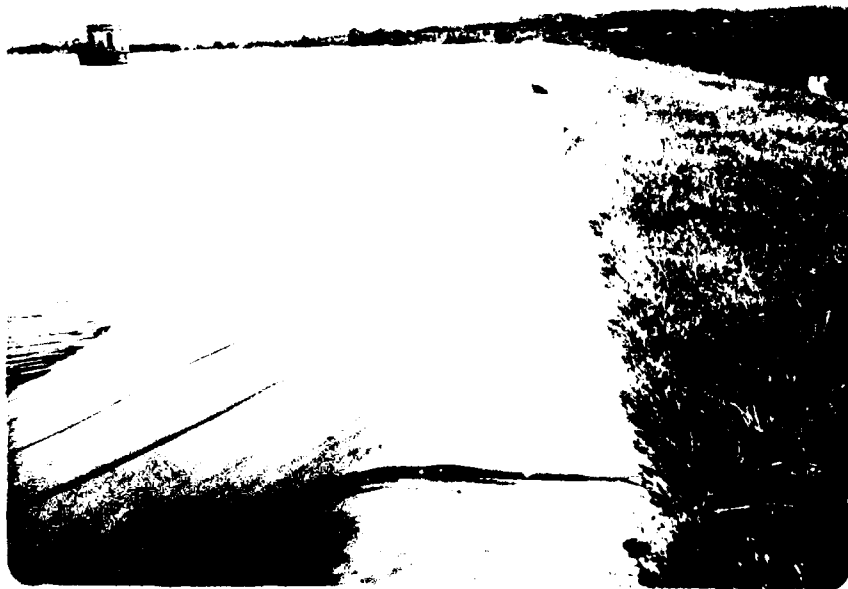
1. Seepage was detected near the toe of the slope of the northwest embankment.
2. Minor tears exist in the hypalon lining near the top of the embankment.
3. No warning system is presently in effect to alert the public should conditions occur which could result in failure of the dam.
4. No formalized inspection system is in effect at the facility.

5. Closeup of hypalon lining.

1. Seepage near the northwest toe of slope should continue to be monitored and data recorded to enable observers to detect changing conditions.
2. Tears in the hypalon liner should be repaired.
3. A flood warning and emergency evacuation system should be implemented to alert the public should conditions occur which could result in failure of the dam.
4. A formalized inspection system should be initiated to develop data on conditions and maintenance operations at the facility. Specifically, data should be collected and recorded regarding flow from the sub-drain system of the facility.

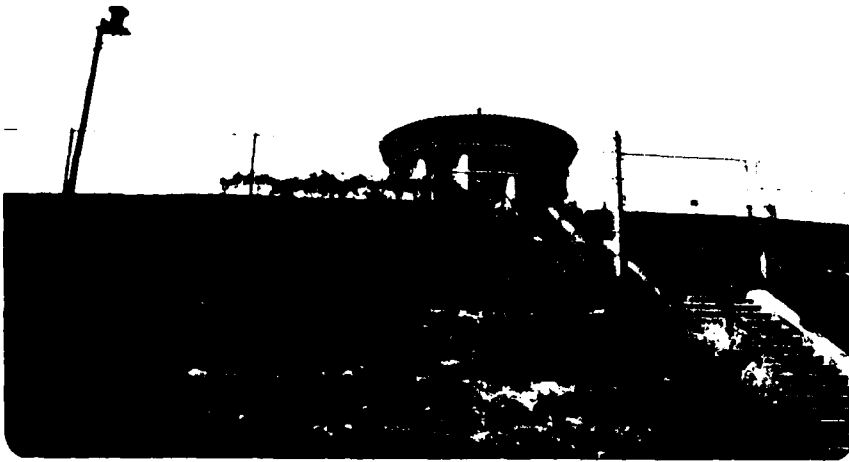
The gatehouse at the toe of the slope to the south of the impoundment was found to be in operating condition and generally in good repair.

6. Gatehouse at south end of reservoir.
