| REPORT DOCUMENTATION PAGE | | READ INSTRUCTIONS<br>BEFORE COMPLETING FORM |
|---|---|---|
| 4. TITLE (and Subtitle)<br>Phase I Inspection Report<br>Tomahawk Lake Dam<br>Lower Hudson River Basin, Orange County, NY<br>Inventory No. 618 | | 5. TYPE OF REPORT & PERIOD COVERED<br>Phase I Inspection Report<br>National Dam Safety Program |

Overall View of Dam  
Tomahawk Lake Dam  
I.D. No. NY 618  
9 March 1981

PHASE I INSPECTION REPORT  
NATIONAL DAM SAFETY PROGRAM  
TOMAHAWK LAKE DAM  
I.D. No. NY 618  
DEC DAM No. 195A-2507  
LOWER HUDSON RIVER BASIN  
ORANGE COUNTY, NEW YORK

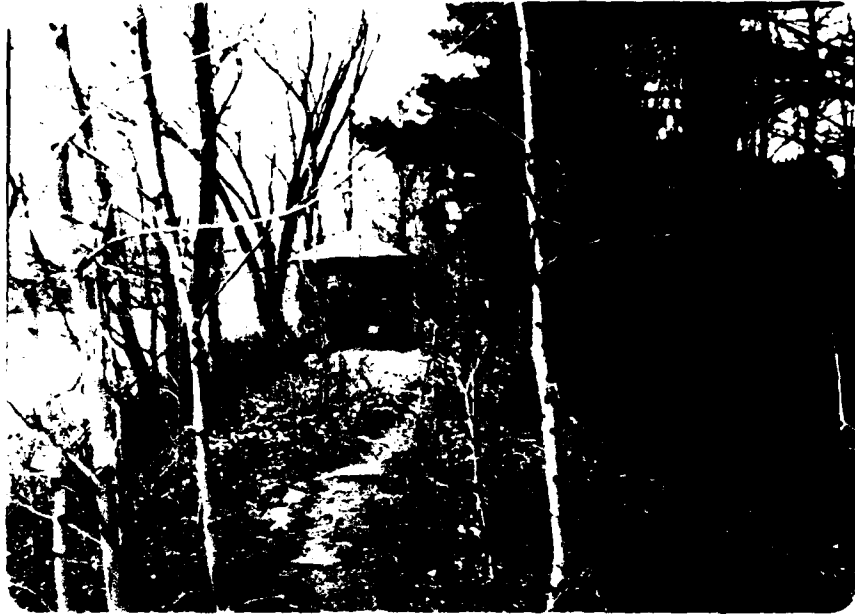
Photo 1. View of Crest, Downstream Slope, and  
Valve House on Right Side of Spillway  
9 March 1981
