| REPORT DOCUMENTATION PAGE | | READ INSTRUCTIONS<br>BEFORE COMPLETING FORM |
|---|---|---|
| 4. TITLE (and Subtitle)<br>Phase I Dam Inspection Report<br>National Dam Safety Program<br>Sunnen Dam (MO 30111)<br>Washington County, Missouri | | 5. TYPE OF REPORT & PERIOD COVERED<br>Final Report |

SUNNEN LAKE DAM  
WASHINGTON COUNTY, MISSOURI  
MISSOURI INVENTORY NO. 30111

PHASE I INSPECTION REPORT  
NATIONAL DAM SAFETY PROGRAM

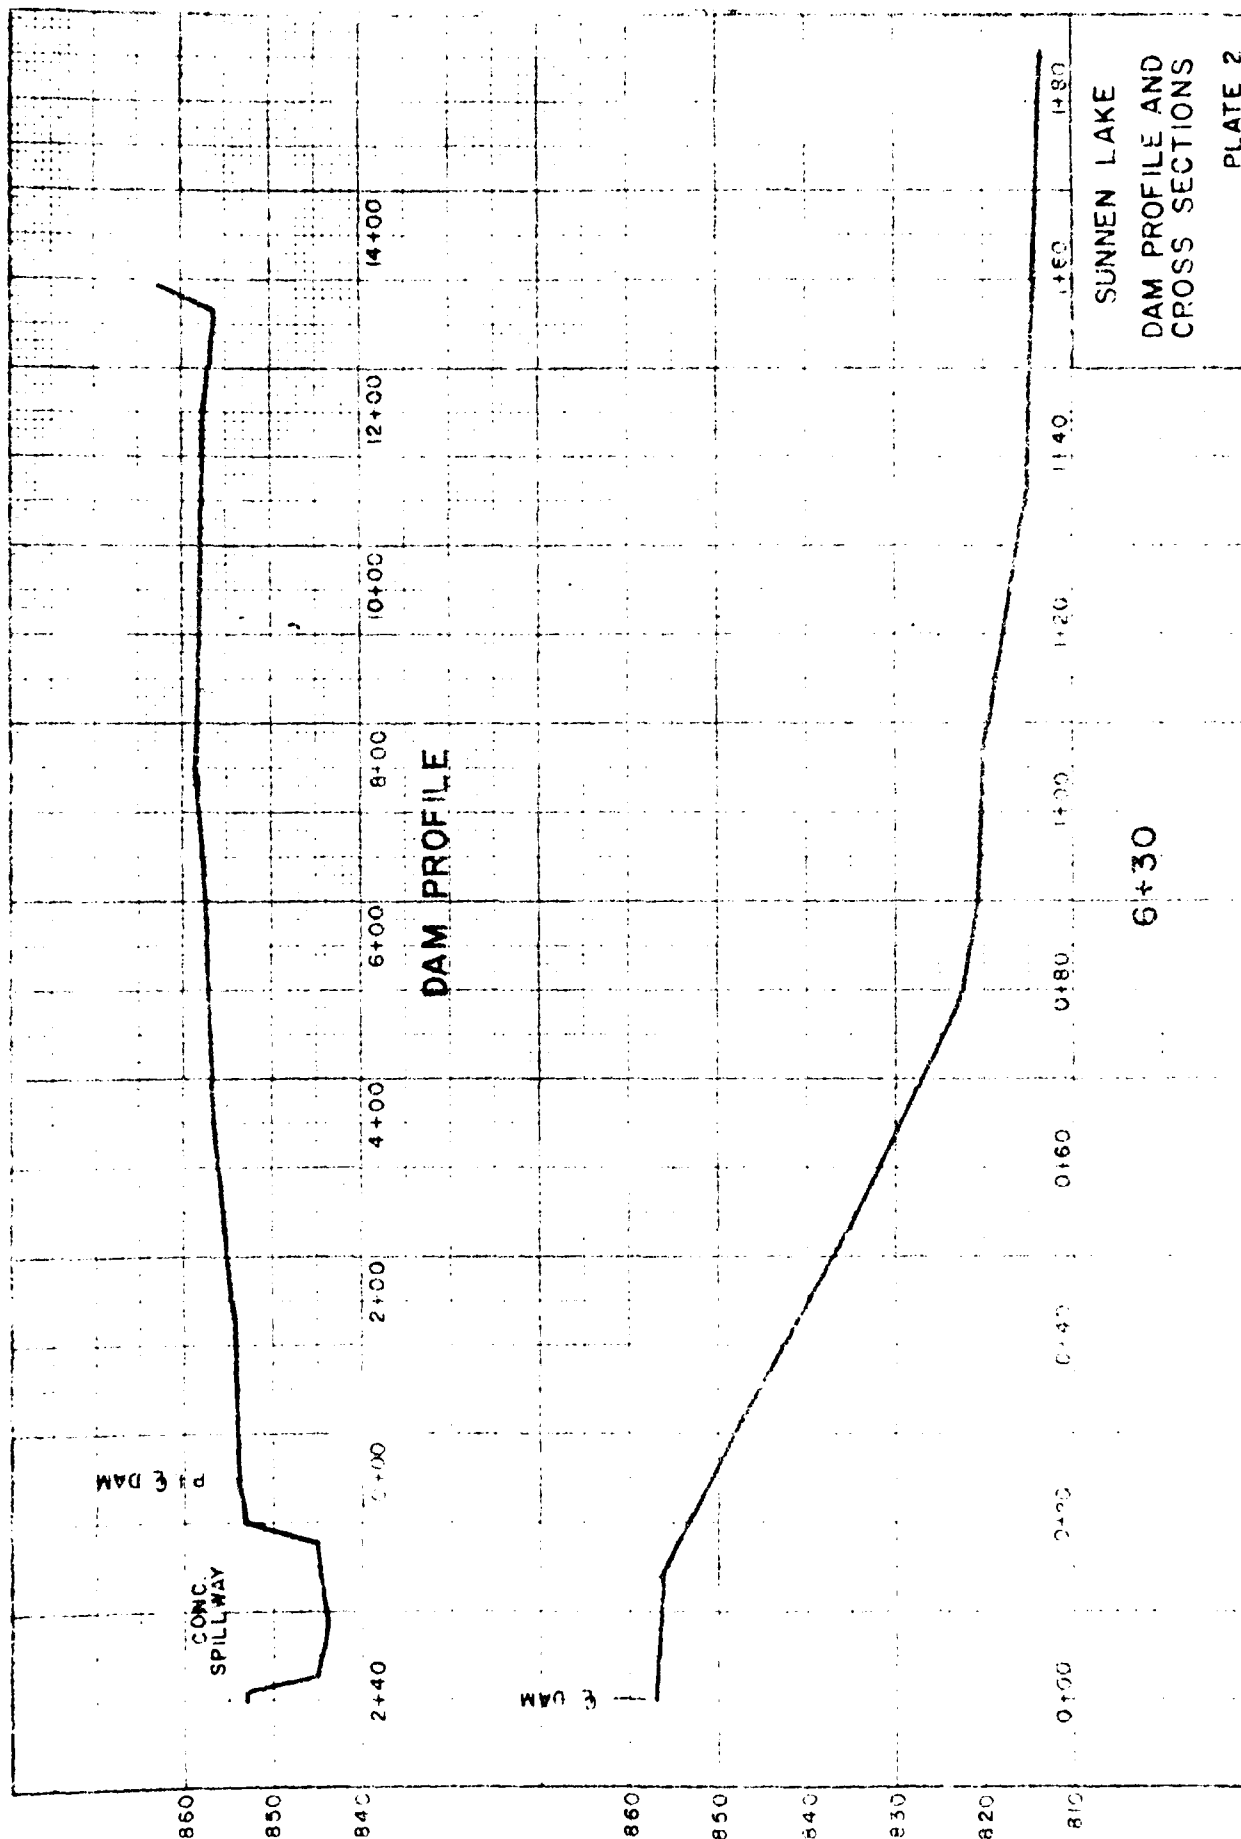
SUNNEN LAKE  
DAM PROFILE AND  
CROSS SECTIONS  
PLATE 2

(1) No detrimental cracking, settlement, sinkholes, or slides were observed in the embankment. Embankment cross-sections shown in Plates 2 and 3 are typical. Downstream slopes are relatively steep for a dam of this height, as evidenced by slow soil creep or sloughing along the portions of the slope. One-inch pipes were driven into the embankment in the mid-1950's, reportedly to retard the creep; the pipes are now sloping at various, in some cases extreme, angles. Some disruption of the pipes by pedestrian or horse traffic is also apparent. The steepness of the downstream slope

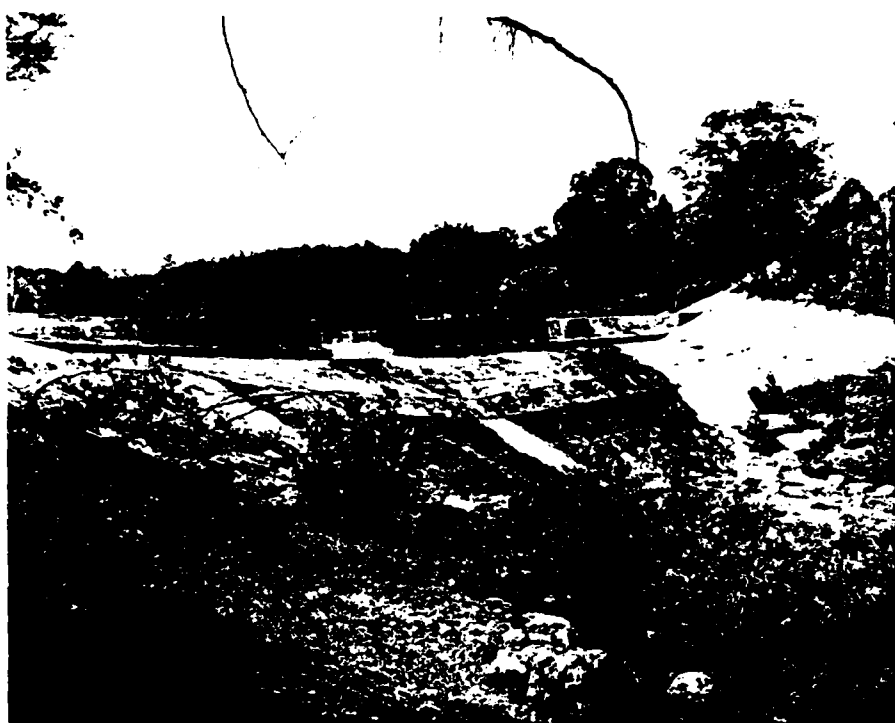
1 Spillway

(2) Spillway concrete was generally in good condition with no structural cracking. Surface spalling was present in several locations and the slab on the right of the apron just below the weir had extensive surface cracking which apparently had been repaired with a white grout.

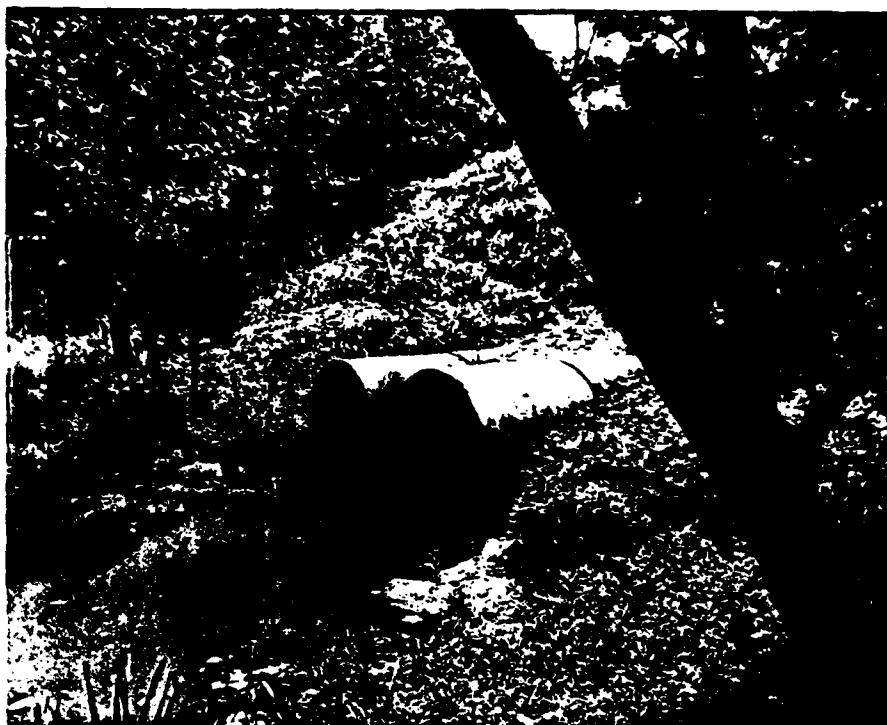
3    Outlet Pipes

h. Normal Operating Procedure. The dam has an uncontrolled spillway for normal flow and two 48-inch gated outlets. The outlet works are never used and are presently inoperative.

j. Regulating Outlets. Two 48-inch reinforced concrete pipes with gates set in a concrete box. Outlet works are presently unoperable.

Additional maintenance in the form of removing brush and small trees is recommended. When the gate tower is repaired, it should be of a type that will allow removal of the gates for inspection and maintenance.

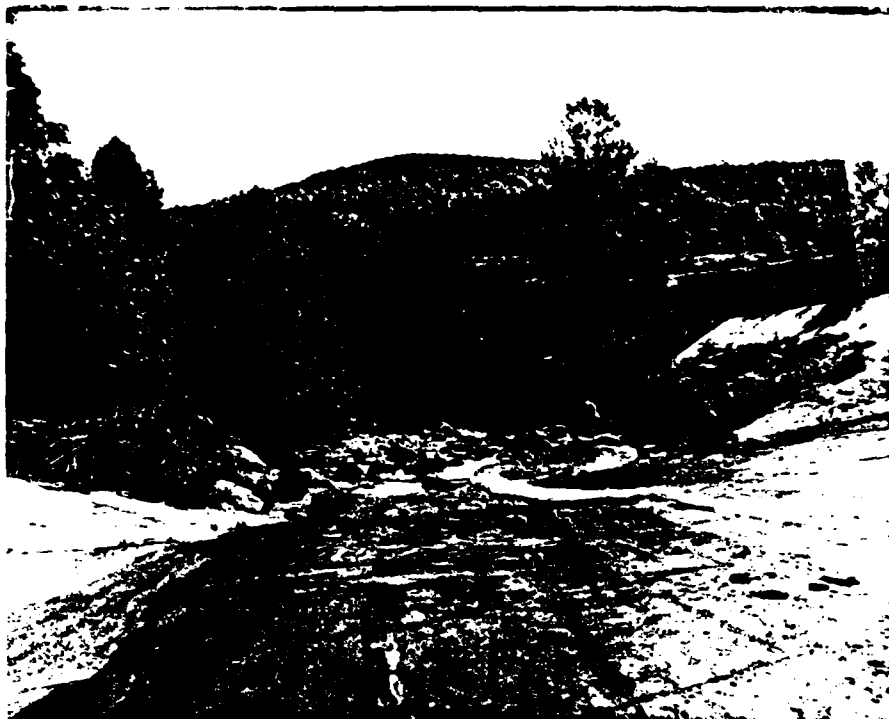
7 Spillway Outlet Channel

f. Downstream Channel. Erosion was noted at the downstream end of the spillway. Trees and vegetation were presented in both the spillway and outlet channels.

(3) Exit channels of the spillway and outlet pipes had trees and vegetation overgrown throughout. Some sediment deposition was noted in channels which could allow additional overgrowth problems.

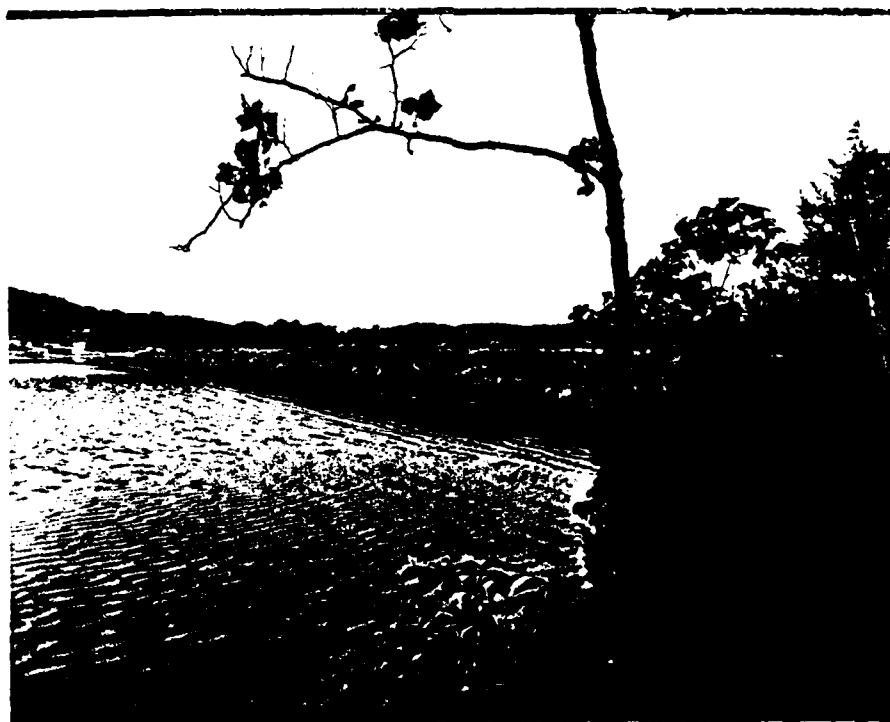
8 Upstream Slope

Brush and small trees on the embankment, lack of erosion protection on the upstream face, benching of the upstream face, and present inaccessability and inoperable condition of outlet gates are deficiencies which should be corrected. Steepness of the dam's slopes inhibit routine maintenance and are a factor in creep or sloughing of the downstream face. The slope creep, gate leakage, abutment seepage, and marshy conditions at the dam toe are not presently of a serious nature but should be carefully monitored for any change. Spalling concrete in the spillway should be patched. Voids under the spillway apron should be filled and any pipes or other water flow therein directed out from under the slab. Continued flow of water under the slab could further undermine the slab and endanger its performance where needed to pass large flows. Horse traffic on dam prevents establishment of turf and induces erosion. The tie-in embankment between the spillway and main dam lacks erosion protection and may be inadequate to resist a sustained high spillway flow.

c. Provide adequate erosion protection such as riprap on the upstream face of the dam. Repair benching of the embankment.

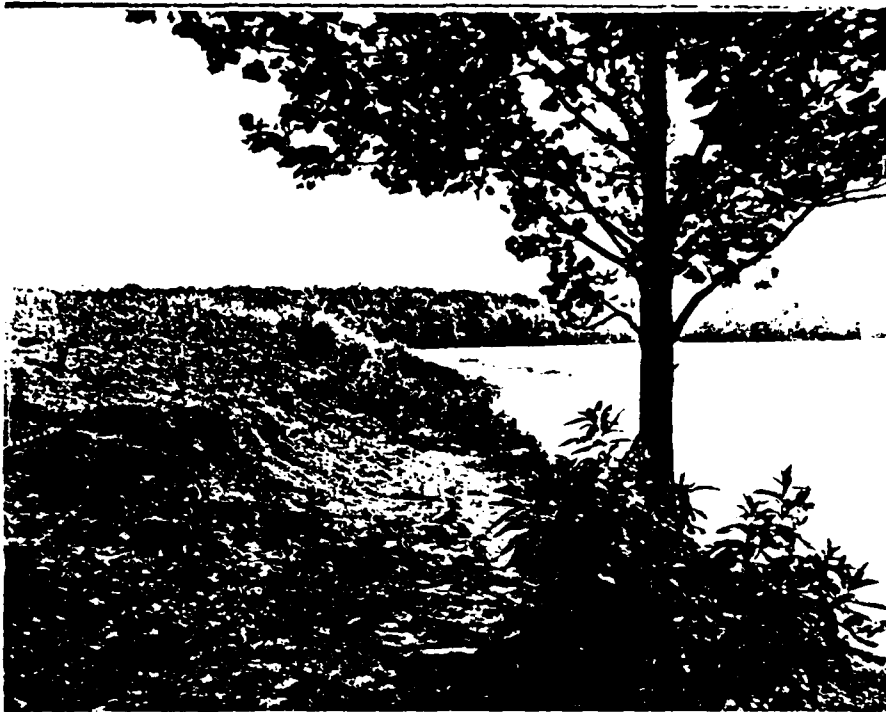
11 Benching in Upstream Slope

(1) Several items are deficient which should be corrected. No erosion protection is present on the upstream face of the embankment and wave action has caused benching along the length of the embankment. Brush and small trees are growing on the embankment. Horse traffic on the embankment has removed grass in localized areas. Voids under the spillway apron could lead to undermining. The outlet works is presently inoperable.
