ODD FELLOWS HOME LAKE DAM

MISSOURI INVENTORY NO. 11022

PHASE I INSPECTION REPORT

NATIONAL DAM SAFETY PROGRAM

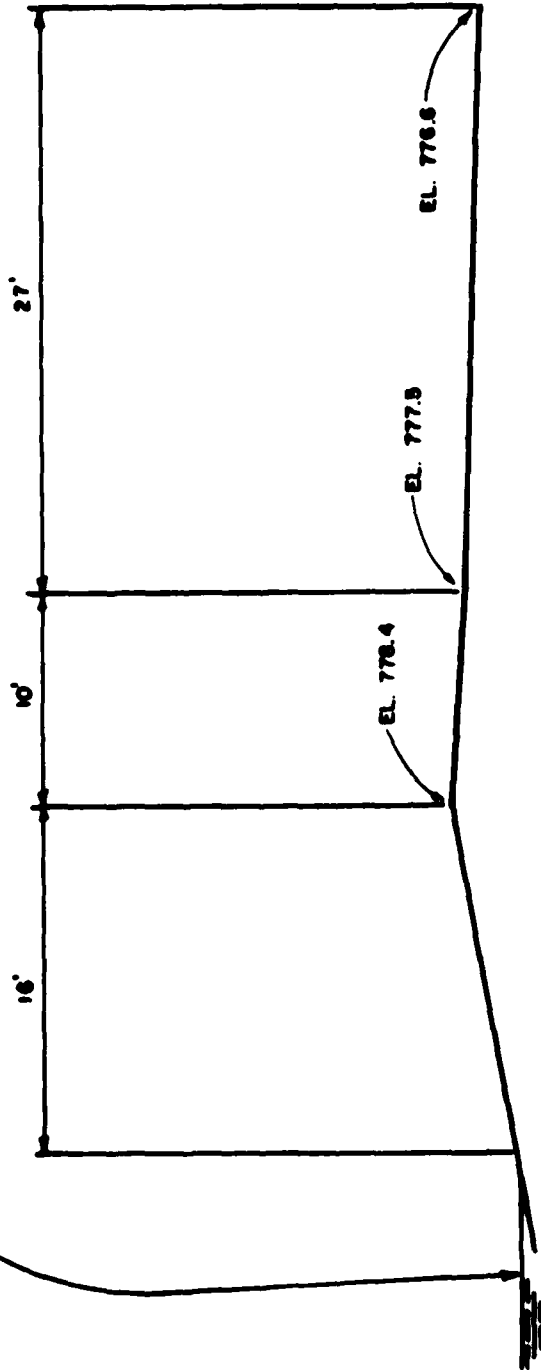
# ODD FELLOWS HOME LAKE DAM DAM CROSS SECTION

ODD FELLOWS HOME LAKE LEVEL  
AT TIME OF INSPECTION EL. 774.8

NOTE: CROSS SECTION TAKEN  
NEAR STATION 4 + 00
