LAKE CHARLES DAM

CHARLES COUNTY, VIRGINIA

VA. NO. 01124

PHASE I INSPECTION REPORT

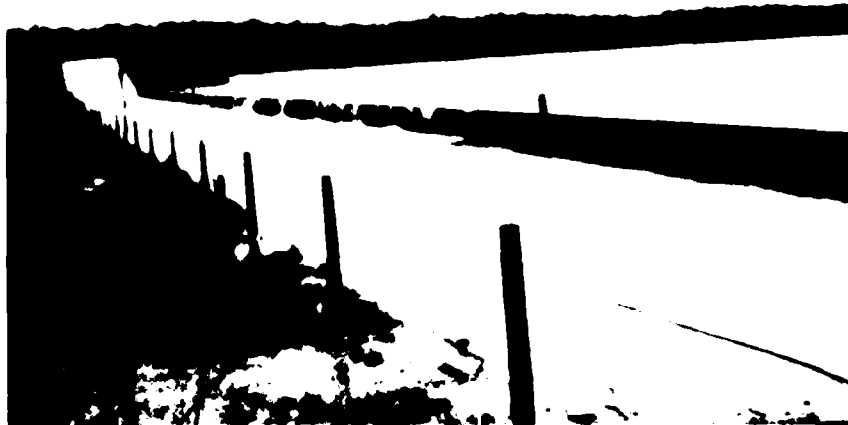
An overflow spillway and apron are located at the left abutment and consist of a 400 ft wide concrete weir with a 8 ft wide by 3 inch deep low flow notch. No signs of deterioration were noted and the concrete appeared to be in good condition. There was no separate approach channel to the spillway. The reservoir area upstream of the weir was riprap lined and appeared to be in good condition. The discharge channel is approximately 300 ft wide and slopes at about 7.5 percent. Immediately downstream from the weir, the discharge channel is occupied by the access road which crosses the dam crest. The road is concrete through the spillway area and bordered by a cable guardrail along the downstream edge. The discharge channel is lined with stone riprap and grouted along the center portion below the roadway. Evidence of severe erosion during Hurricane Camille is still visible in the lower reaches of the discharge area. It was reported that 11 ft deep gullies were carved into the discharge channel below the concrete section. These have been backfilled with riprap and concrete slurry and appeared stable.

Photograph No. 1 - Spillway
Note Access Road Across Spillway

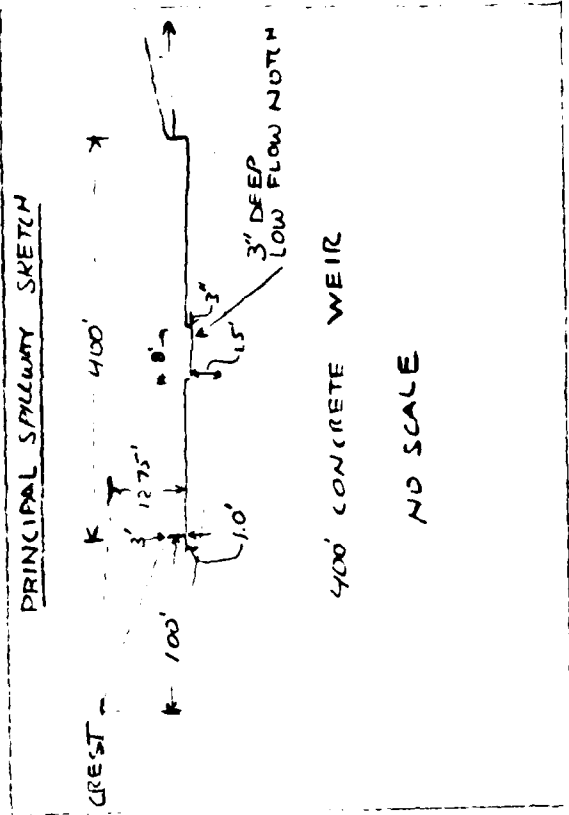
FIELD SKETCH LAKE CAROLINE DAM

VISUAL EXAMINATION OF	OBSERVATIONS	REMARKS AND RECOMMENDATIONS
CONTROL SECTIONS	Principal spillway consists of a 400 ft wide concrete wier with a 7 ft wide x 3" deep low flow notch. See Field Sketch, Sheet 1.	Combined principal-emergency spillway in good condition.
APPROACH CHANNEL	No separate approach channel. Area upstream of wier is riprap lined and in good condition.	-
DISCHARGE CHANNEL	The discharge channel is approximately 300 ft wide and slopes at about 7.5%. Immediately below the wier the discharge channel is connected and bordered by a cable guard rail along the downstream edge. This area serves as part of the road crossing the dam. Just downstream from the roadway the discharge channel is covered with riprap. The discharge channel area downstream from the concrete section was severely eroded in 1969 during hurricane Camille. 11 ft deep gullies eroded in the channel areas during the storm were backfilled with riprap and concrete slurry. Evidence of severe erosion during the storm is still visible in the lower reaches of the discharge area. The area appeared stable.	This information was received from Mr. Miller during the inspection.
