**ODESSA DAM
LAFAYETTE COUNTY, MISSOURI
MO. 20042**

PHASE 1 INSPECTION REPORT NATIONAL DAM SAFETY PROGRAM

PHASE I INSPECTION REPORT
NATIONAL DAM SAFETY PROGRAM

PREPARED BY
BLACK & VEATCH
CONSULTING ENGINEERS
KANSAS CITY, MISSOURI

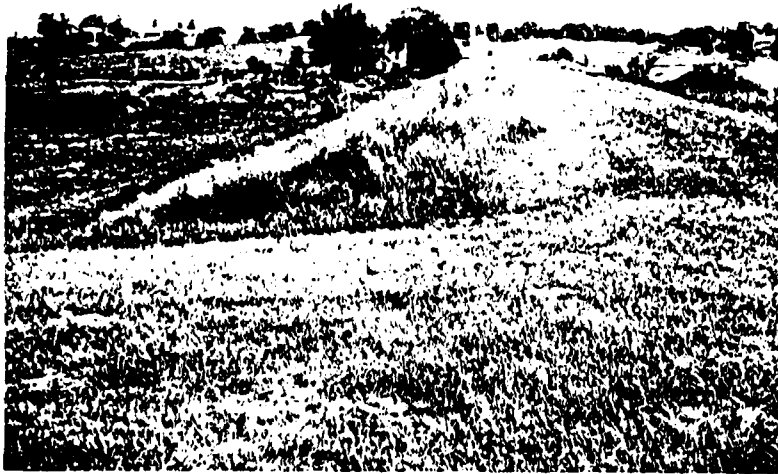
b. Dam. The inspection team observed the following items at the dam. Small trees and dense weeds were observed on both the upstream and downstream faces. Several larger trees had been cut from the upstream slope but the stumps and roots were not removed. Visible seepage was observed near the downstream toe of slope near the left abutment. Evidence of seepage was observed along the downstream face about 5 feet above the toe of slope; however, the seepage was not visible on the day of the inspection. No cracks or slides were noticed along the embankment. Some minor erosion on the downstream slope was observed.

Photo No. 1: DOWNSTREAM FACE OF DAM

(1) Check the downstream face of the dam periodically for seepage and stability problems. If increased seepage flows are observed or deterioration of the foundations of the embankment noted, the dam should be inspected and the pending condition evaluated by an engineer experienced in design and construction of earthen dams.

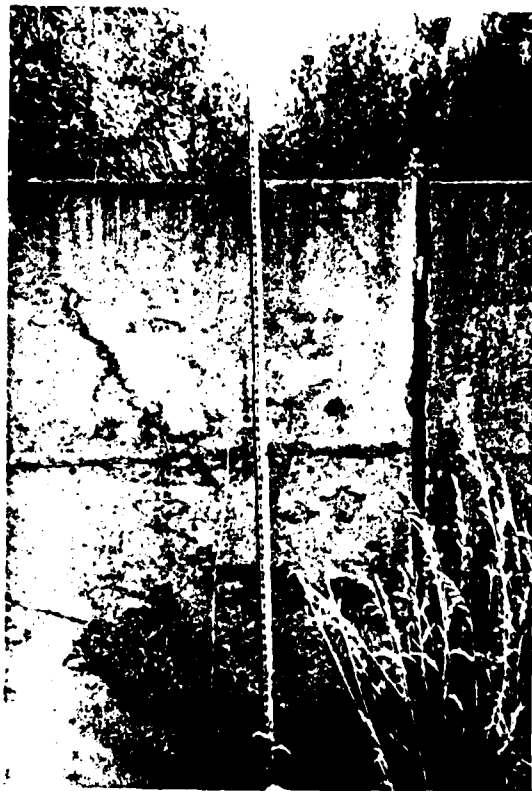
Photo No. 12: RIGHT TRAINING WALL AT SPILLWAY CREST

(4) The trees growing on the back side of the concrete training walls (approach channel) should be removed.
