**INDIAN CREEK MINE DAMS
WASHINGTON COUNTY, MISSOURI
MO 30717 & 31036**

**PHASE 1 INSPECTION REPORT
NATIONAL DAM SAFETY PROGRAM**

FEBRUARY 1980

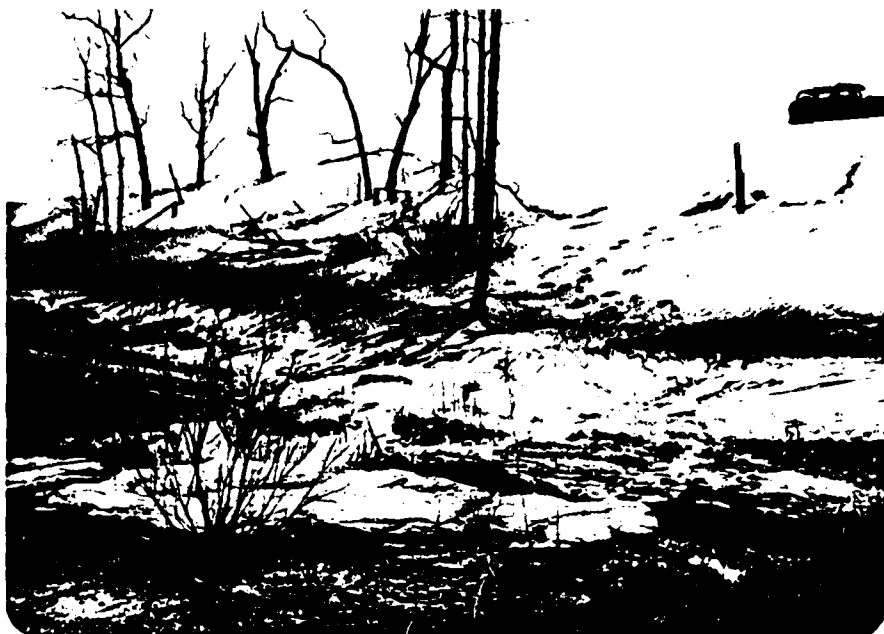
<u>Photo No.</u>	<u>Description</u>
1	Toe of tailings embankment near right abutment. Note seepage near toe and bedrock exposure.
2	View of dam toe along rock buttress at maximum section. Note erosion.
3	Toe of dam at maximum section. Note erosion and marshy ground.
4	View downstream from crest toward area behind left abutment. Note seepage wetting line, abandoned spigot line supports, and erosion rills at edge of the old dam.
5	Diverted drainage ponded behind left abutment. Note seepage through diversion dike.
6	Typical sloughing of embankment tailings from seepage.
7	Area below toe of starter dam. Note eroded materials and marshy ground.
8	View toward right abutment showing downstream slope and toe of starter dam. Note rock buttress, eroded materials and marshy ground at toe.
9	Spillway channel downstream from bridge. Note condition of slopes and materials.
10	Entrance to spillway channel.
