NDI ID PA 00640

## LAKE AKIBA DAM

### PHASE I INSPECTION REPORT NATIONAL DAM INSPECTION PROGRAM

AUGUST 1981

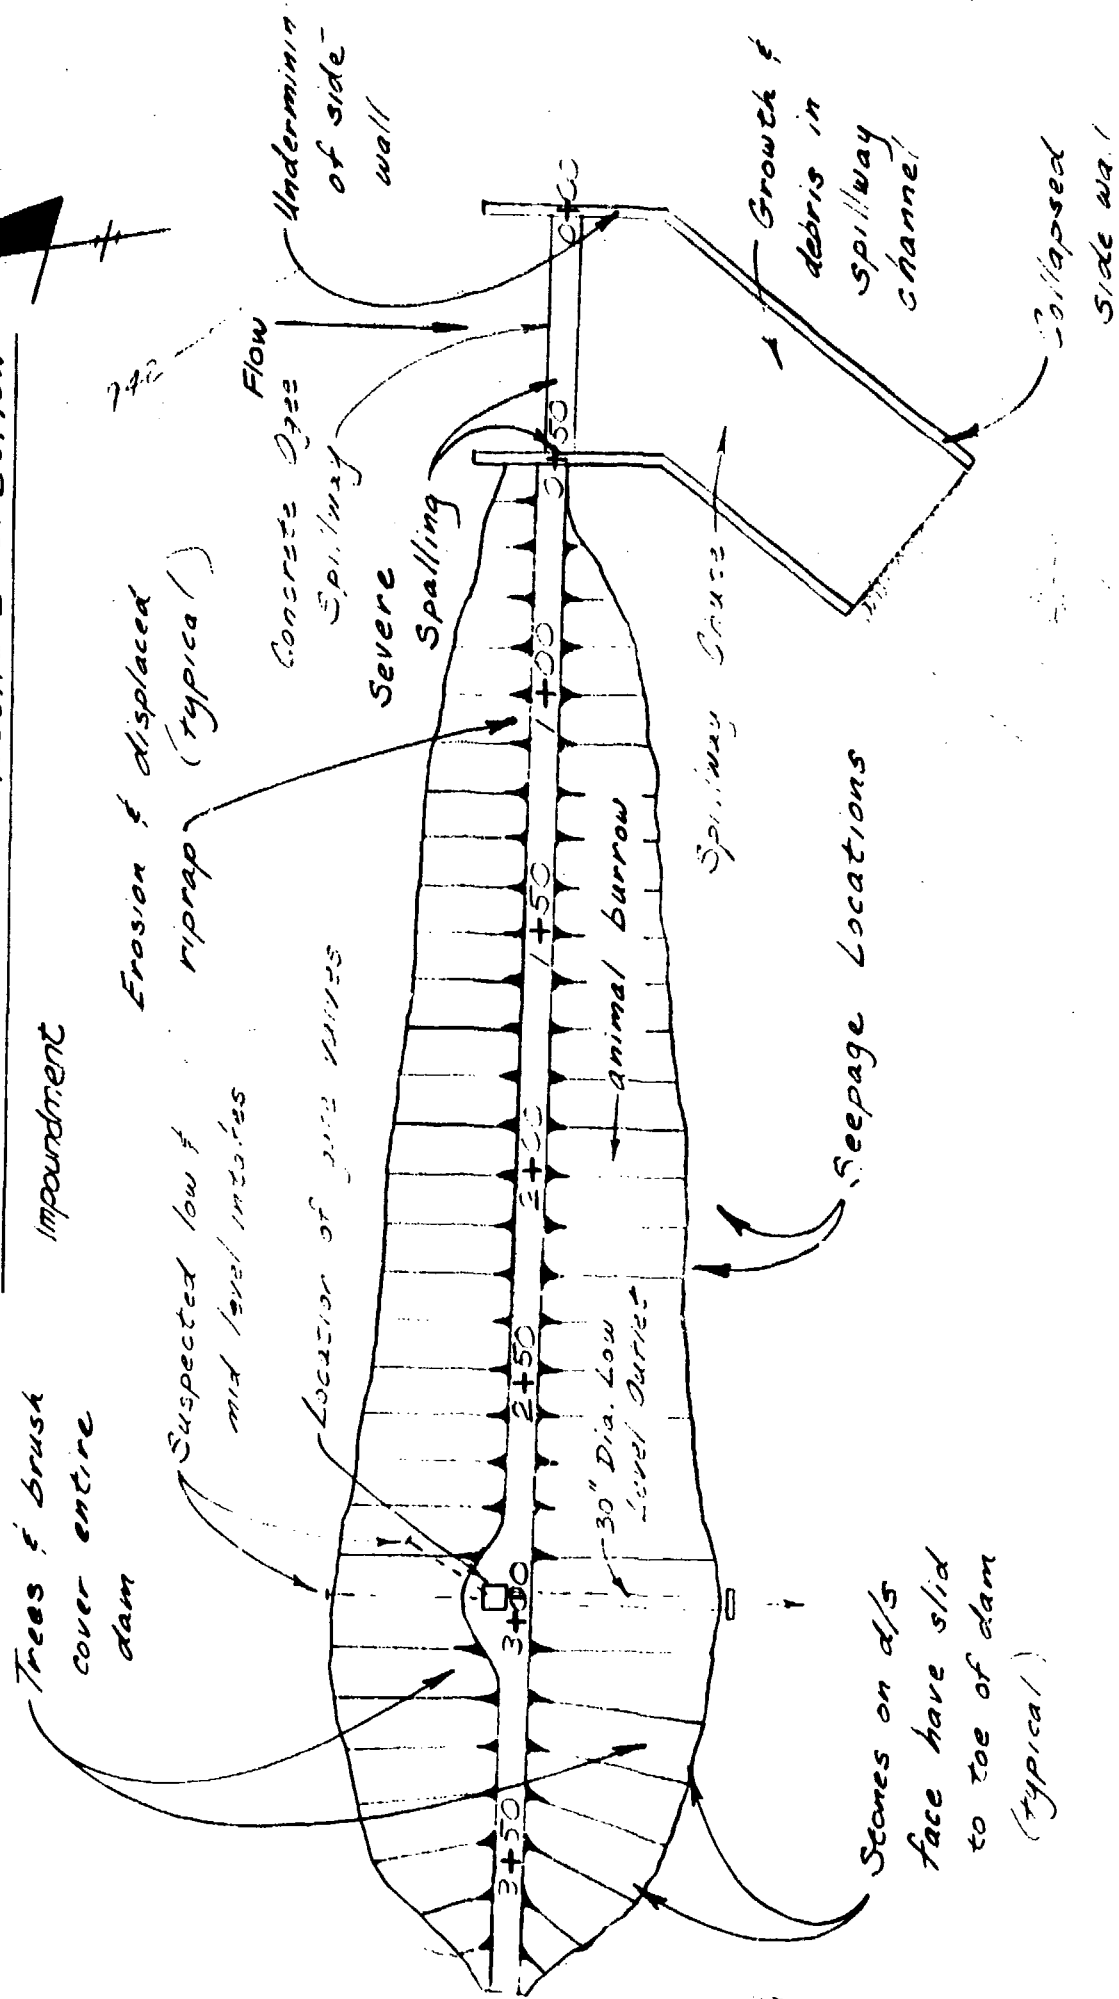
LOCATION PLAN OF DEFICIENCIES  
OBSERVED DURING VISUAL INSPECTION

Seepage was found at two locations to the east of the outlet works (See sheet 11A of Appendix A). It was estimated to be approximately one gallon per minute at the western most location and no flow was observed at the other location (Photo 8, Appendix C).
