DELAWARE RIVER BASIN
MILLTOWN DAM
WEST CHESTER AREA MUNICIPAL AUTHORITY

NDI NO. PA-00218
DER NO. 15-146

CHESTER COUNTY, PENNSYLVANIA
PHASE I INSPECTION REPORT
NATIONAL DAM INSPECTION PROGRAM

JULY 1981

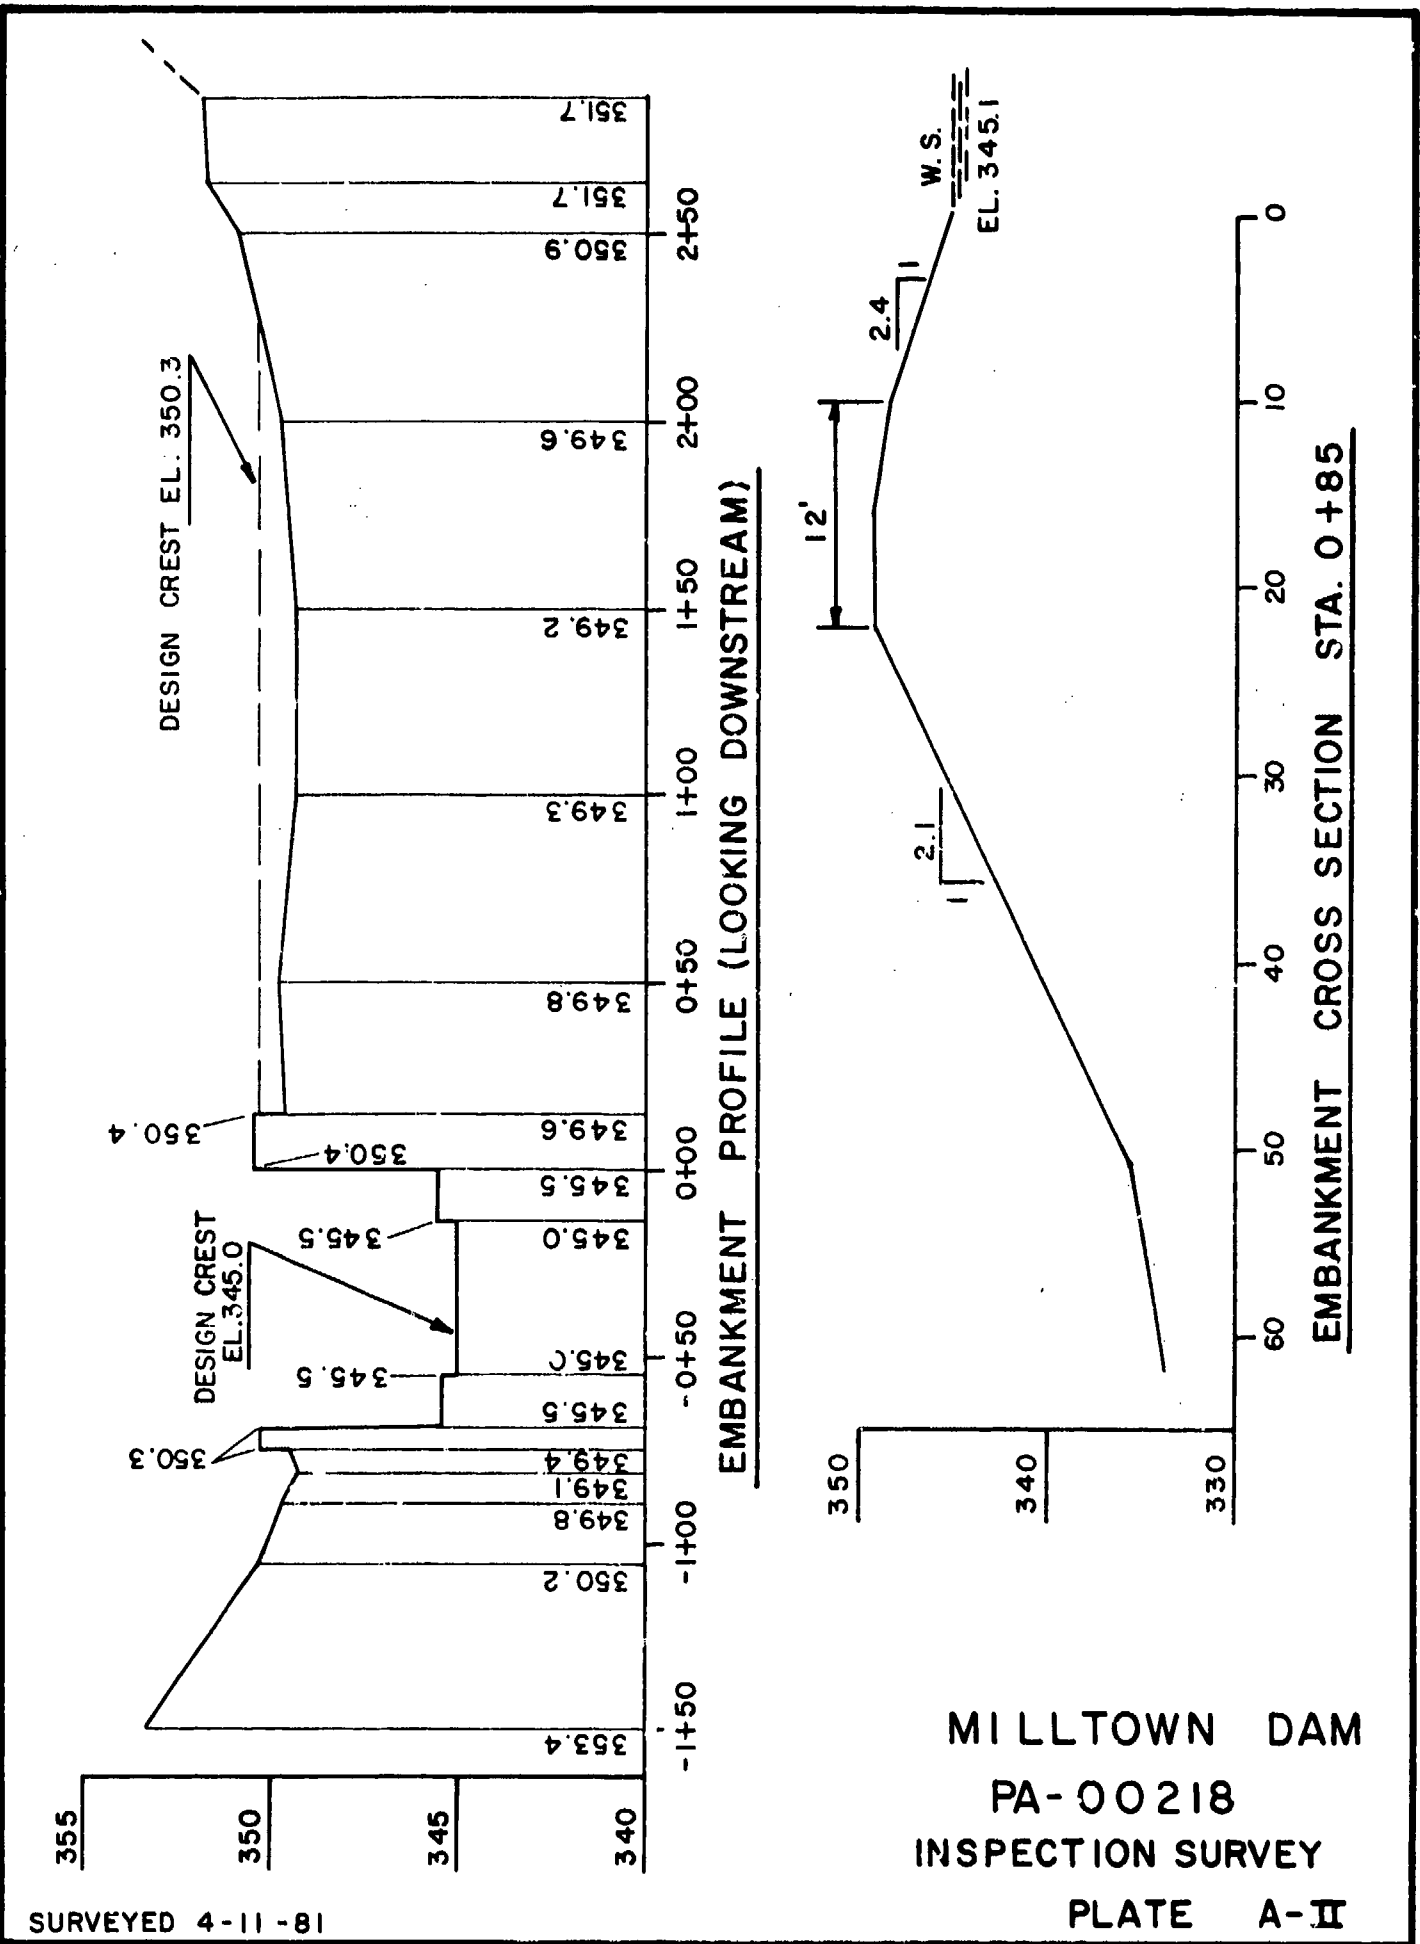
MILLTOWN DAM
PA-00218
INSPECTION SURVEY
PLATE A-I

The embankment on the left side of the spillway has a low and narrow crest (Photographs No. 1 and No. 6). Several large trees are growing on both the upstream and downstream slopes. The embankment to the right of the spillway has a poor appearance. The crest is below the design elevation and has very little protective cover. The upstream slope is covered with dumped rock with a considerable growth of brush near the normal flow line (Photograph No. 3). The downstream slope has very dense brush over most of its surface, which prevented close observation of the condition of this slope. Rubbish and fill have been dumped on this slope. A steep, bare footpath is located adjacent to the spillway on the downstream slope. A concrete slab has been placed on the crest adjacent to the control structure (Photograph No. 5). A sewer line and several man holes are located immediately downstream of the dam (Plate A-I). Piles of rock, brush, tires, and other debris were dumped in this area.

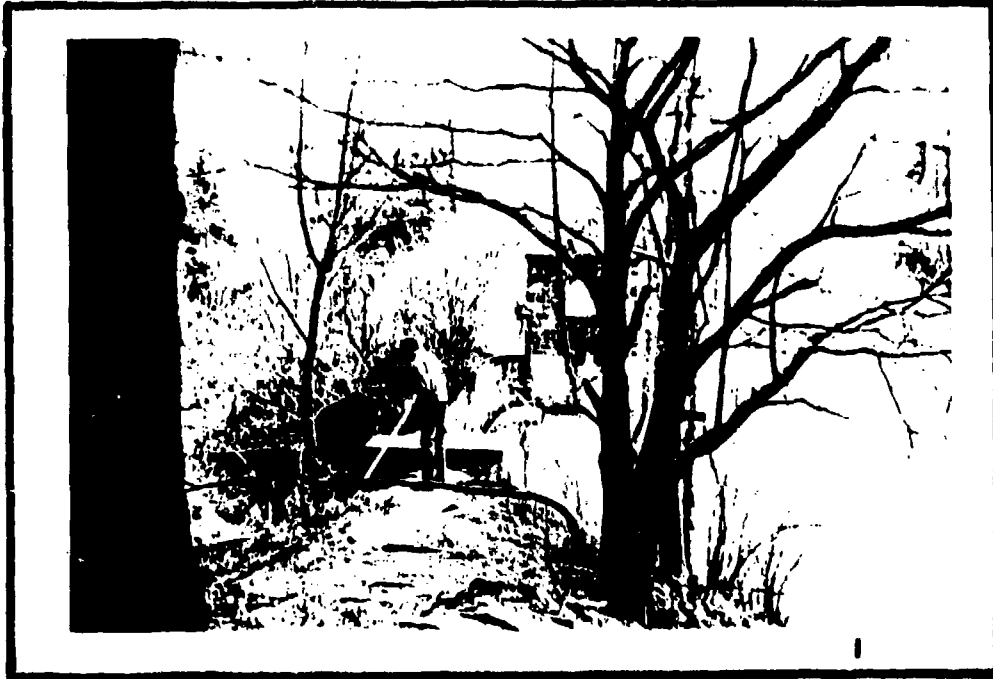
LEFT EMBANKMENT - NO. 6
NOTE: TREES AND NARROW CREST

The overall visual evaluation of Milltown Dam indicates that the dam is in poor condition due to poor maintenance practices. It is recommended that the embankment and the area immediately downstream of the embankment be cleared of all trees, brush and debris. The crest of the embankment and the slopes should be restored to their original design dimensions and be provided with a protective vegetative cover.

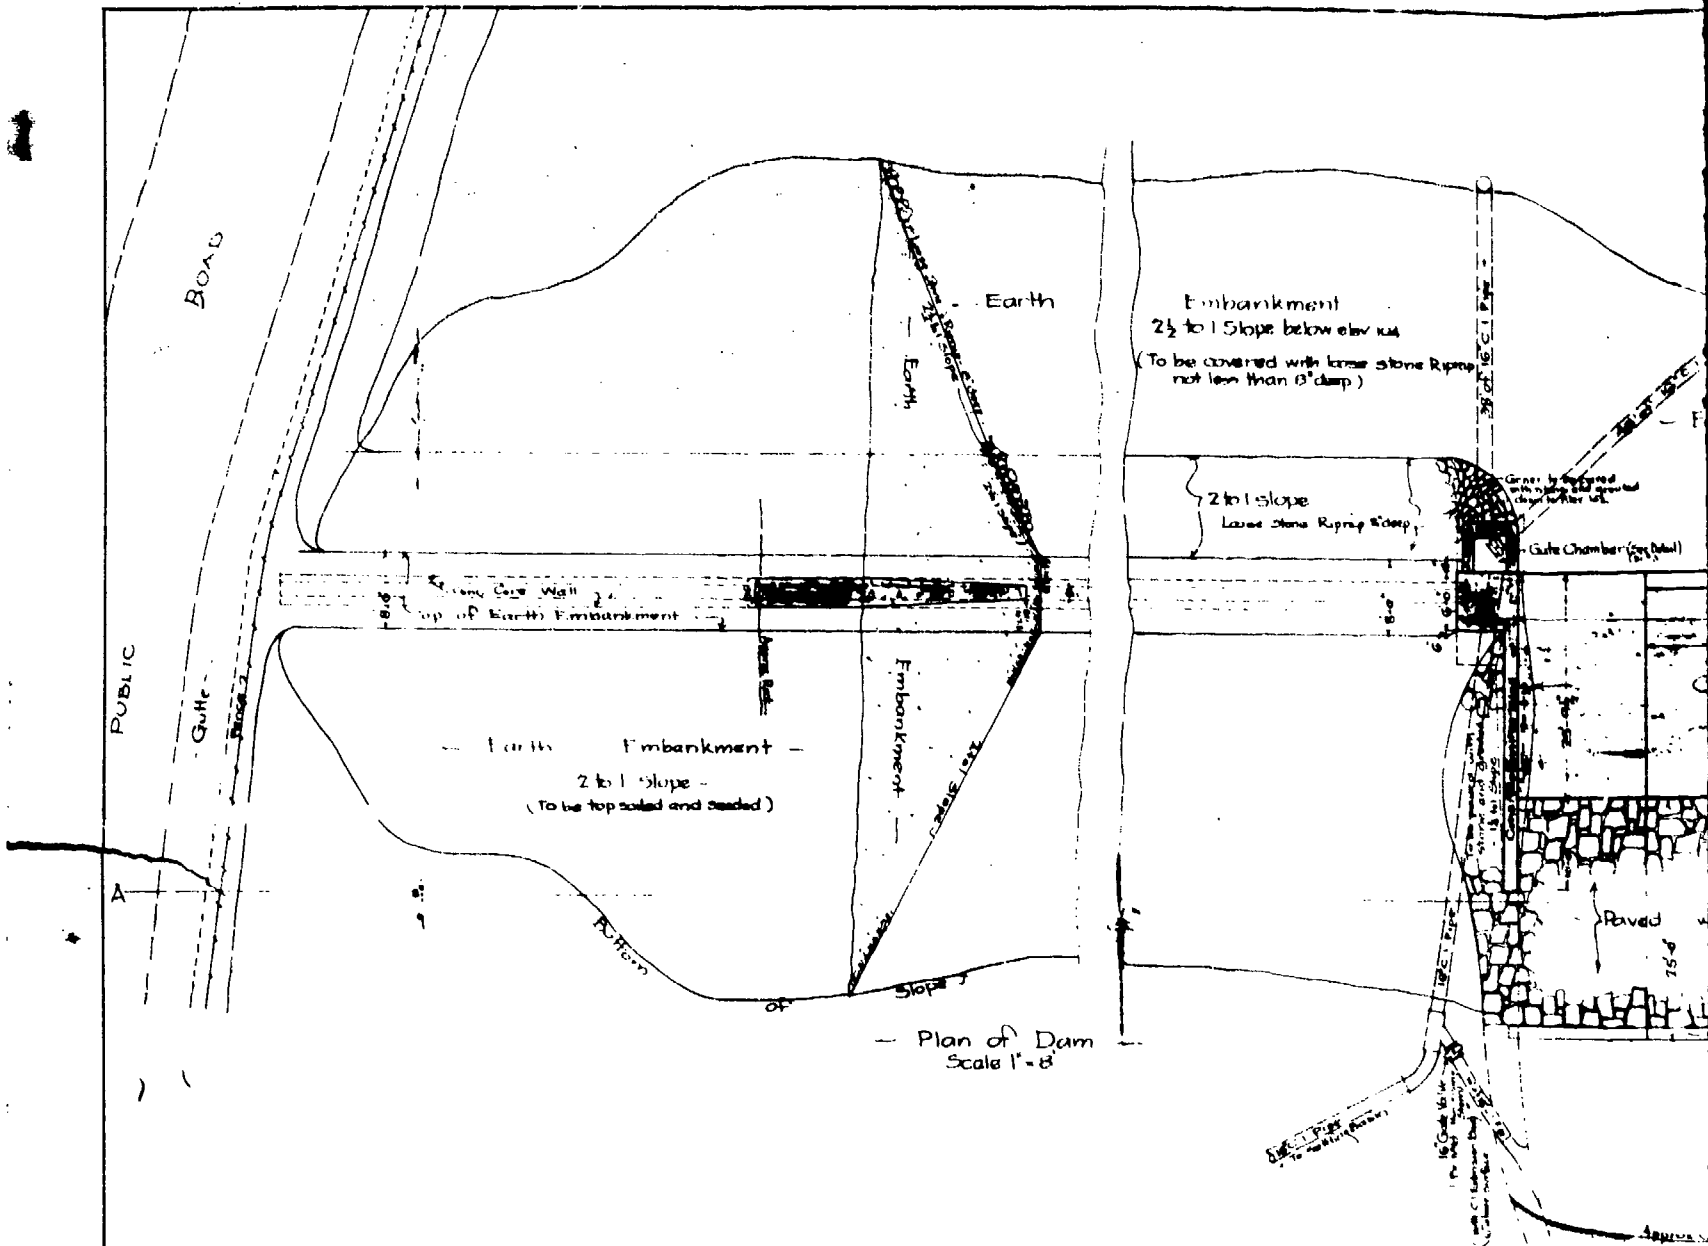
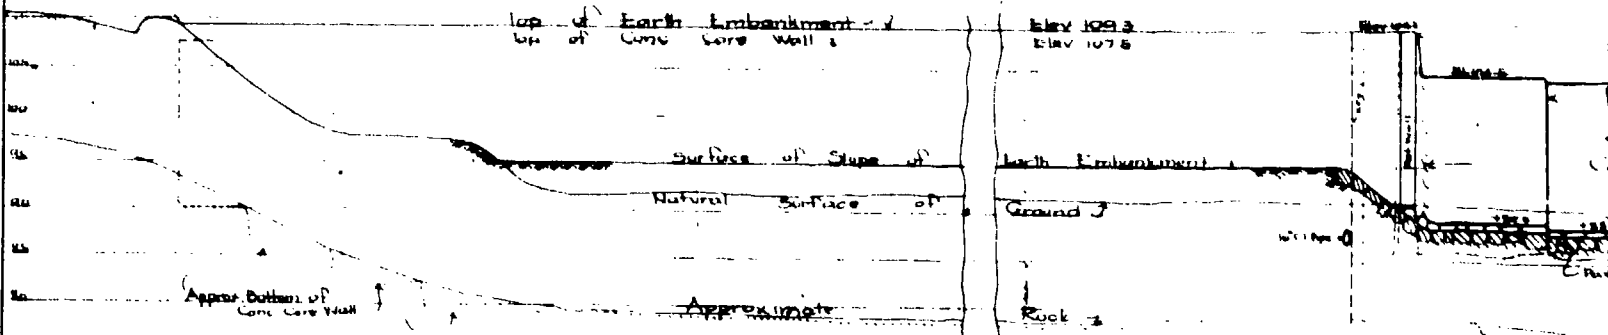
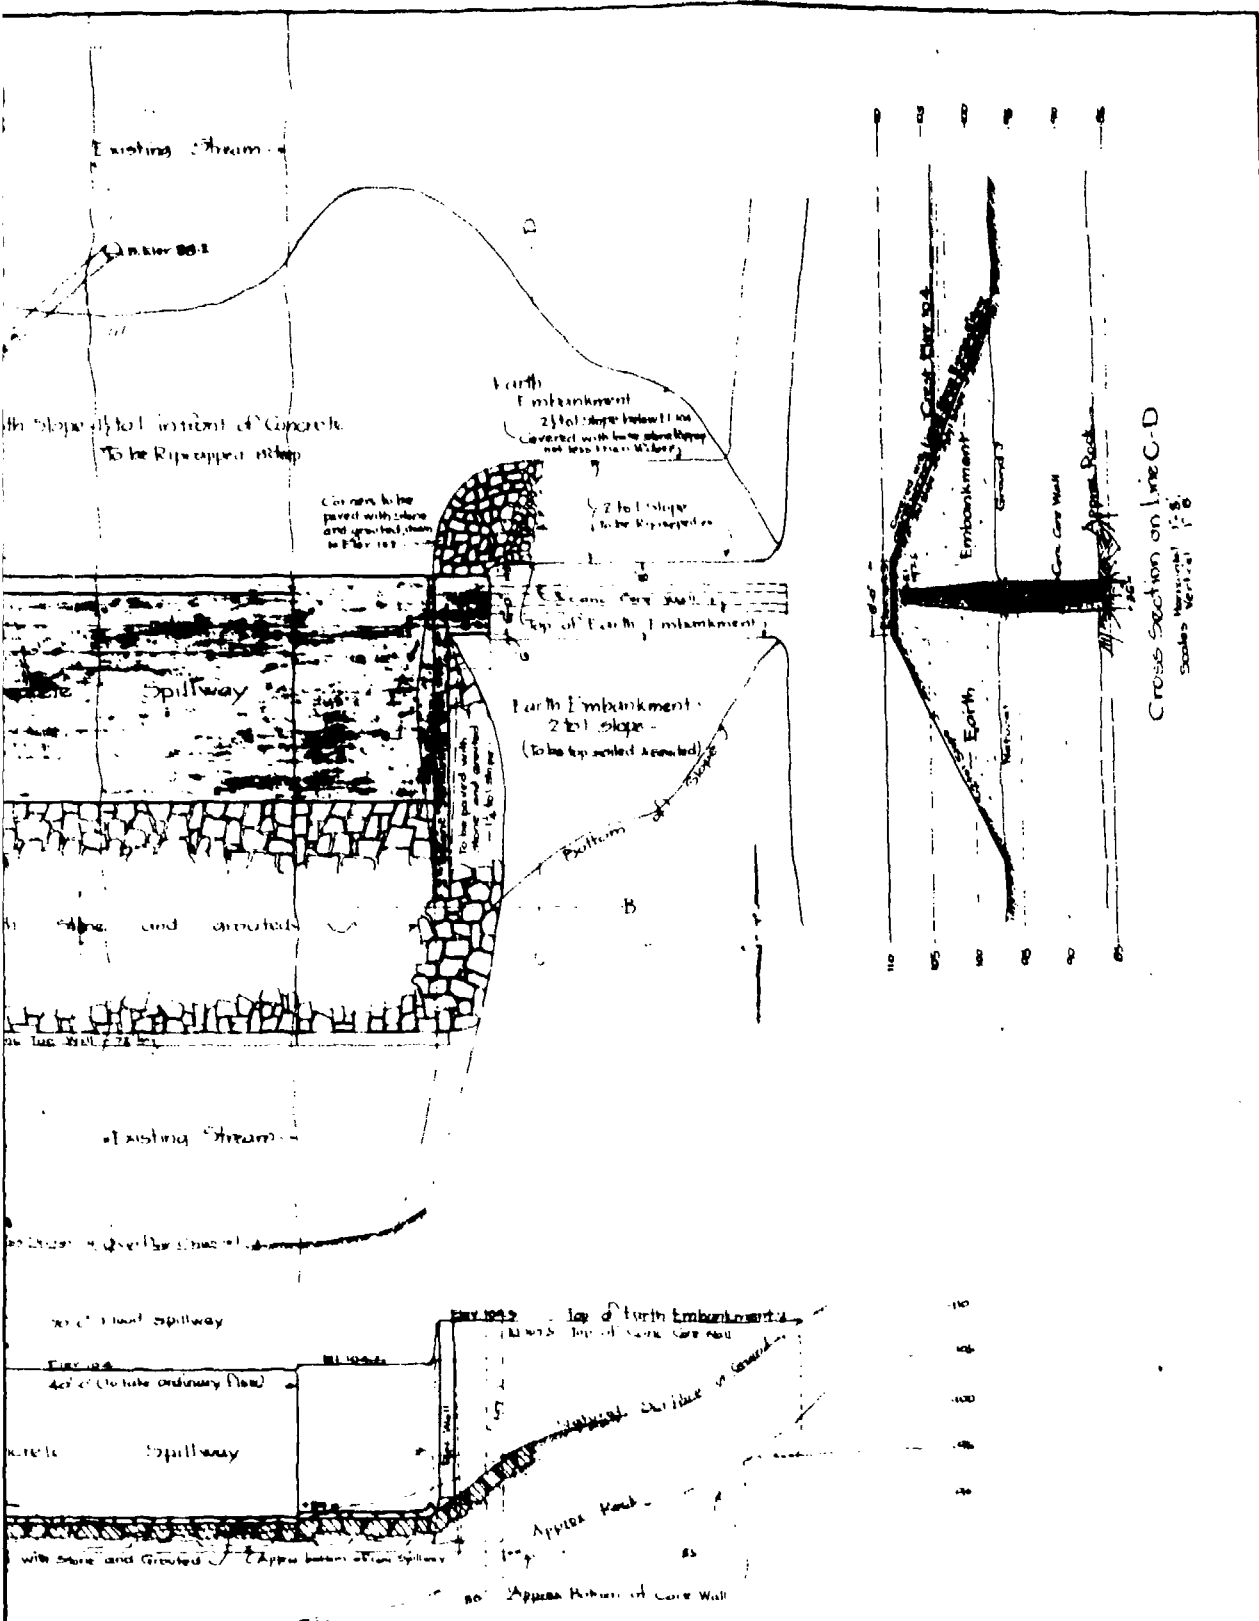
PLATE III
 PA-00218

The typical embankment section (Plate III, Appendix E) indicates an earthfill embankment with a concrete core wall along the centerline of the dam. The core wall has a bottom width of three feet and was founded on rock. A trench up to 15 feet deep was excavated through the overburden. The top of the core was 1.8 feet below the design crest elevation. The upstream slope was protected with riprap.

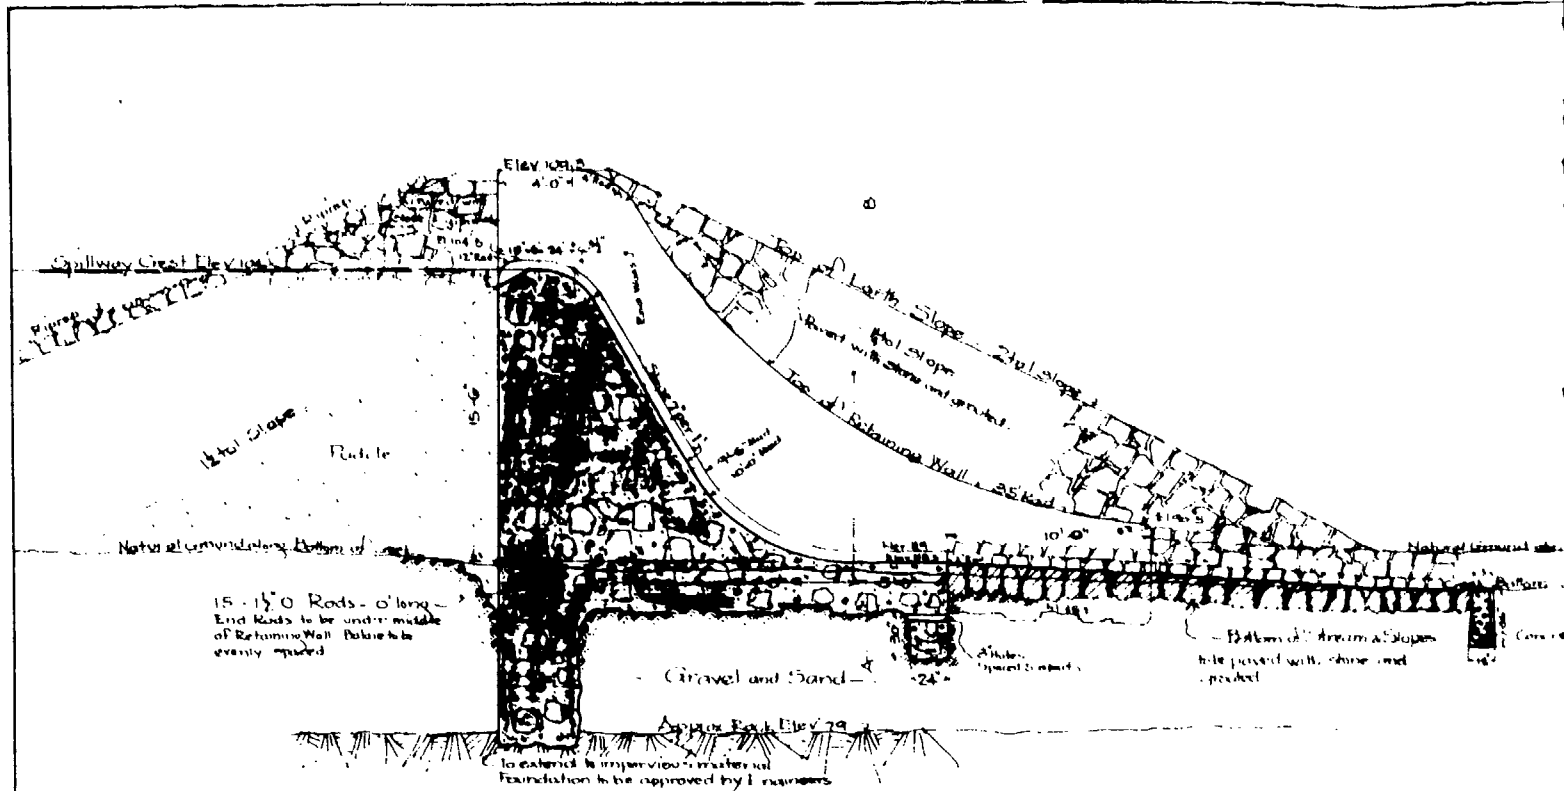
--- Cross Section of Concrete Spillway ---
 (about center line looking east)
 Scale: 1/4"

The typical section of the spillway (Plate IV, Appendix E) indicates only a token amount of reinforcement in the concrete section. Fifteen tension bars, spaced at about 5 feet, are located on the upstream side. A cutoff wall is placed on the upstream side. The spillway is founded on gravel and sand. At the downstream side, there is a 30-inch deep cutoff wall with weepholes. Beyond this cutoff wall is a grouted stone slab about 25 feet long with another three foot deep cutoff wall.
