LAKE GREELEY DAM

NDI ID. NO. PA-00752
PENNDER ID. NO. 52-20

PHASE I INSPECTION REPORT
NATIONAL DAM INSPECTION PROGRAM

SEPTEMBER 1981

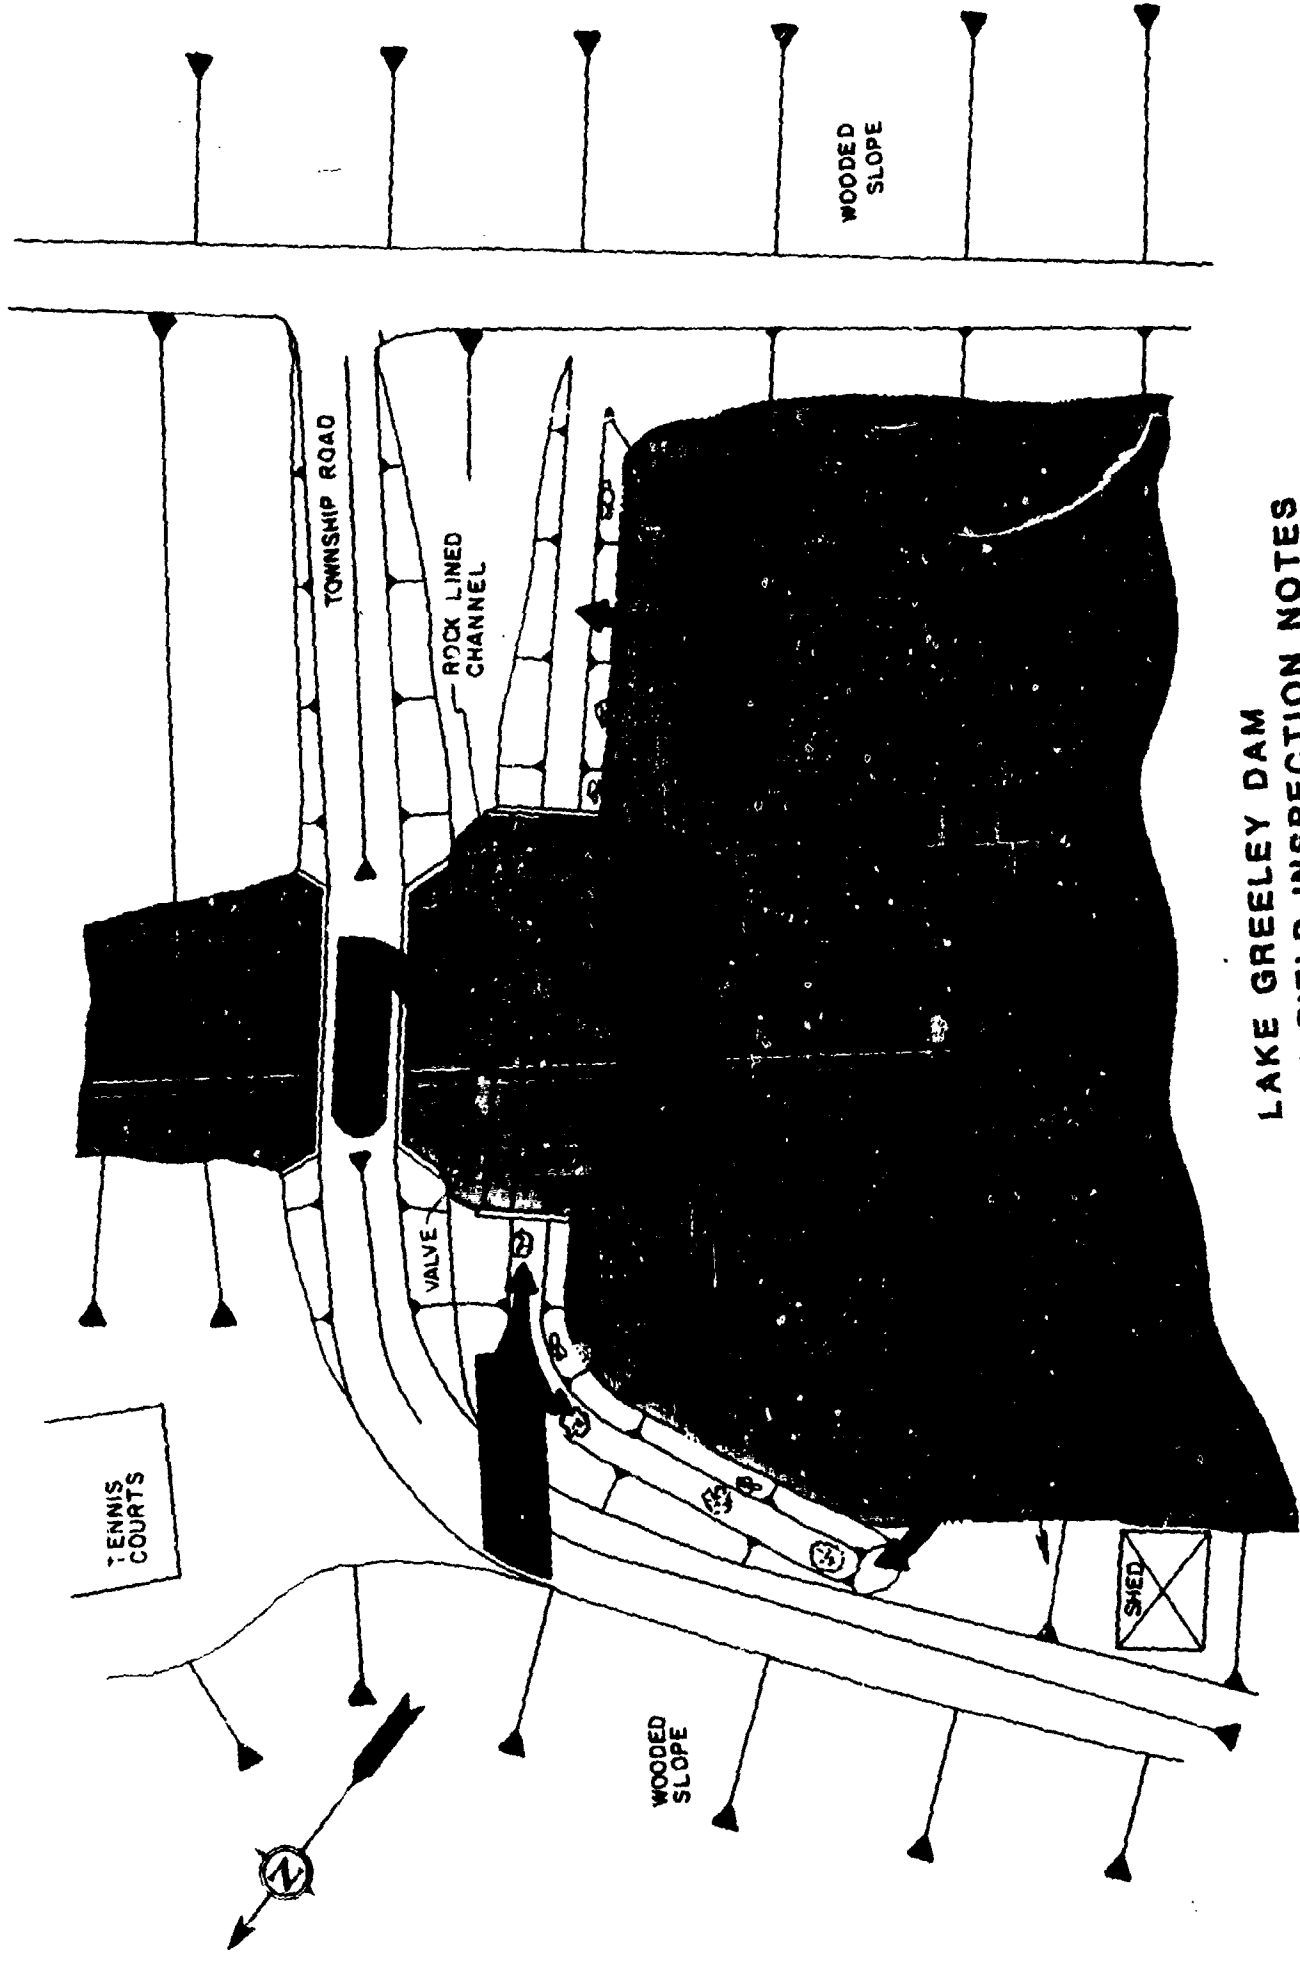
LAKE GREELEY DAM
GENERAL PLAN-FIELD INSPECTION NOTES

ITEM	OBSERVATIONS/REMARKS/RECOMMENDATIONS	NDI# PA - 00752
SURFACE CRACKS	None observed.	
UNUSUAL MOVEMENT OR CRACKING AT OR BEYOND THE TOE	None observed.	
SLOUGHING OR EROSION OF EMBANKMENT AND ABUTMENT SLOPES	Upstream face of left embankment section is irregular and appears somewhat eroded.	
VERTICAL AND HORIZONTAL ALIGNMENT OF THE CREST	Horizontal - curved embankment. Vertical - see "Profile of Embankment Crest from Field Survey", Appendix A.	
RIPRAP FAILURES	Riprap is composed of hard, well graded sandstone boulders and rock fragments. Riprap along the upstream face of the left embankment section appears displaced in some areas.	
JUNCTION OF EMBANKMENT AND ABUTMENT, SPILLWAY AND DAM	Junctions of embankment - right abutment, spillway and dam are in good condition. Left embankment section suddenly stops at its extreme left end and does not extend into the left abutment. Obvious low area.
