13. MONITORING AGENCY NAME & ADDRESS (if different from Controlling Office) Department of the Army 26 Federal Plaza New York District, CofE New York, NY 10287		12. REPORT DATE 14 August 1981

Assessment - Newtown-Hoffman Creeks Watershed Project - Floodwater
Retarding Dam Site 18

DEC I.D. 61D-4285

PHASE I INSPECTION REPORT
NATIONAL DAM SAFETY PROGRAM
NEWTOWN-HOFFMAN CREEKS WATERSHED PROJECT -
FLOODWATER RETARDING DAM SITE 18
N.Y. 700
DEC I.D. NO. 61D-4285
CHEMUNG RIVER BASIN
CHEMUNG COUNTY, NEW YORK

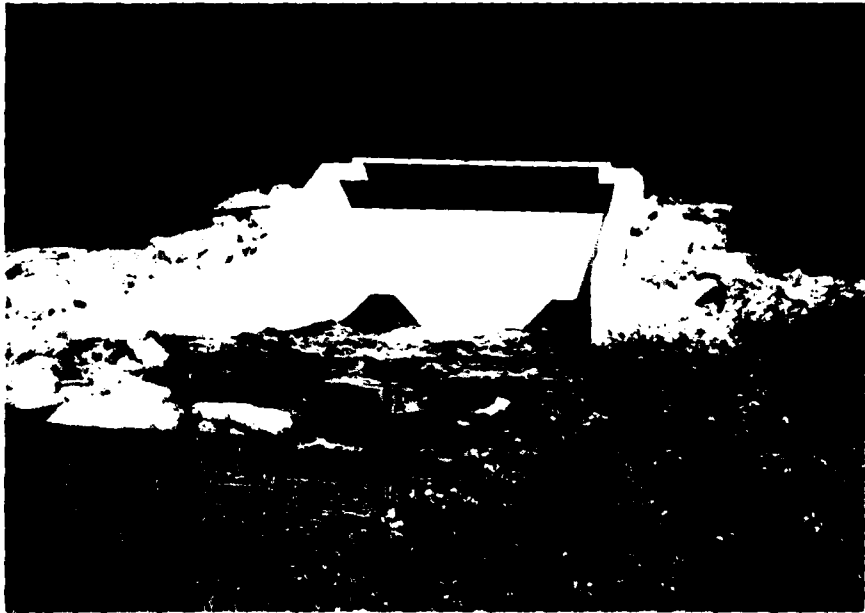
PHOTOGRAPH NO. 7
Primary Spillway Impact Basin

b. Structural Cracking The outlet structure had some cracking
on the baffle slab.

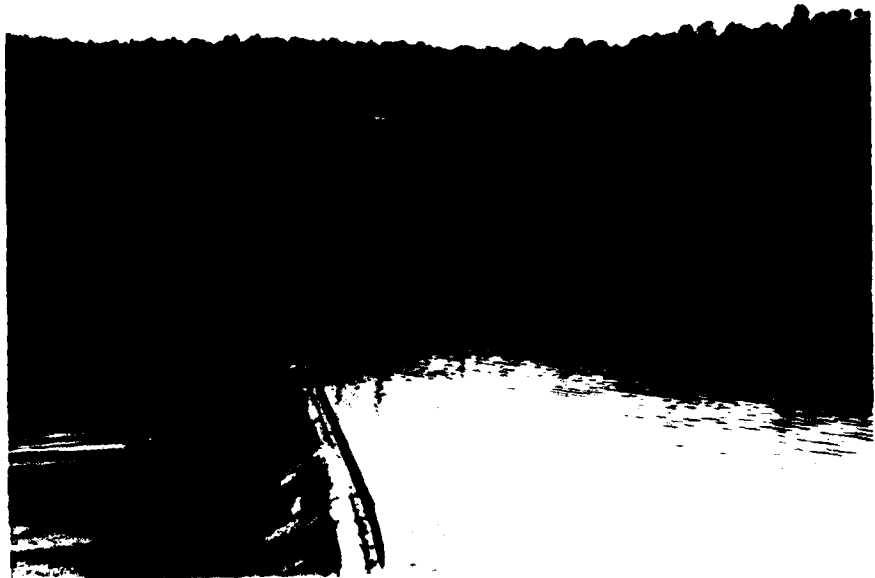
The dam is classified to be in the high hazard category. Elmira Reservoir, an earth dam with an approximate height of 34 feet and storage capacity of 420 acre-feet, is located immediately below the dam. Downstream from Elmira Reservoir, Hoffman Brook flows through residential areas of Elmira before joining Chemung River approximately 2.5 miles below the dam.

PHOTOGRAPH NO. 8
Elmira Reservoir Dam
(0.5 mile downstream)
