CHAZY LAKE DAM

INVENTORY No. NY 236

PHASE I INSPECTION REPORT
NATIONAL DAM SAFETY PROGRAM

AUGUST 1981

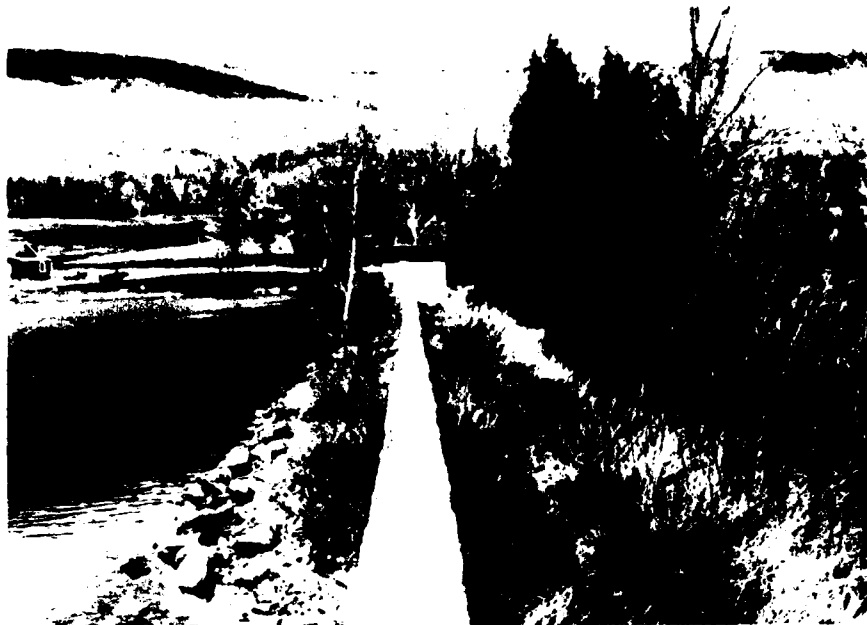
5. VIEW TOWARDS LEFT
ABUTMENT OF CORE WALL
SECTION. GATEHOUSE
CONTROLS RESERVOIR
DRAIN.

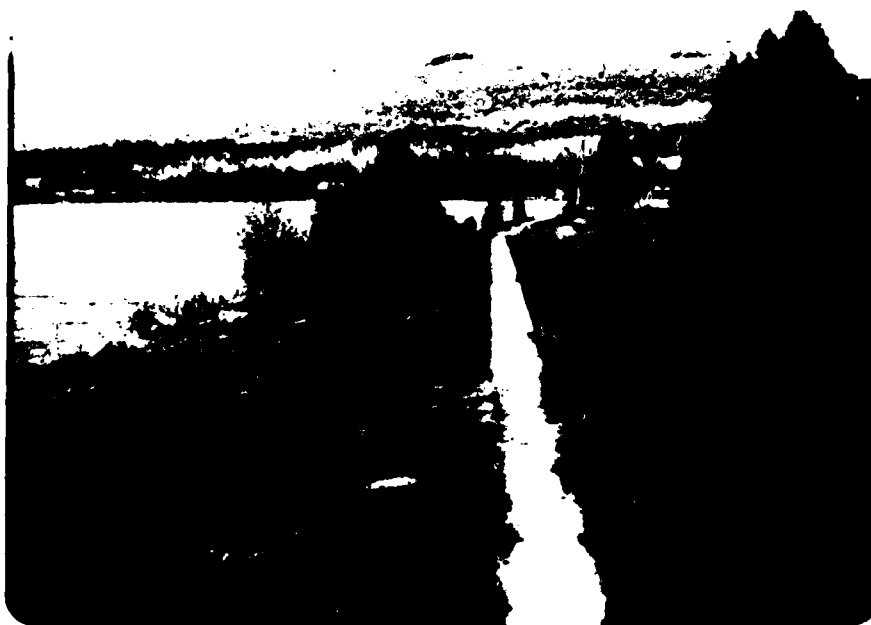
7. VIEW FROM RIGHT
ABUTMENT OF CORE WALL
SECTION. GRASSED AREA
IS PART OF TOWN PARK

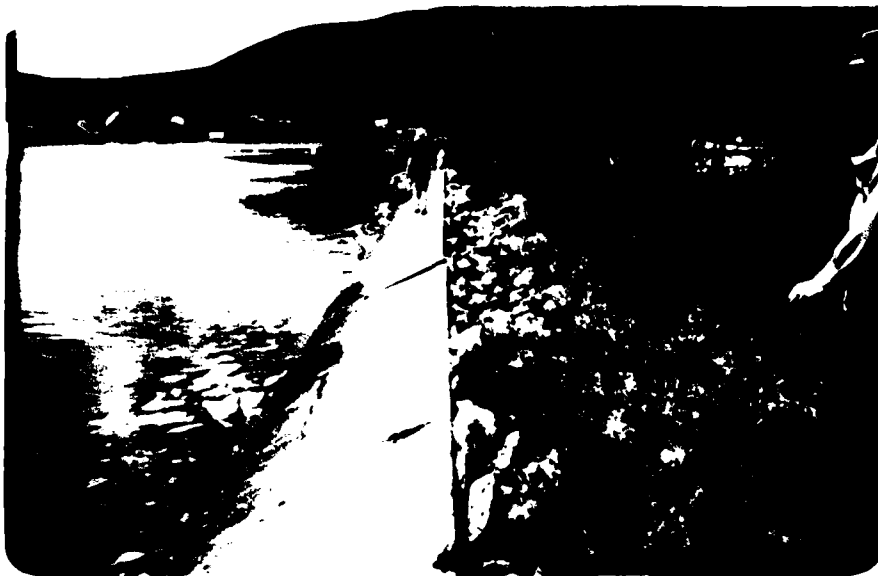
8. VIEW TOWARD LEFT
ABUTMENT OF FACE WALL
SECTION.
NOTE: BOAT DOCK IN
BACKGROUND, PARKING
LOT TO RIGHT

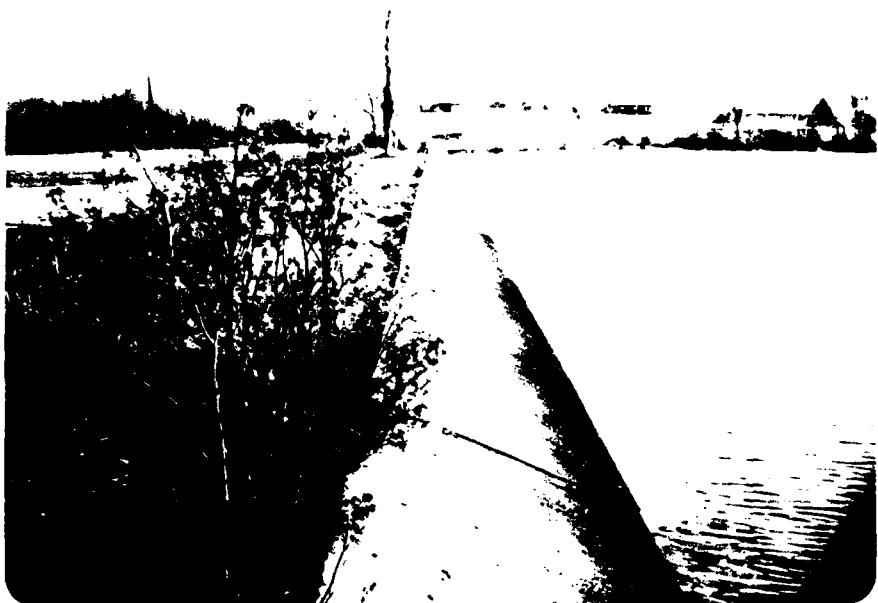
9. VIEW TOWARD RIGHT
ABUTMENT OF FACE
WALL SECTION

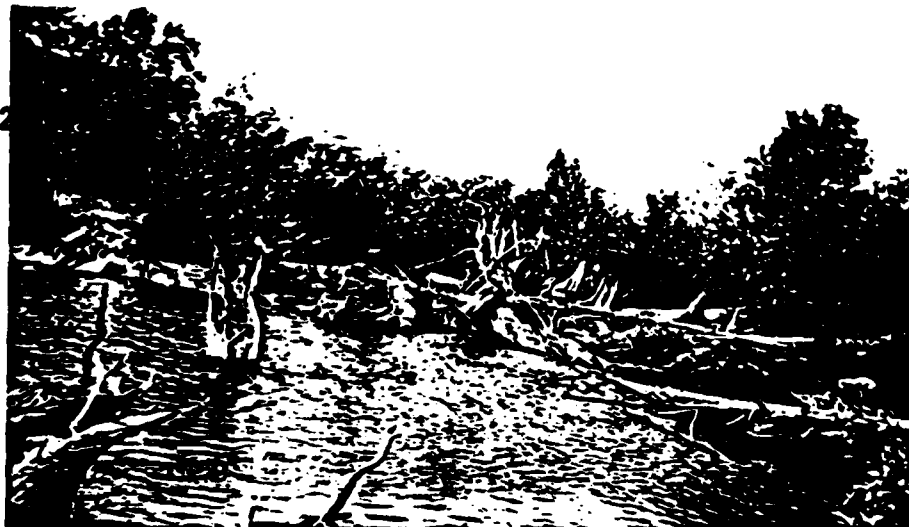
Chazy Lake Dam. The picture shows the spill way
destroyed by decay and ice.
This lake is the source of
The Big Chazy River.
May 1922
