Special Report 81-31

December 1981

ROOF MOISTURE SURVEY: RESERVE CENTER GARAGE, GRENIER FIELD, MANCHESTER, N.H.

Prepared for
DIRECTORATE OF FACILITIES AND HOUSING
FORT DEVENS, MASSACHUSETTS

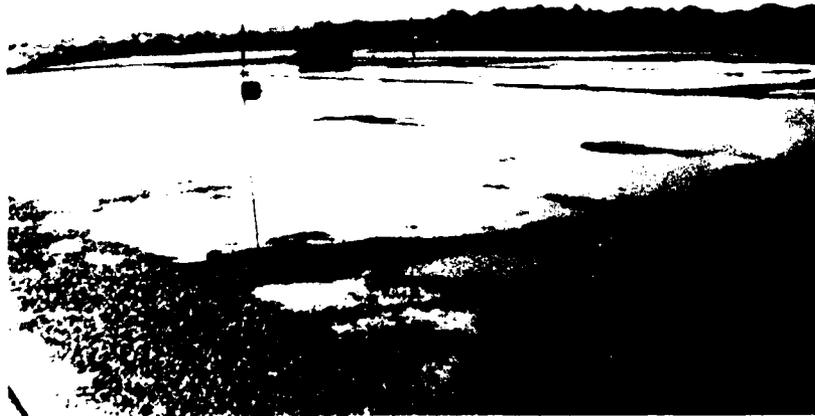
Figure 1. Ponds on the flat roof of the Reserve Center garage, June 1979.

The lack of internal drains on the main roof and the apparent lack of slope to drain cause water to pond over most of the roof, as shown in Figure 1. When water is allowed to pond on a roof the risk of premature failure is greatly increased. If this roof had been sloped to drain, much less water would have entered the insulation through membrane and flashing flaws.

1. Remove the existing membrane and insulation.
2. Repair the existing vapor retarder or install a new one towards the warm side of the roofing system.
3. Install internal drains on the main roof. Internal drains are expensive in a retrofit operation, but they are much preferred to over-the-eaves drainage for low-slope roofs in areas where it snows. Ice dams at the eaves can cause significant ponding loads on low-slope roofs in such areas.
4. On the main roof provide a positive slope to drain, of about 1/4 in./ft, using either tapered insulation or a wet fill. Use crickets in valleys to assure lateral flow of water to the drains.
5. Install curbs on which the antenna and guy wire anchors can be located, or side-mount the antenna on an exterior wall.
6. Install new insulation and a new membrane.

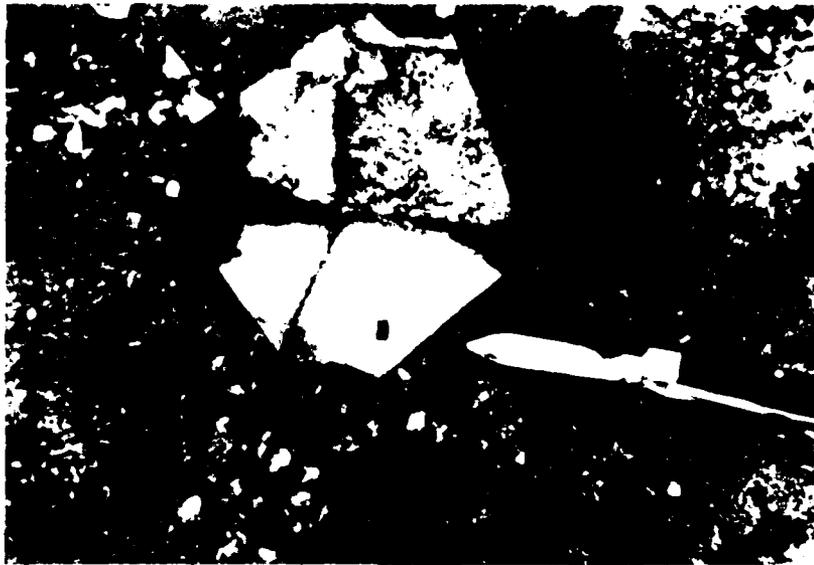
Figure 11. Core hole I and adjacent cut showing insulation seams. Note that the core hole is nearly full of water.

core samples in that area (Fig. 11) verified that the bright lines coincided with insulation seams and that the insulation was wetter there. Core hole I nearly filled with water (Fig. 11) immediately after the core was removed.

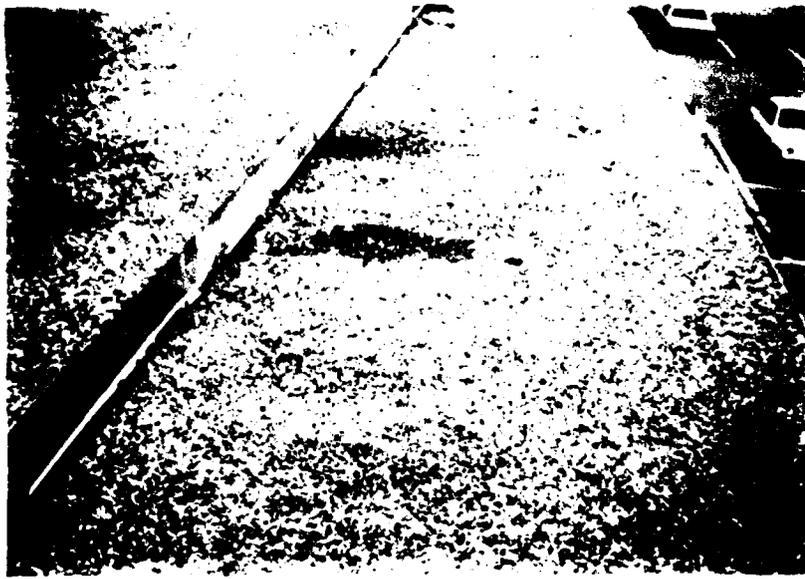
Visually, the uninsulated lower porch roof appeared in good condition. The infrared camera detected a few dark spots on it extending out from the upper roof-lower roof intersection (Fig. 21). These dark (cool) areas were caused by water from the insulation of the main roof that had seeped out at the edge, down along the flashing and out onto the porch roof. The porch roof was moist during the infrared survey and the following day (Fig. 22).

Figure 22. The two moist areas of gravel on the porch roof that appear cold in the Figure 21 thermogram.

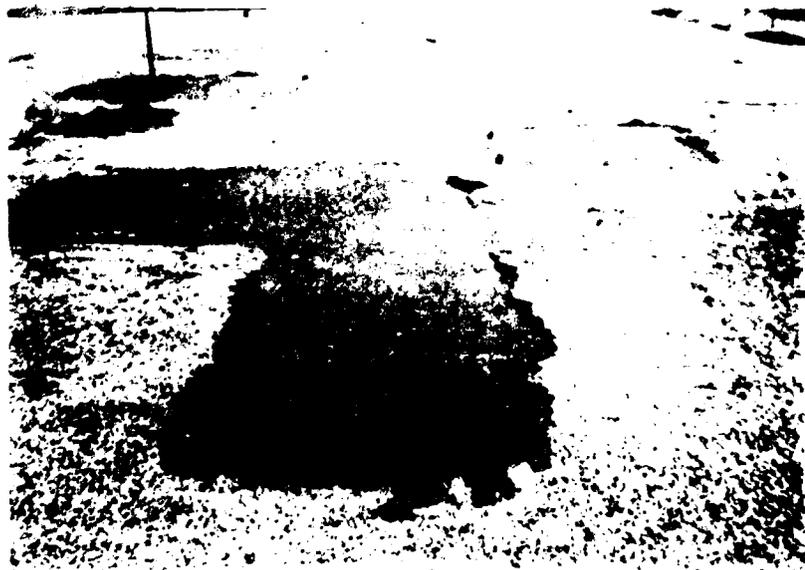
The membrane of the main roof contained several patches (Fig. 23) and tunnel blisters (Fig. 3). A cut into a blister adjacent to sample D revealed evidence of poor installation. The blister contained water between the plies and areas of bare felt (Fig. 24). The bitumen had a glossy appearance, which is a good indication that it had cooled and not adhered to the felt above. During sampling we noticed two types of urethane-perlite insulation present. Some urethane was yellow and some green, as indicated in Table 2. In addition, at sample P the insulation

Figure 23. Some of the large patches on the main roof.
