ARMY MATERIEL SYSTEMS ANALYSIS ACTIVITY ABERDEEN PROV--ETC F/G 9/5
WATER ENTRY INTO THE MX-6707/VRC ANTENNA MATCHING UNIT-BASE.(U)
JUN 82 H N HARRIS

AMSAA-TR-364

4. TITLE (and Subtitle) Water Entry Into the MX-6707/VRC Antenna Matching Unit-Base		5. TYPE OF REPORT & PERIOD COVERED
7. AUTHOR(s) Harry N. Harris		6. PERFORMING ORG. REPORT NUMBER

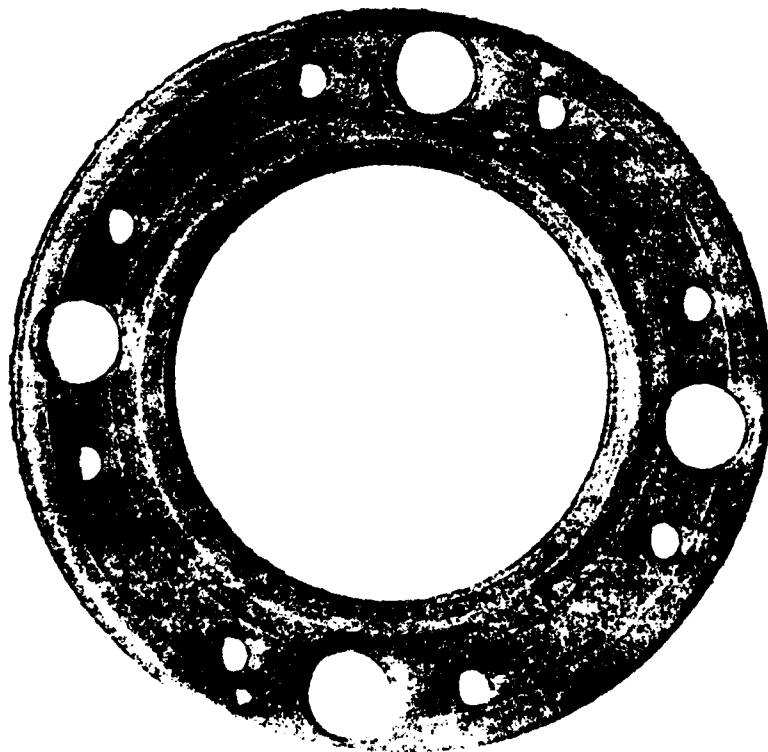
FIGURE G1 - GASKET DAMAGE

RIGHT - USED

LEFT - NEW
