**MISSOURI RIVER**

**GAVINS POINT DAM - LEWIS AND CLARK LAKE  
NEBRASKA AND SOUTH DAKOTA**

**EMBANKMENT CRITERIA AND  
PERFORMANCE REPORT**

**OMAHA DISTRICT**

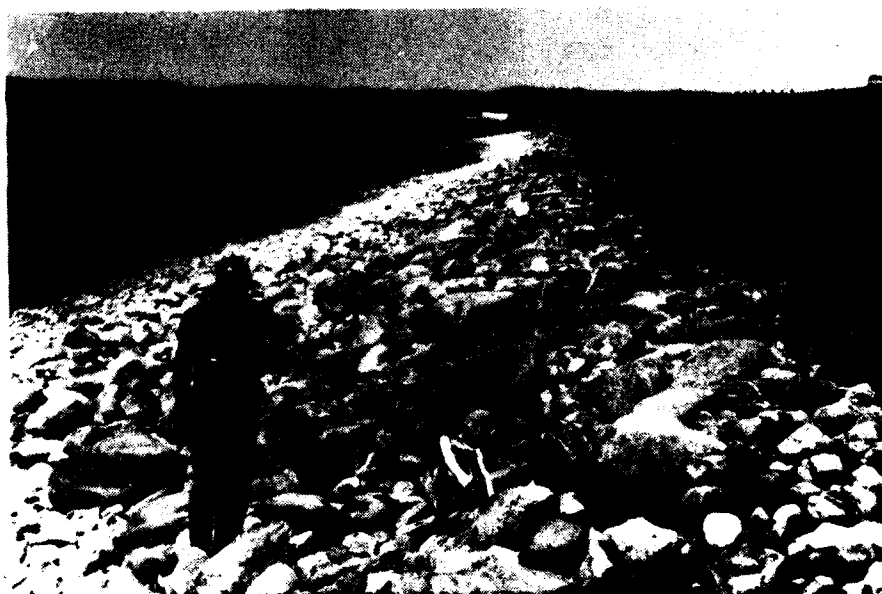
Photo No. 4 - Field boulder upstream slope protection. May 1979.
