EXPERIMENTAL POLYURETHANE FOAM ROOF SYSTEMS - II(U)  
NAVAL CIVIL ENGINEERING LAB PORT HUENEME CA  
R L ALUMBAUGH ET AL. JAN 83 CEL-TN-1656

TITLE: EXPERIMENTAL POLYURETHANE FOAM  
ROOF SYSTEMS - II

AUTHOR: R. L. Alumbaugh, J. R. Keeton, and E. F. Humm

DATE: January 1983

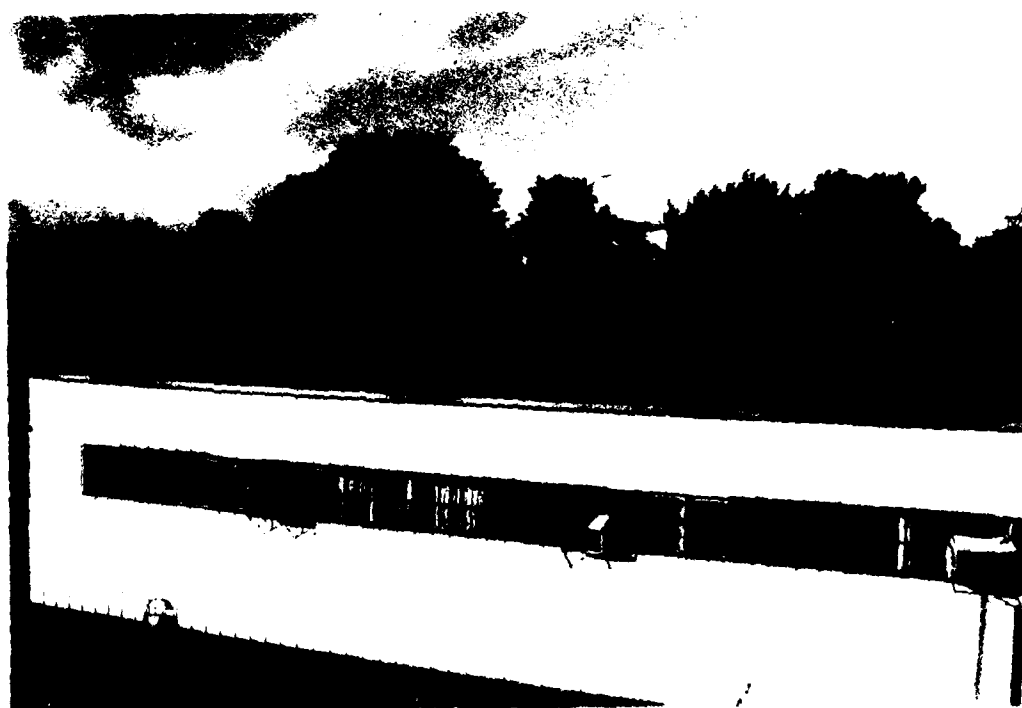
After 6 and 7 years of exposure, the performance of the catalyzed silicone with granules was rated VG (see Figure 5). The slight lowering of the rating resulted primarily from the bird pecking problem and, to a lesser extent, from the light cracking of the silicone along the rib. It is believed that with a minimum of annual maintenance, this system will perform very well for at least 10 years before recoating is necessary.

Figure 5. Overview of southerly surface of System 1. After seven years, System 1 was performing very well and was rated very good.

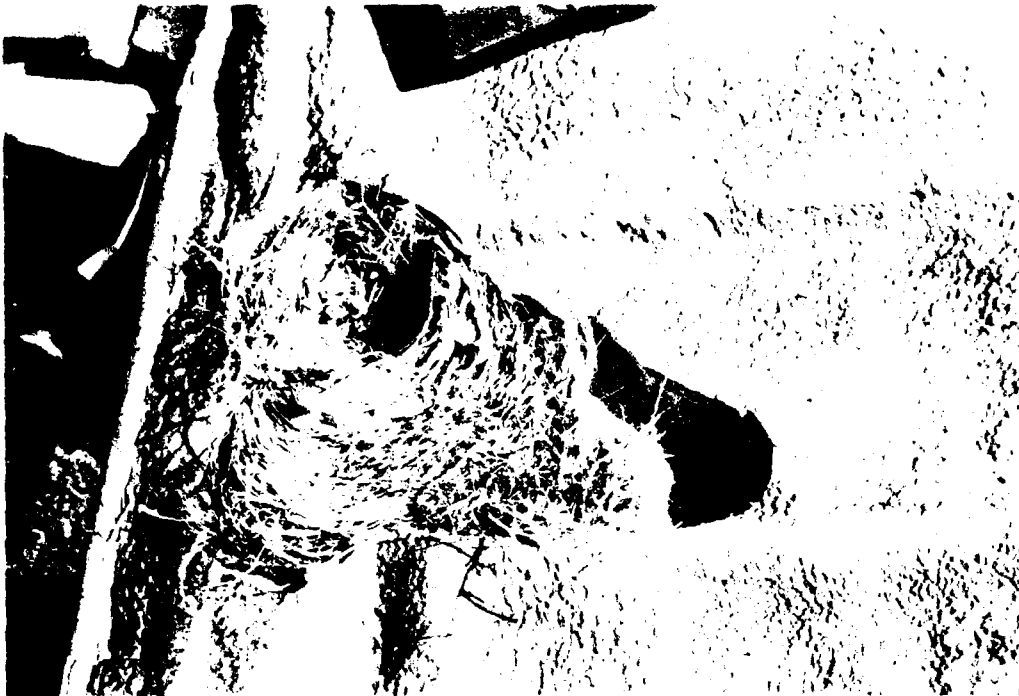
Figure 8. Small birds entering underneath grave, stop pecked out foam and nested

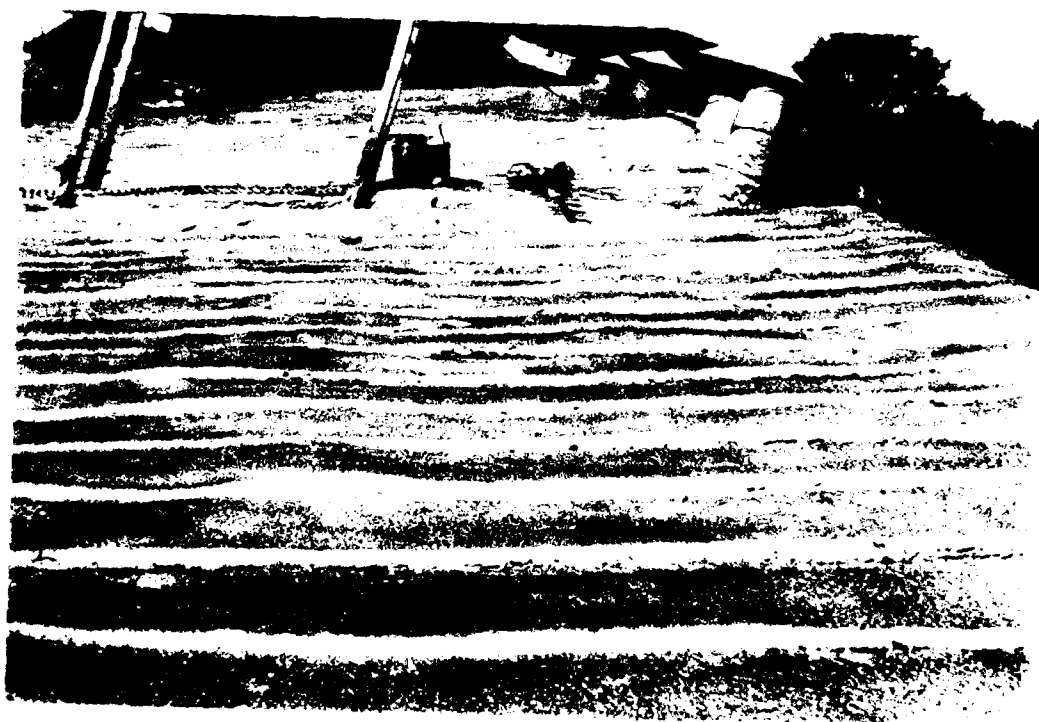
Figure 11. Cracking of silicone coating of System 2 along base of rth. Spraying foam and coating in two directions ("cross hatched") rather than in only one direction would have eliminated the problem.

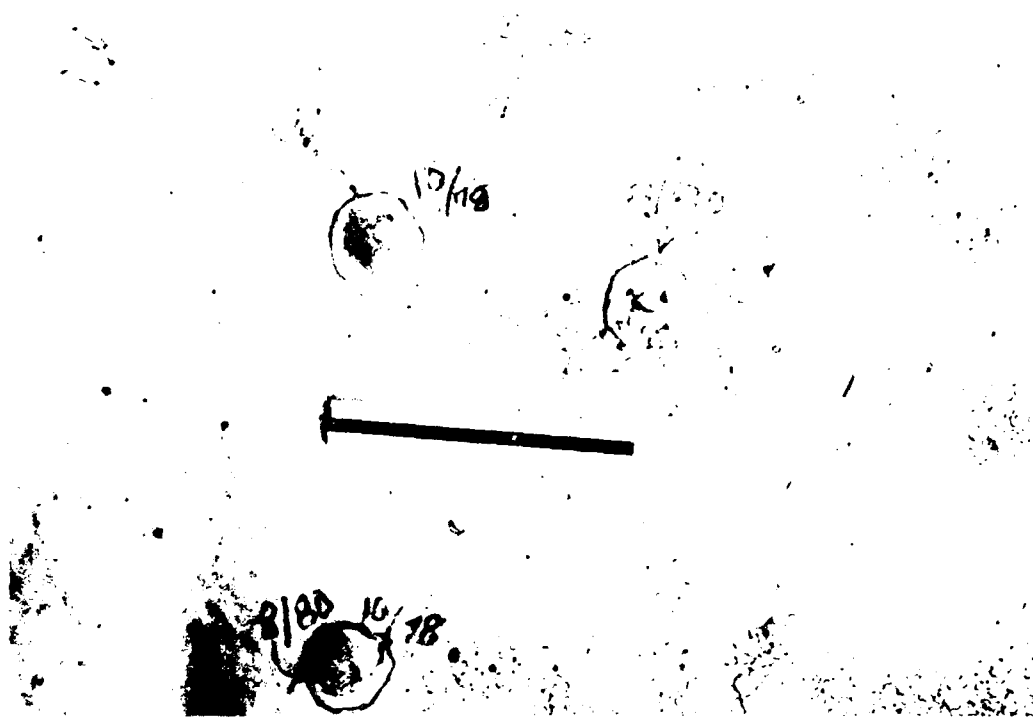
In the area where the boiler house roof joined the roof of the south building, numerous blisters (approximately 15) formed, ranging in size from 1 to 4 inches in diameter. Three of these blisters are shown in Figure 14. The blisters occurred both between the old and new coatings and between the very thin (1/8-inch thick) top and adjacent lifts of foam, and in some cases were attributed to the presence of moisture. Because of the toughness of the new coating system, the blisters caused no problem.

Figure 14 Blisters in System 7 coating attributed to moisture on System 4 when recoated with System 7

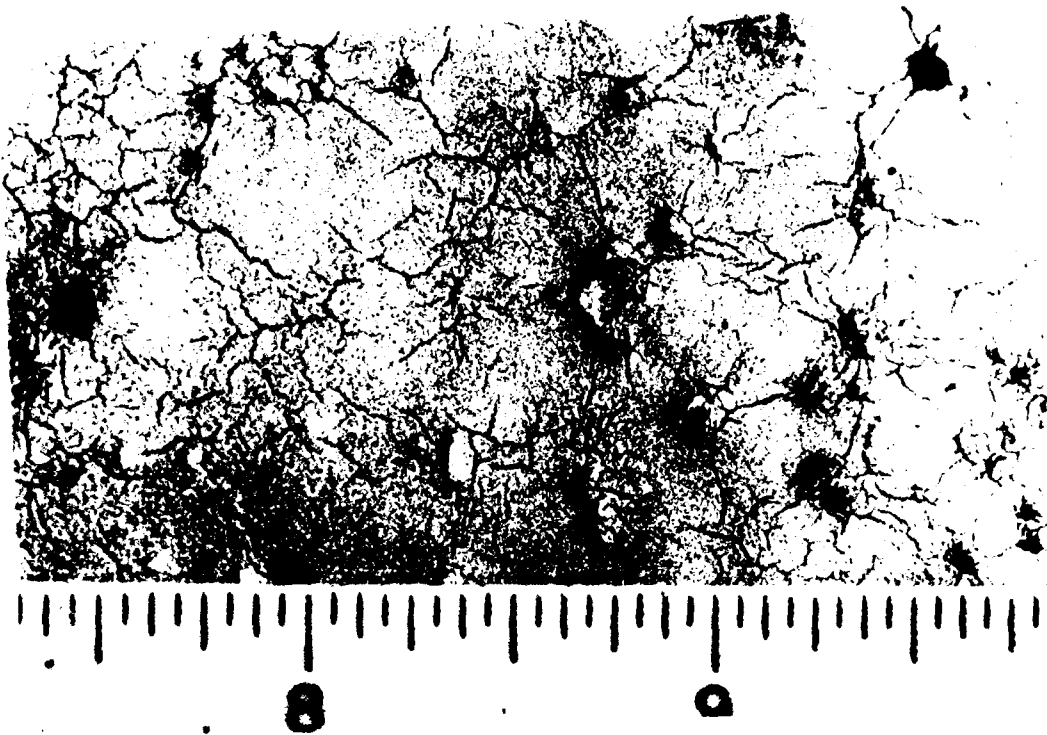
Figure 16 Cracking and checking of aluminum topcoat of System 7
