PTPD REPORT NO. 83-R-02  
AFPEA PROJECT NO. 82-P7-68

TEST AND EVALUATION OF METHOD II, GAU-8 30mm  
AMMUNITION CONTAINERS

HQ AFALD/PTPD  
AIR FORCE PACKAGING EVALUATION AGENCY  
Wright-Patterson AFB OH 45433

August 1983

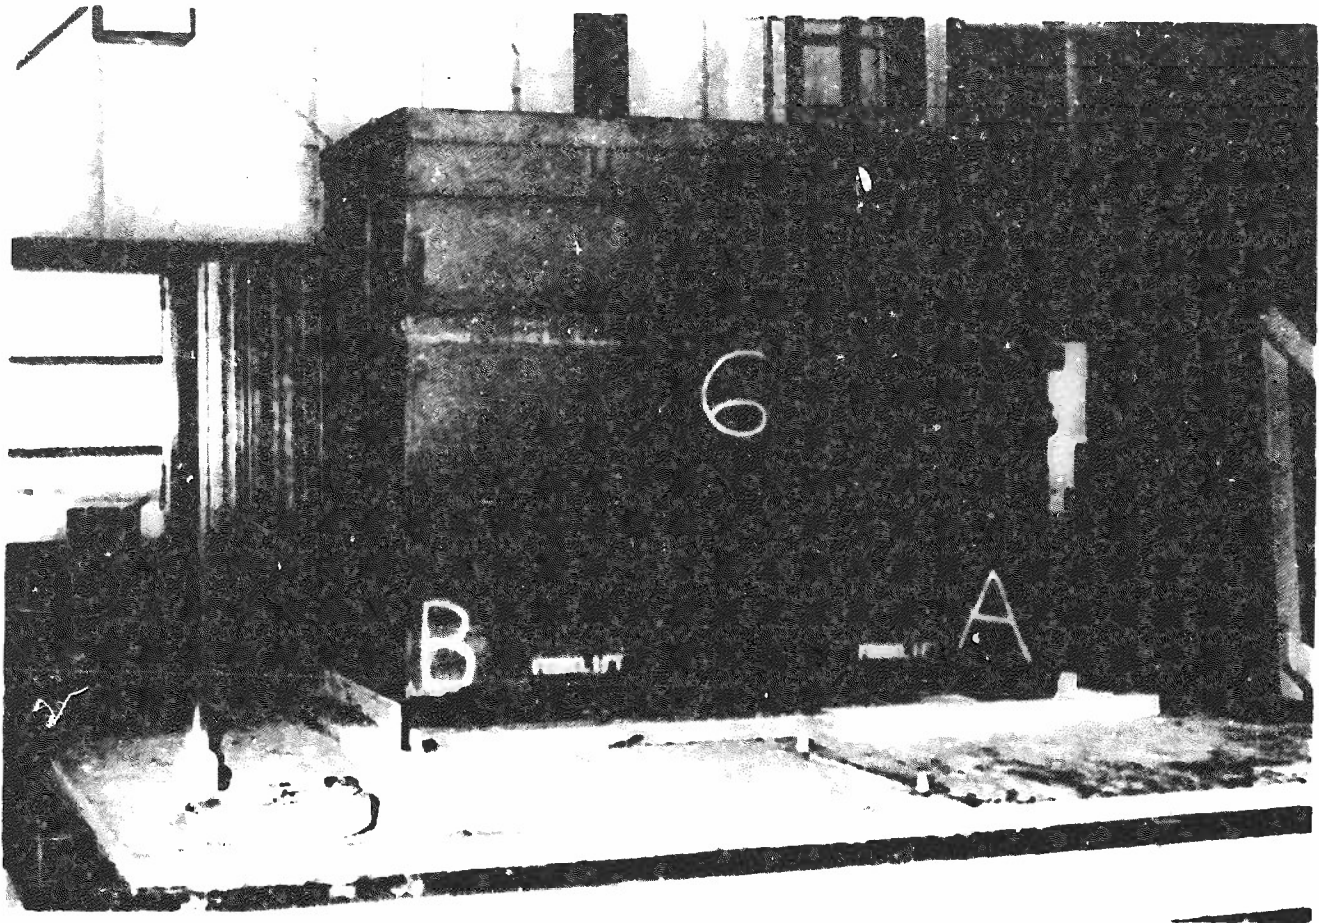
Comments: Although the vibration test was performed according to criteria listed in the test method, the attachment welds of the fork pocket to the container body were subjected to extremely severe loading forces which were excessive and not representative of the intent of the test. These excessive loads were generated primarily by the side to side rocking of the containers. However, since the containers were restrained at the bottom by a 2x4 fence (see Figure 8) and at the top by loose chains which prevented the containers from falling over and the input from the table was 1G, the test was completed.

FIGURE 8. Restraining system used for first vibration test. Chains (not shown) were also used to prevent container from falling over during the test.
