PEQUONNOCK RIVER BASIN
BRIDGEPORT, CONNECTICUT

FOREST LAKE DAM
CT 00078

PHASE I INSPECTION REPORT
NATIONAL DAM INSPECTION PROGRAM

AUGUST 1978

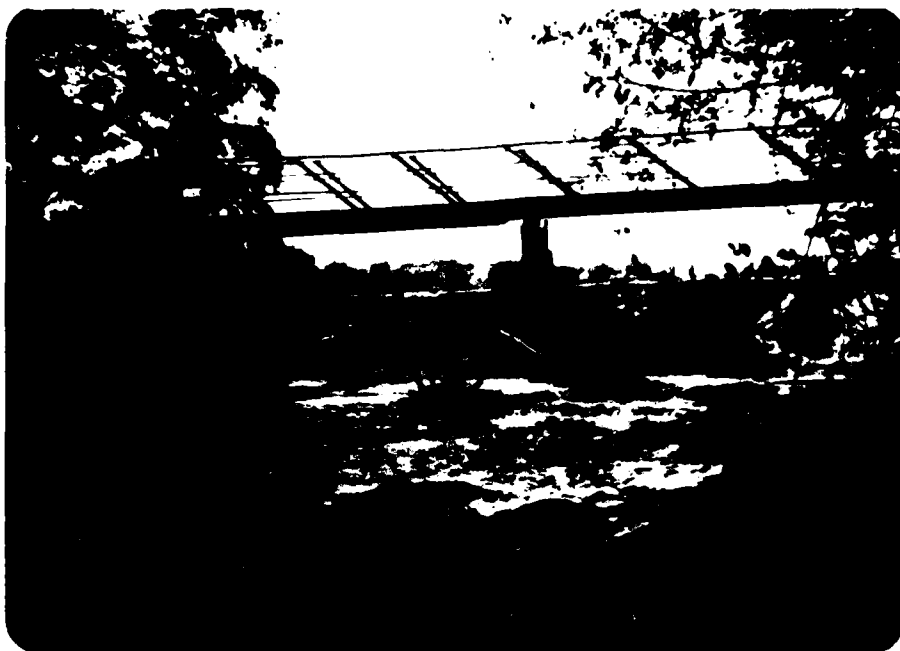
e. Downstream Channel - The spillway channel has low stone walls within about 50 feet of the spillway. The left wall has partially collapsed while the right wall is in good condition. The channel is strewn with boulders, and there are some tree branches which have fallen into the stream. Heavy tree and bush growth next to the channel can, in the future, result in additional branches falling into the channel.

PHOTO NO.1 - Outlet spillway channel, note tree branches and other debris.
