# Special Report 84-12

Cold Regions Research &  
Engineering Laboratory

## *Deteriorated concrete panels on buildings at Sondrestrom, Greenland*

Charles Korhonen

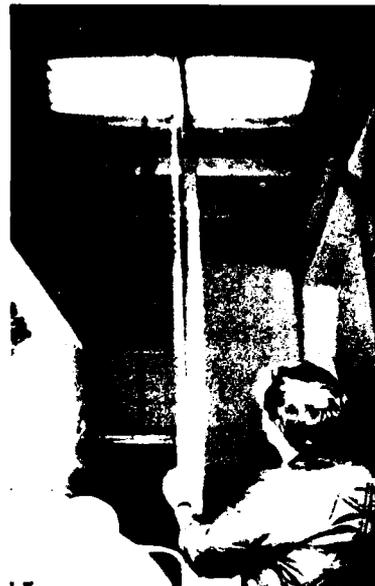
My measurements and observations suggest that most of these buildings have settled differentially. Cracks and separations in the structural framework at several locations were evidence of this. For example, in the corner of one building a section of grade beam (Fig. 3a) had cracked and separated from the floor slab by as much as  $1/4$  in. but had remained in contact with the floor along the rest of its length. In another case, an equipment support rod that was securely bolted to the ceiling and floor had bowed (Fig. 3b). A comparison of the bowed and unbowed rod heights showed that the ceiling-to-floor distance had decreased by  $1/16$  in. These and similar movements are considered responsible for developing shear forces within many of the concrete panels, causing them to crack across their widths. Figure 4 shows a typical panel-wide crack. The diagonal nature of these cracks indicates a shear-type failure mode.

b. Bowed equipment support rod, representing a  $1/16$ -in. movement.

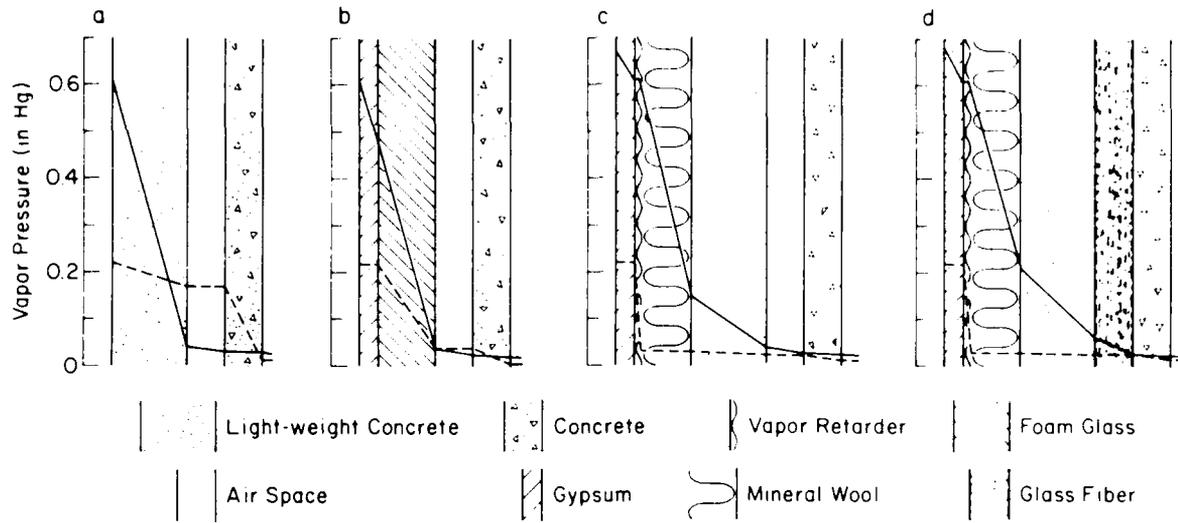
Figure 8 compares the vapor pressure profile through each of these walls as outlined in ASHRAE (1981). It was assumed that the walls were exposed to indoor conditions of 70°F and 30% relative humidity and outdoor conditions of

Figure 8. Vapor pressure profiles through four wall cross sections. Moisture condenses when the actual vapor pressure (dotted line) exceeds the vapor pressure of saturated air (solid line). The warm side of each wall is on the left.

-10°F and 70% relative humidity. As can be seen, condensation is more likely to occur in the two walls without a warm-side vapor retarder (Fig. 8a,b). It was in these walls that I found the most debris. Also, it was on these buildings that the wall panels seemed to be a bit more cracked. Thus, it appears that much of the deterioration of these buildings can be alleviated by adding a vapor retarder on the warm side of the walls.

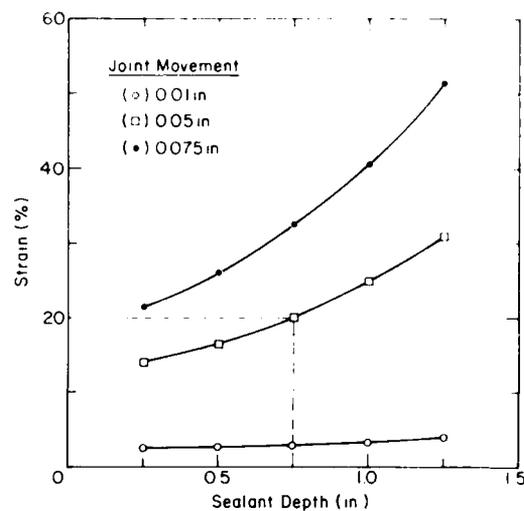
Figure 10. Relationship between movement, sealant strain and sealant depth for a 3/8-in.-wide joint. (After American Concrete Institute 1983b.)

they will return to their original shape even in very cold weather. To be effective, the sealant should not completely fill the joint. There is a definite correlation between sealant depth and joint width (Fig. 10). As an elastic material is stretched, it begins to thin, producing the greatest strain at the top and bottom surfaces. For the elastomeric sealants mentioned above, the allowable working strain is  $\pm 25\%$  (Maslow 1974). As shown in Figure 10, a 3/8-in. joint subjected to a 0.05-in. movement produces a 25% strain in a 1-in.-thick bead of sealant. However, to avoid even approaching this strain, the sealant should not be placed any deeper than 3/4 in. A polyethylene-foam backer rod should first be inserted to the proper depth in the joint, both to create the desired sealant cross section and to prevent the sealant from sticking on its bottom side.
