**SOUTHWESTERN COASTAL BASIN  
GREENWICH, CONNECTICUT**

**MIANUS FILTER PLANT DAM  
CT 00040**

**PHASE 1 INSPECTION REPORT  
NATIONAL DAM INSPECTION PROGRAM**

**FEBRUARY, 1980**

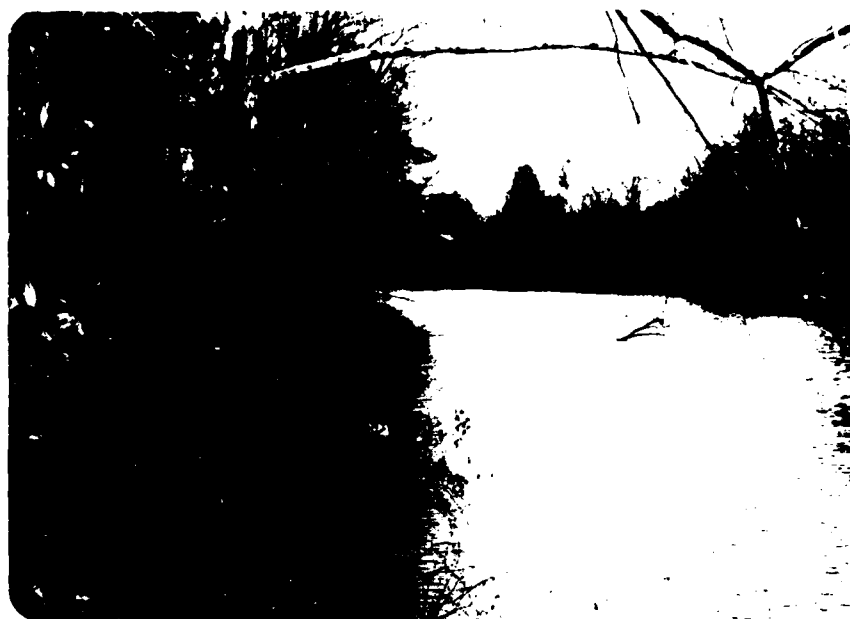
with no visible signs of erosion or sloughing. There were two trees in the riverbed that the maintenance personnel are trying to have removed, but some difficulty was noted (Photo C-1). Concern was expressed that during a heavy storm these trees could be a problem.

C-1 UPSTREAM IMPOUNDMENT - LOOKING FROM WEST  
BANK

- a. **Operation and Maintenance Procedures:**
  - 1. Trees from the floor of the upstream riverbed should be removed as soon as possible.
  - 2. The seepage on the downstream face should be monitored to note any change from the existing conditions.

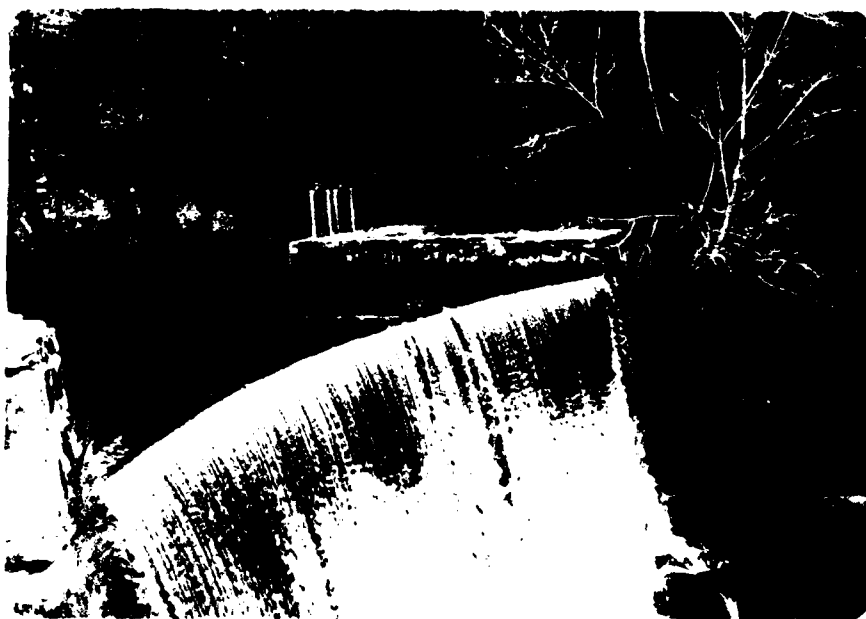
1. **Spillway:** The spillway for the dam is a 65 foot long stone capped weir with a free drop of approximately 28 feet to the tailwater (Photos C-2, 4). The water level on the day of inspection was 30 inches below the east top of the dam and water was flowing over the spillway. The spillway appears to be in generally good condition.

C-4 EAST CREST OF DAM - LOOKING FROM WEST ABUT-  
MENT

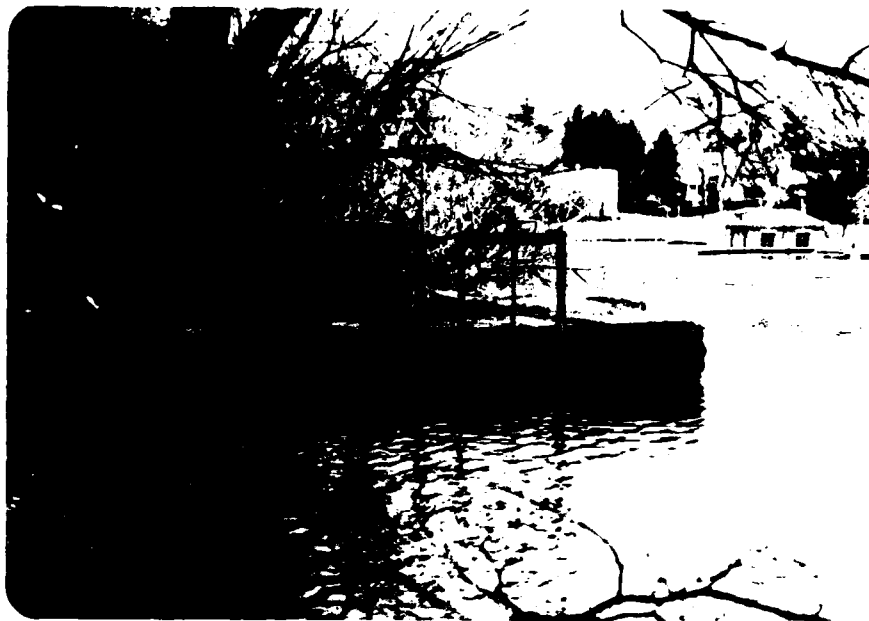
4. **Twin Flood Gates:** Two flood gates are located below the dam's east crest at a shallow level (Photos C-5, 6). They are controlled by lift mechanisms on the top of the dam and appear in good condition. A 4 inch gate valve at the base of the flood gates is maintained in an open condition as per an agreement with adjacent homeowners. A natural, rock discharge channel rejoins the Mianus River just downstream of the dam.

C-5 FLOODGATES ON EAST CREST

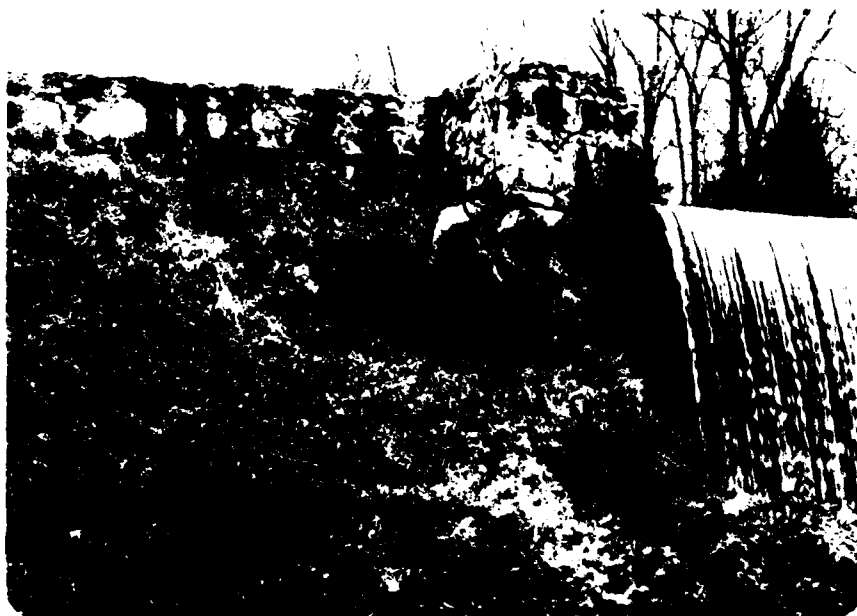
3. **Downstream Slope:** The downstream slope is also stone masonry with a nearly vertical face. There are numerous places where seepage is steady on the face of each abutment (Photos C-8, 9). The condition of the joints is quite poor (Photo C-9) and one joint on the west abutment has a void which measures 18 inches deep (Photo C-10). A few loose stones were noted on the east abutment and grass was growing from some of the joints. The fill on the downstream face of the west abutment seemed to be quite moist, indicating that seepage occurs below grade as well as above.

C-8 SEEPAGE POINT BELOW WEST CREST
