**GRUPES RESERVOIR DAM  
CT 00057**

**PHASE I INSPECTION REPORT  
NATIONAL DAM INSPECTION PROGRAM**

**DEPARTMENT OF THE ARMY  
NEW ENGLAND DIVISION, CORPS OF ENGINEERS  
WALTHAM, MASS. 02154**

**DECEMBER, 1979**

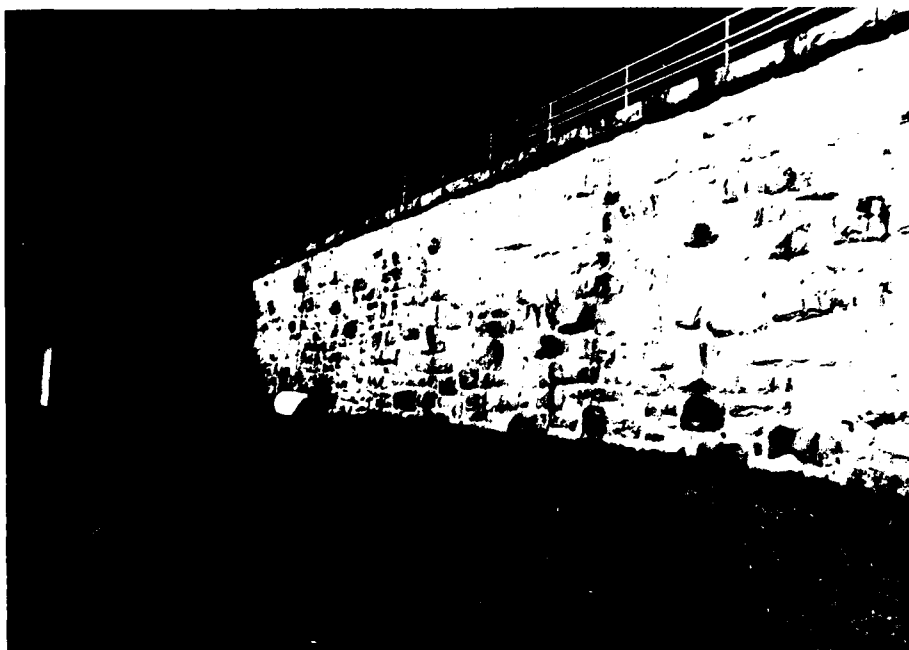
Downstream Slope - No misalignment or signs of movement were observed on this slope. Efflorescence was noted along the mortar joints of this slope (Photo 3). There are several seepage areas on the right side and central portion of the downstream slope (Photos 11 and 12). In this area of the slope, seepage emanated through the numerous cracks in the joints of the stone masonry. In some places, the mortar is completely washed out from between the stones. There are several metal pipes protruding from the downstream slope and are reported to have been used for pressure grouting of the masonry in the 1960's (Photo 12).

Photo 3 - Downstream slope of dam (Nov. 1979)

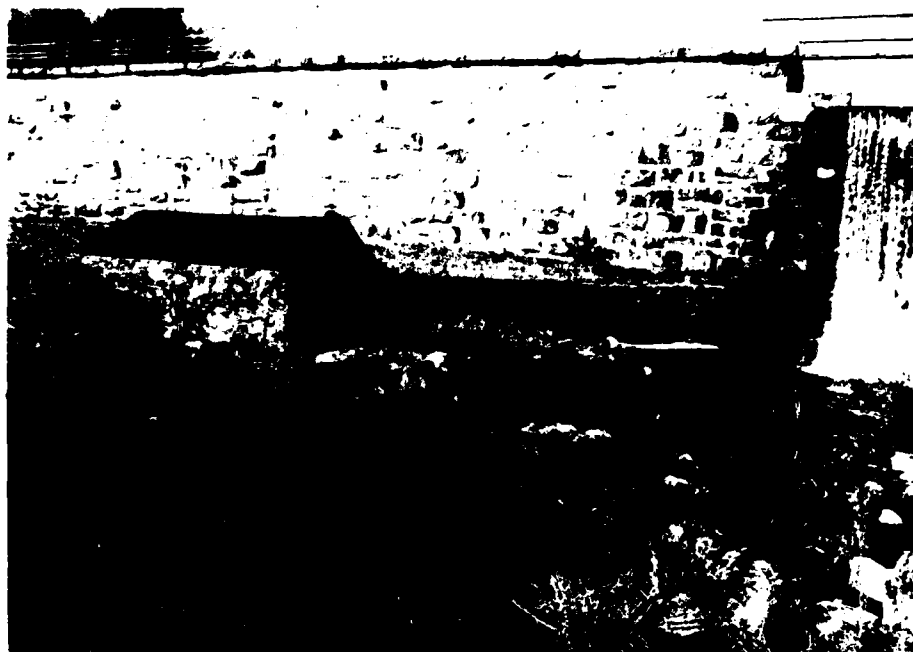
The 24 inch low-level outlet chamber is a masonry structure with some signs of cracking and weathering (Photo 7). The other structures at the right downstream toe of the dam, such as the chlorine house, diffuser, venturi and 24 inch valve house are in good condition.

Photo 7 - Valve chamber and outlet for 24 inch low-level outlet  
(Nov. 1979)

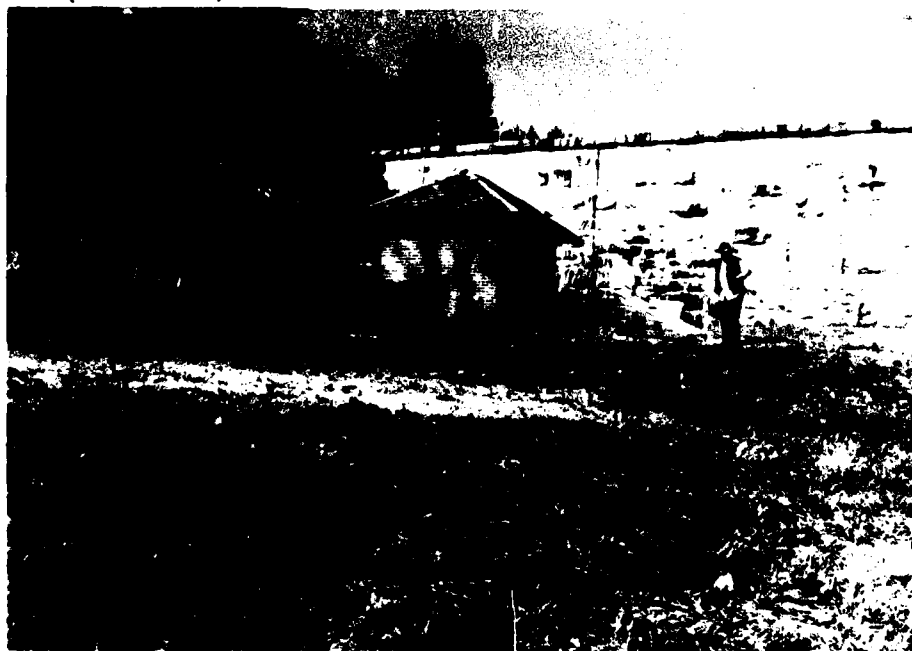
Photo 8 - Brick Chlorine house, valve chamber for 20 inch  
supply line, and diffuser house on right. (Nov. 1979)

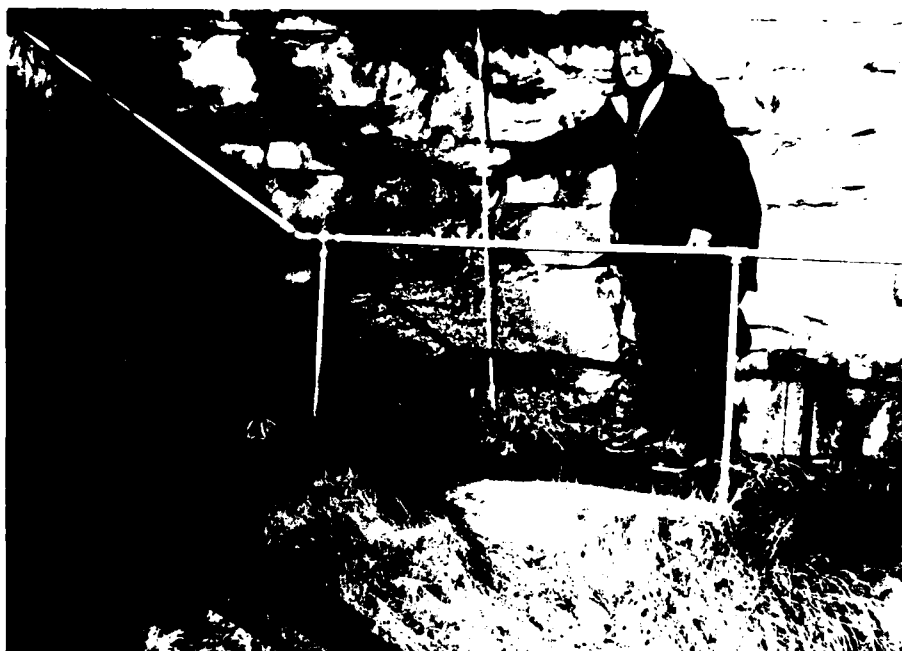
Photo 11- seepage near stairway at right downstream side of dam. (Dec. 1979).

- c. Condition of the main spillway when it is not overflowing.
- d. Condition of the dam upstream face and the concrete lining.
- e. The cracking and leakage through the mortar joints in the upstream walls of the upper 30 inch and the emergency intake valve chambers.
- f. Condition of the 16 and 24 inch pipes through the dam. These pipes could be deteriorated and produce additional seepage flow through the dam.
- g. Monitoring of seepage through the dam, the upper valve chambers and through the 12 inch tile drain pipe to measure any changes in seepage quantities. Any acceptable repair measures to reduce or stop seepage through the dam and spillway should be implemented.
