WAUBEEKA LAKE DAM

CT 00065

PHASE I INSPECTION REPORT

JULY 1981

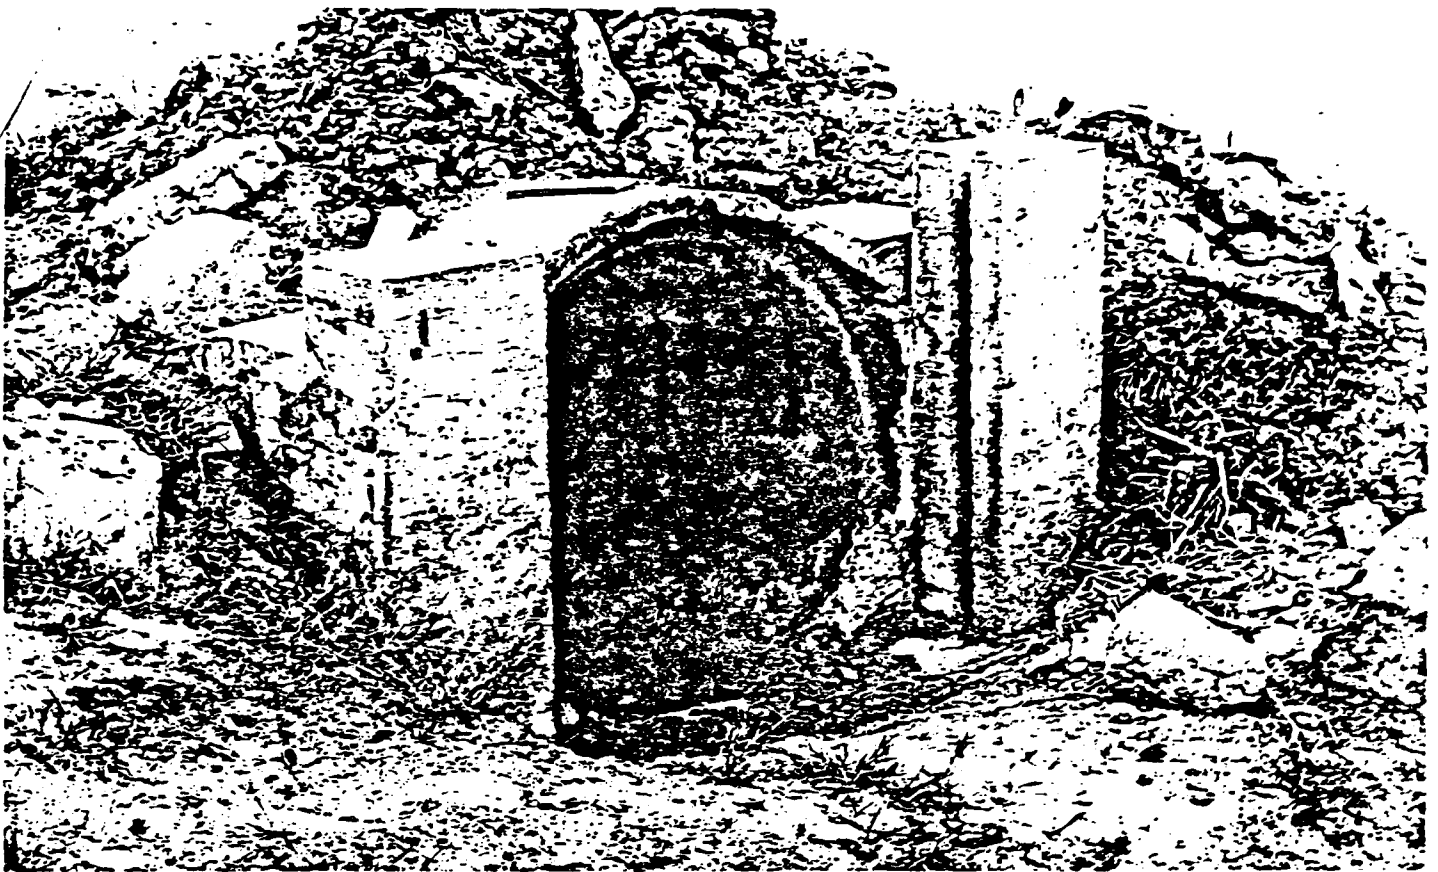
Photo #12

This is close-up of headwall
recently constructed at inlet end
of 36" drain from Lake. See photo #6,
made 3/13/66, for original condition here..

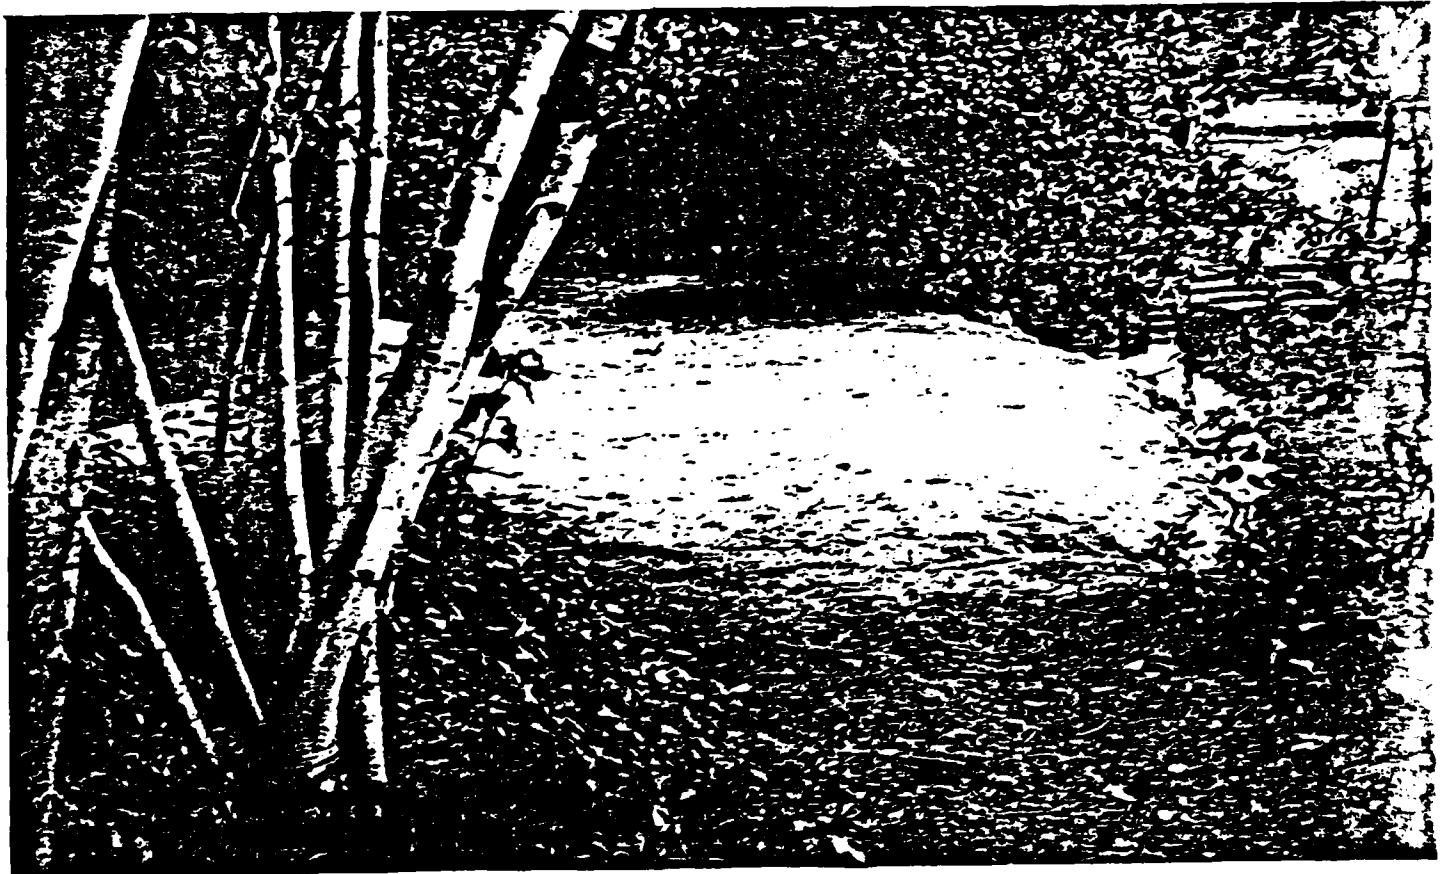
Photo #13

This photo shows recent repairs
to dike on E. side of Lake --- previous
condition here see photo #10 made 3/13/66.
This shot is looking along dike in opposite
direction from photo #10.

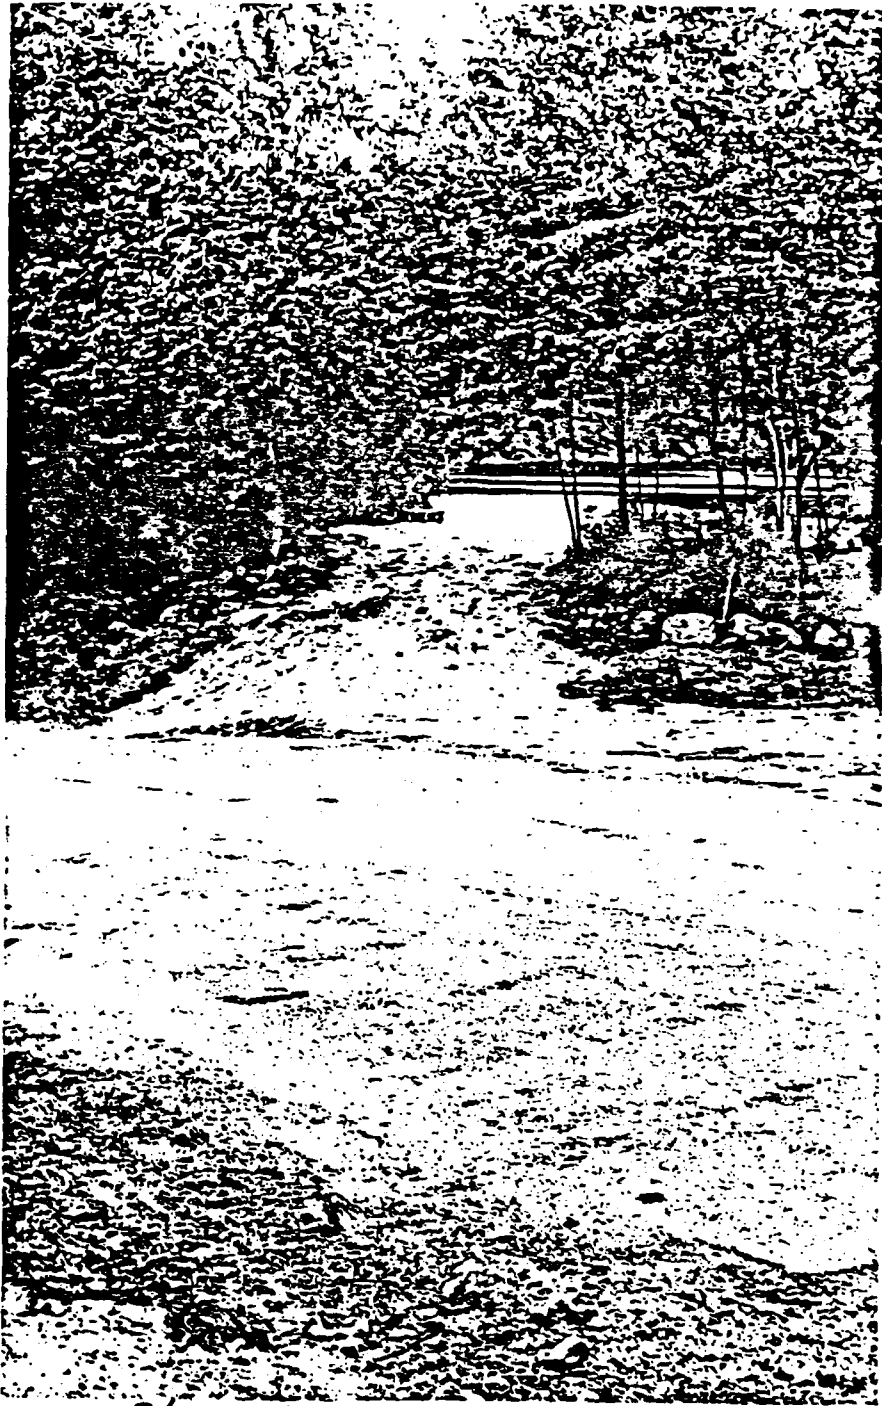
Photo #14

This photo shows same
repair to E. side dike as
that shown in #13. Looking
from road, over dike, Lake
background.

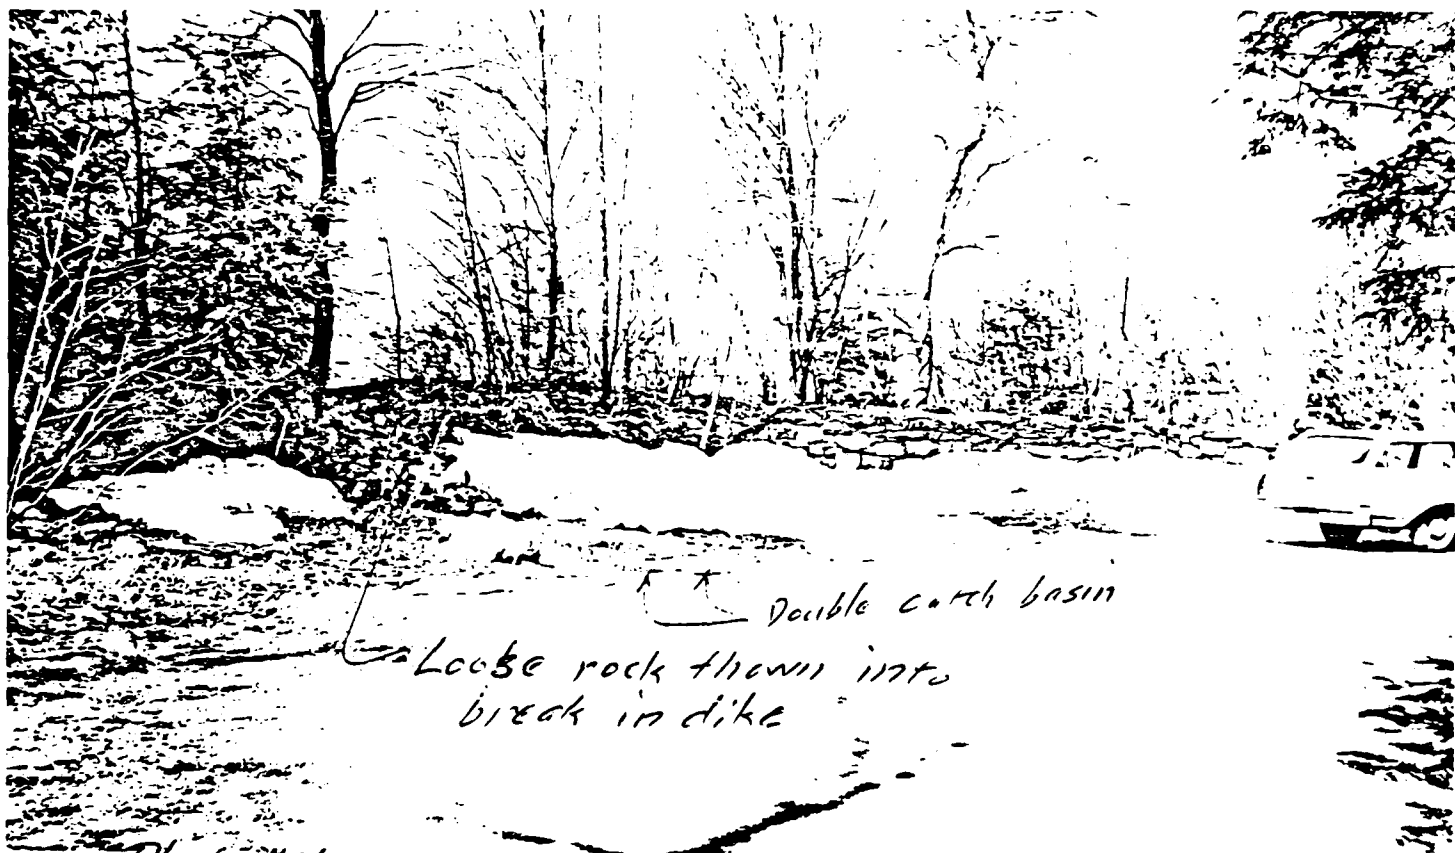
Photo #11

Double catch basin
Loose rock thrown into
break in dike

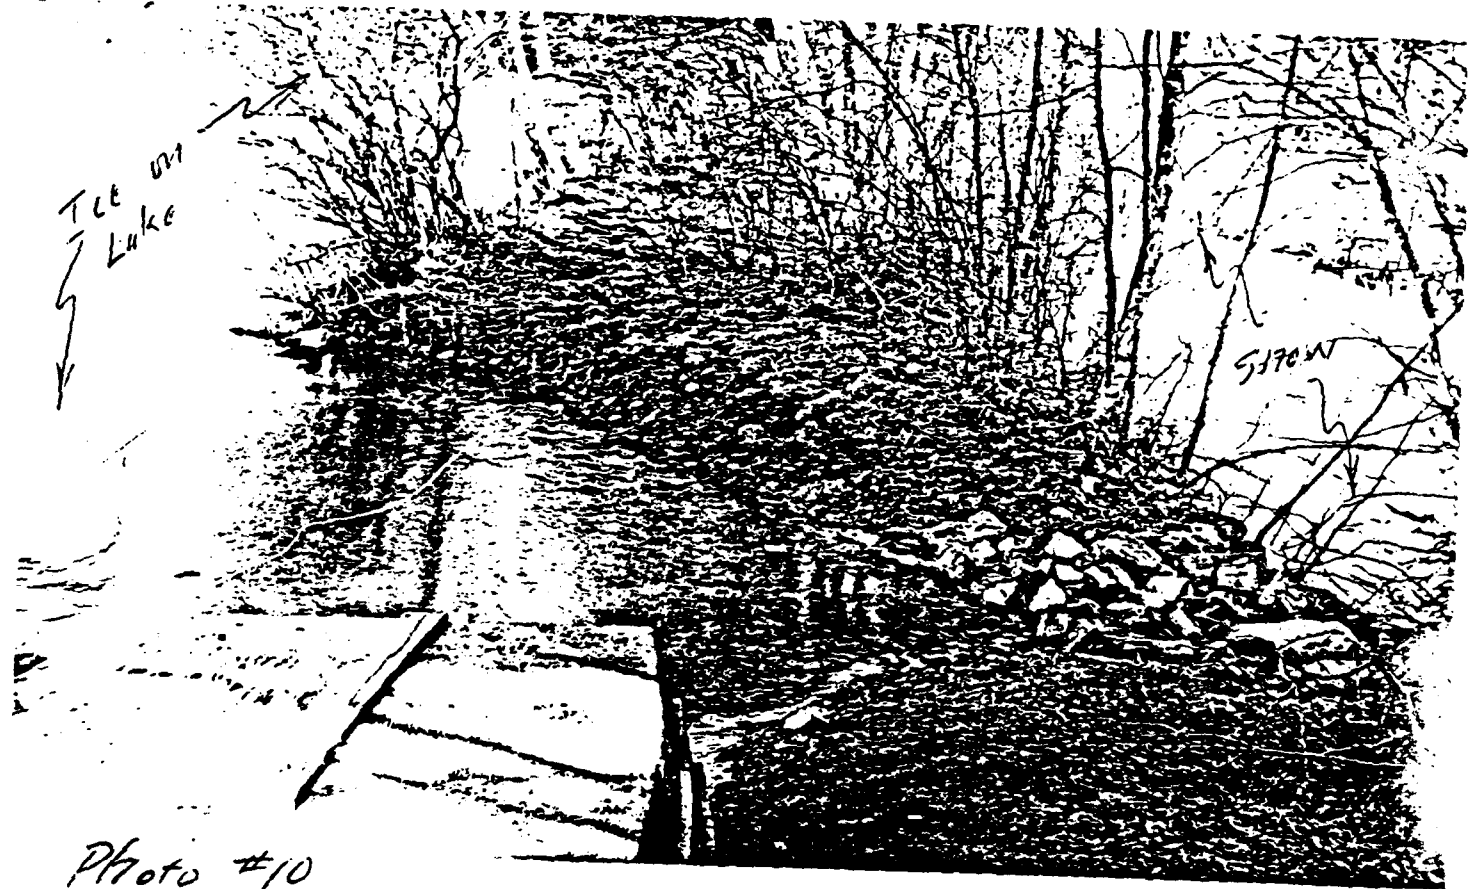
Photo #10

Break in dike on E. shore
of Lake - note loose stone
thrown into break.

It is recommended that a head wall be constructed at the intake end of the 36" ϕ pipe culvert on the west side. On the east side the break in the dike should be repaired with properly compacted earth fill and, where required, raised so that there will be a freeboard of at least 2' for it's entire length. Also, some stone rip-rap should be placed along the water side of the dike to prevent any erosion in case of even slight wave action.

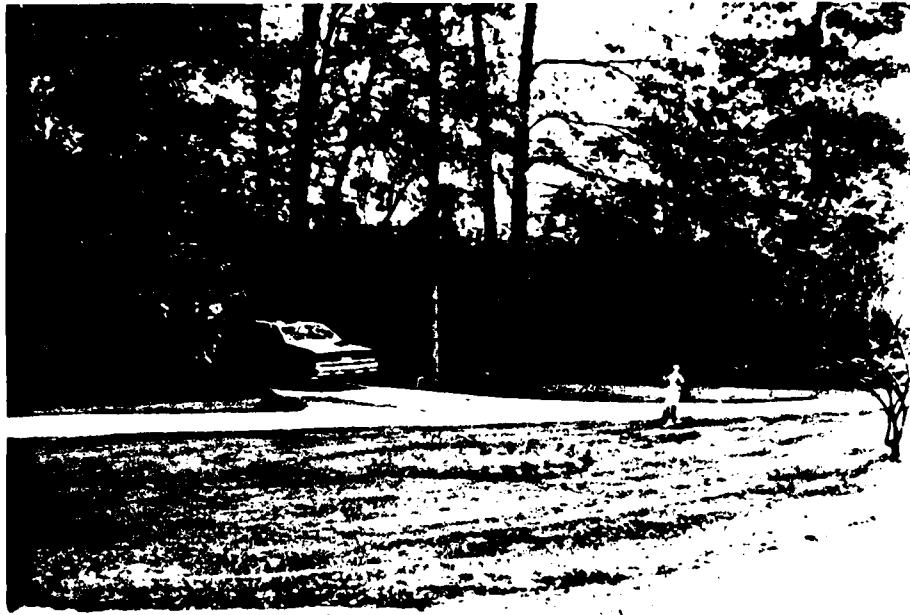
Photo 1 Downstream face and right abutment of dam on west side of Waubeeka Lake. First floor of home in impact area is defined by the deck, left.

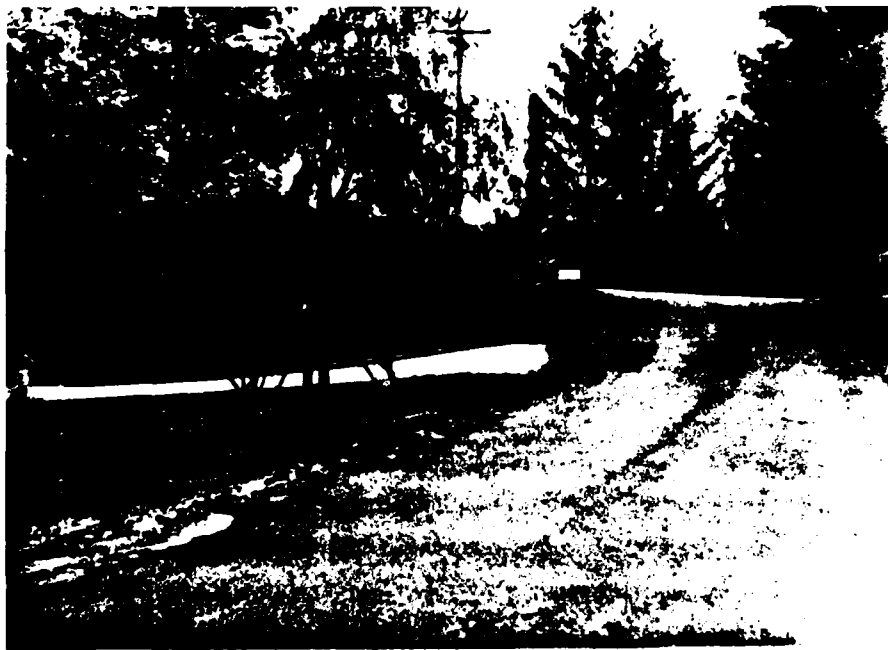
Photo 2 Downstream face of dam and Alan Road (West Dike).

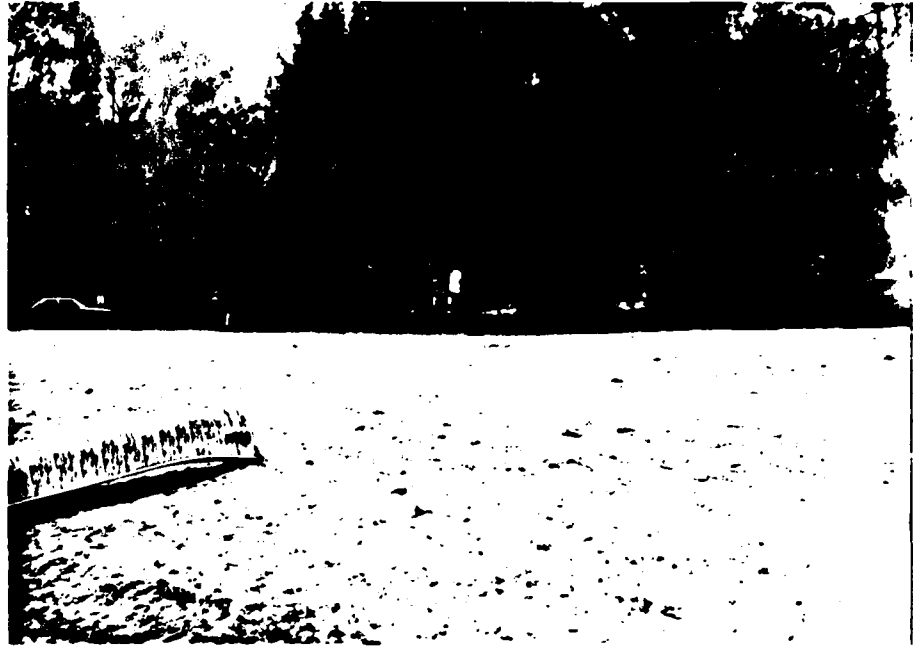
Photo 3 Upstream face of dam - Waubeeka Lake Beach (West Dike).

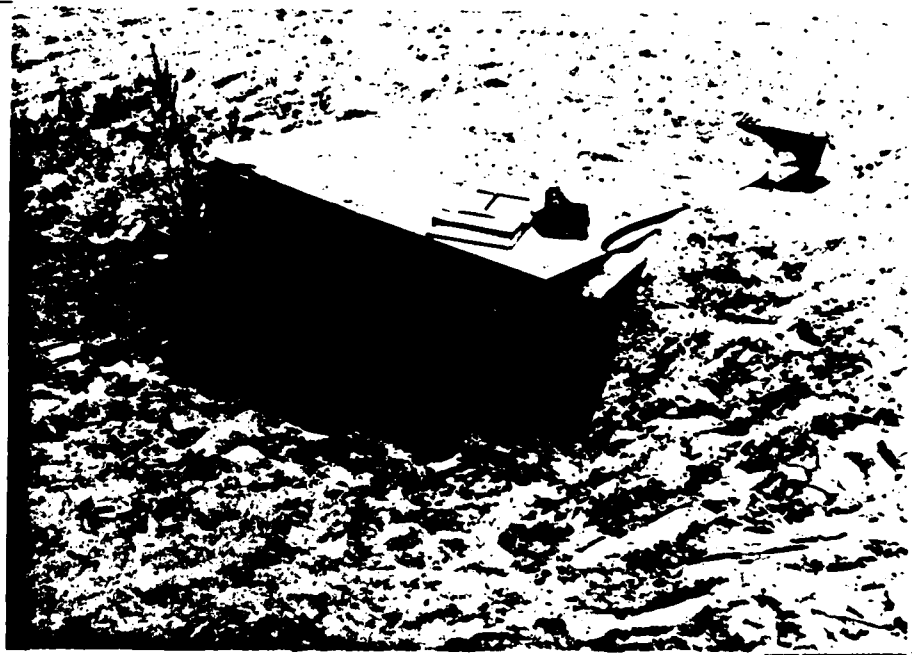
Photo 4 Intake of 3-foot diameter concrete conduit at dam (West Dike).

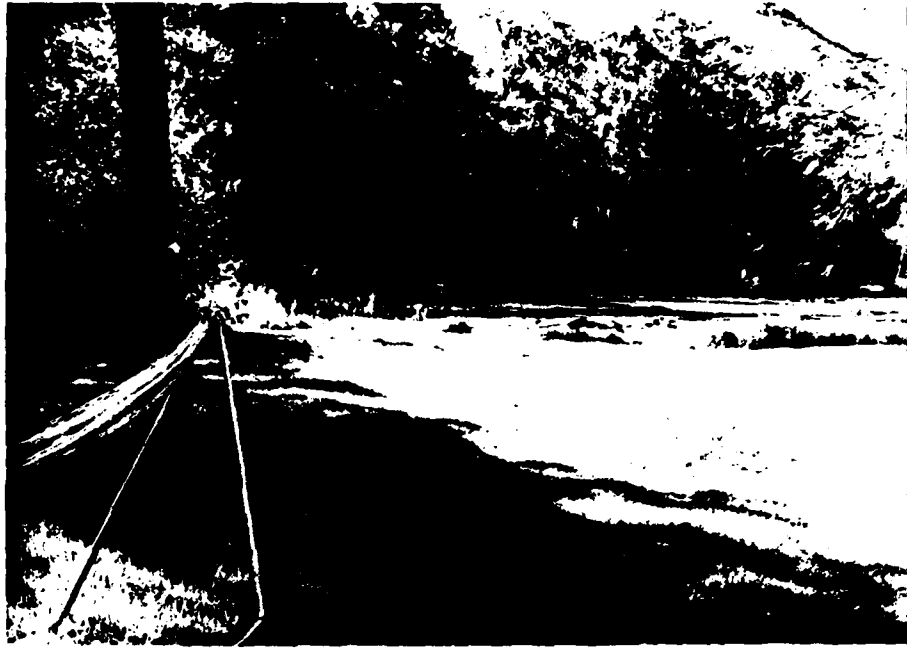
Photo 5 Landfill at southern end of lake.
