RIPPOWAM RIVER BASIN
STAMFORD CONNECTICUT

N. STAMFORD RESERVOIR DAM

CT. 00048

PHASE I INSPECTION REPORT
NATIONAL DAM INSPECTION PROGRAM

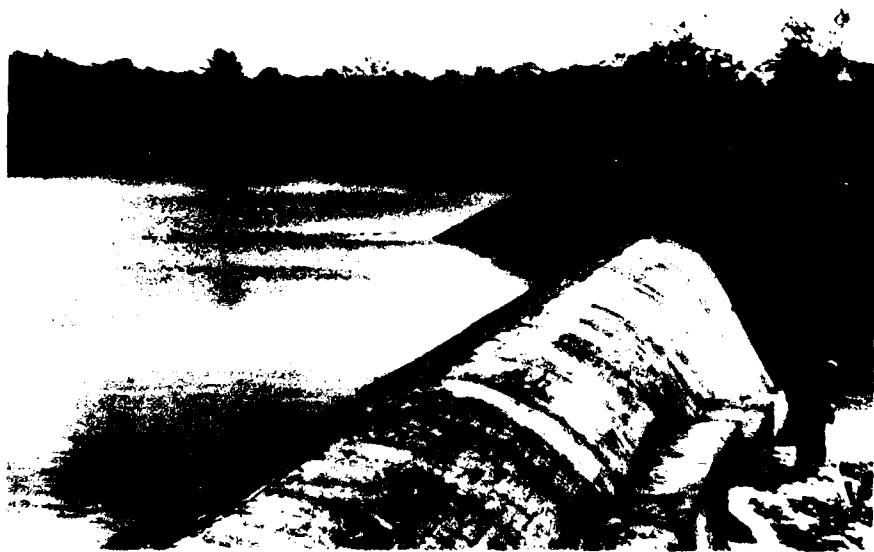
Overview from right abutment: new spillway foreground, gravity section left background.

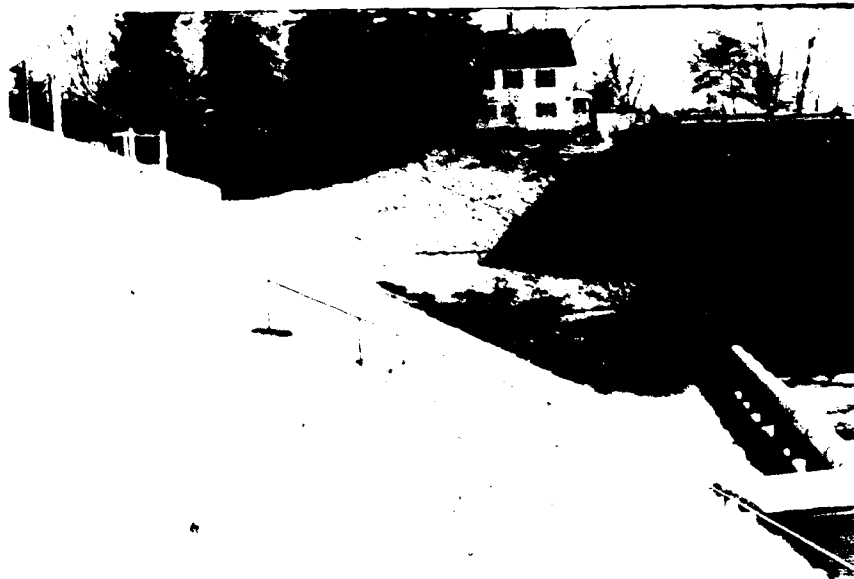
The earth fill on the downstream face of the dam appeared in excellent condition, with no evidence of slope movement, boils, drainage or seepage (Appendix C, Photo Nos. 1 & 2). As noted in Section 1.2b, it is speculated that this fill was added to shore up the dam against sliding and overturning forces. Although the surface of the fill is sodded and appears quite stable, it is not believed that it would remain stable in the event of an overtopping of the dam, and that it would be easily eroded and washed away by any appreciable volume of overtopping flow. Information was not available whether damage was sustained to this fill during the 1955 flood, when the dam was overtopped by 2½ in.

1. Earth slope at downstream toe of concrete gravity dam section.

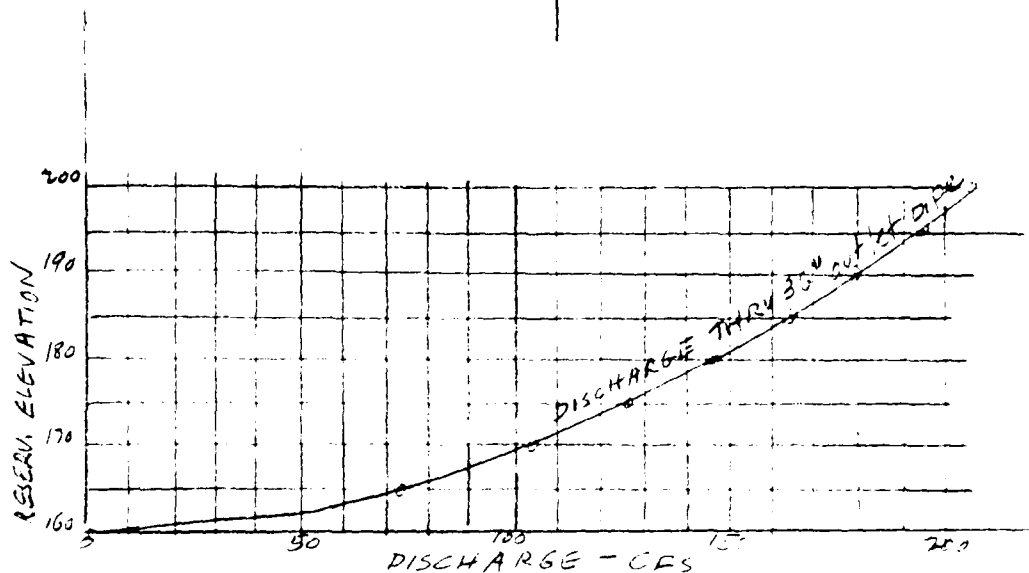
FIGURE 1
SHEET D-3

With the flashboards in place, the capacity of the spillway is accordingly reduced. A discharge curve for the spillway with 12 in. flashboards installed is shown on Figure 1, Sheet D-3. It will be noted that, with the reservoir level at the top of the gravity dam, elevation 200, the spillway discharge will be about 4,800 cfs, or 65 percent of that for the unobstructed crest. With the reservoir at the top of the earth dike, elevation 202, the spillway discharge will be about 10,400 cfs. or 70 percent of that of an unobstructed crest.
