NAUGATUCK RIVER BASIN
SEYMOUR, CONNECTICUT

KINNEYTOWN DAM
CT 00089

PHASE I INSPECTION REPORT
NATIONAL DAM INSPECTION PROGRAM

JANUARY 1980

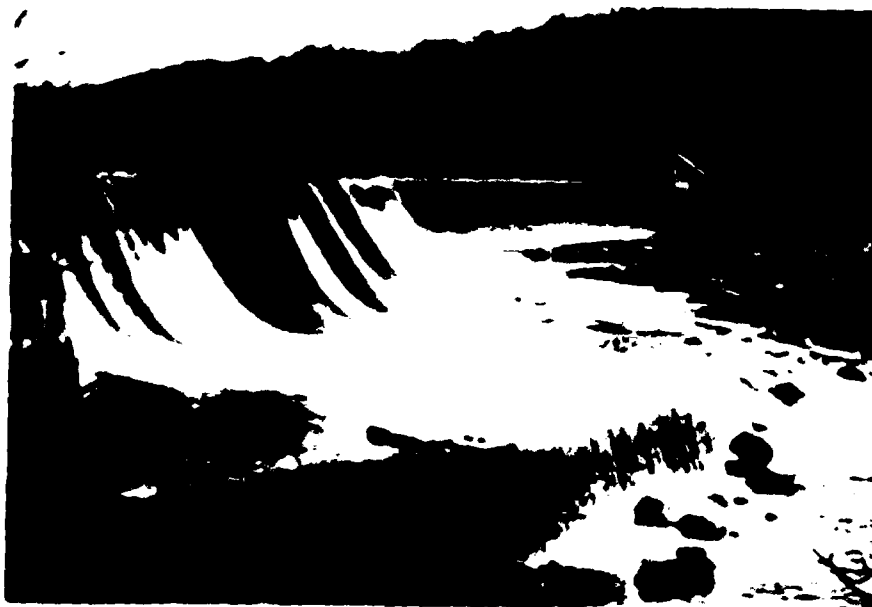
PHOTO NO. 1

Over most of its length, the right (lower) spillway section has a rising foot vertical drop at the end of the spillway apron, as shown in Photo 1. A vertical concrete wall was generally present on this drop. However, at the right end of the spillway this wall was missing and the concrete apron had been undermined up to 12 feet back under the apron, as shown in Photos 1 and 2. No water was observed seeping from the soil exposed by this undermining. The underside of the apron, exposed by the undermining, appeared to be rubble concrete. The undermined and eroded area has begun to spread around the downstream end of the right training wall and a surficial sloughing failure has occurred on the right bank of the river just downstream of the right training wall, as shown in Photo 3. The remainder of the apron of the right spillway section showed cracking and some evidence of erosion, as shown in Photo 4. The spillway apron as observed in the field extends further downstream than shown on the construction plans. The right spillway showed evidence of

spalling in the form of irregularities in the flow of water over the spillway, Photo 1. The right spillway section has provisions for flashboards and some debris was collected at portions of the spillway crest.

EROSION AND UNDERMINING AT RIGHT END OF SPILLWAY APRON,
IRREGULARITIES IN FLOW OVER SPILLWAY

- b) The spalling and cracking of the concrete structures should be examined and necessary repairs should be made.
- c) The causes of the seepage downstream of the left training wall and through the right training wall should be investigated and a seepage control system should be designed and constructed, if necessary.
- d) The tree growth on the earth embankment should be removed by uprooting and the root zones backfilled with carefully selected soil, placed as directed by the engineer.
- e) The condition of the sheet piling downstream of the left training wall should be investigated and repairs made as required.
