HOUSATONIC RIVER BASIN  
SHELTON, CONNECTICUT

SHELTON RES. NO. 2 DAM  
CT 00093

PHASE I INSPECTION REPORT  
NATIONAL DAM INSPECTION PROGRAM

SEPTEMBER 1980

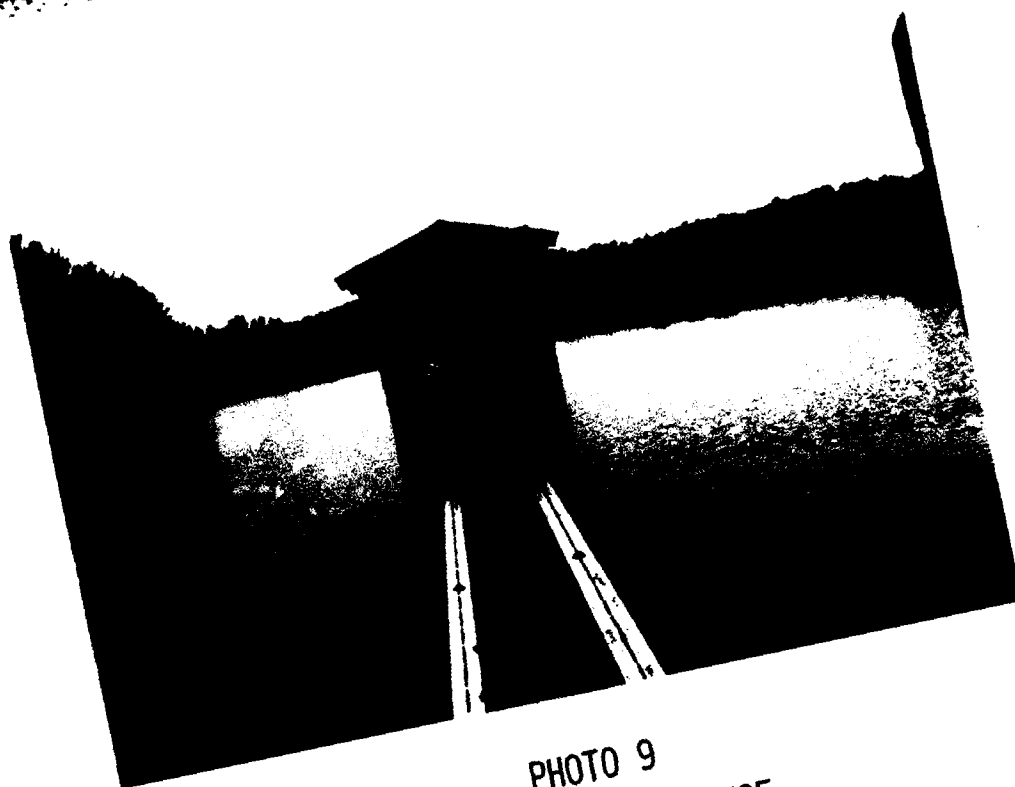
Both the upper and lower gate houses are in poor condition (Photos 8 and 9). The deck of the service bridge to the upper gate house is missing and the support beams are rusting away. The lower gate house is in better condition, however, trespassing is a problem. The water main that was controlled by the gates in the gate houses is not operable and is plugged.

PHOTO 9  
UPSTREAM GATE HOUSE

- d. The condition of the low level discharge pipe and valve should be evaluated and both pipe and valve be made operable.
- e. The bridge to the upper gate house should be repaired.
- f. Prepare a detailed hydraulic/hydrologic study to determine spillway adequacy and an increase of the total project discharge if necessary.
