**BLACK ROCK POND DAM  
CT 00633**

**PHASE I INSPECTION REPORT  
NATIONAL DAM INSPECTION PROGRAM**

IDENTIFICATION NO: CT 00633  
NAME OF DAM: Black Rock Pond Dam  
TOWN: Watertown  
COUNTY AND STATE: Litchfield County, Connecticut  
STREAM: Purgatory Brook  
DATE OF INSPECTION: July 28, 1980

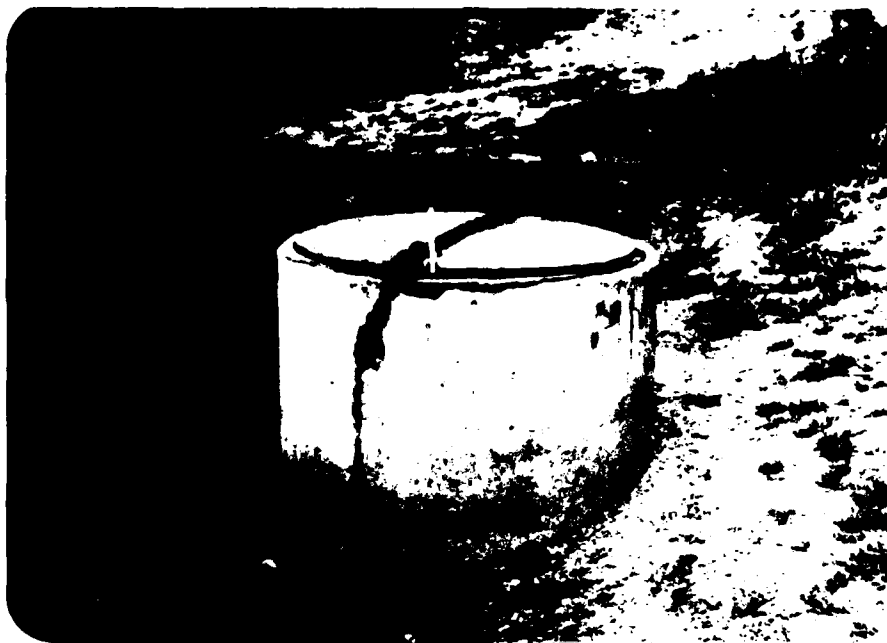
PHOTO NO. 7

The low level outlet or blowoff consists of a 12 inch diameter cast iron pipe through the dam controlled by an upstream gate contained in a reinforced concrete pipe chamber, Photos 4 and 7. There was a slight amount of leakage coming from the pipe. The upstream gate was reported to be operable.

CONCRETE RISER FOR LOW LEVEL  
OUTLET OR BLOWOFF GATE

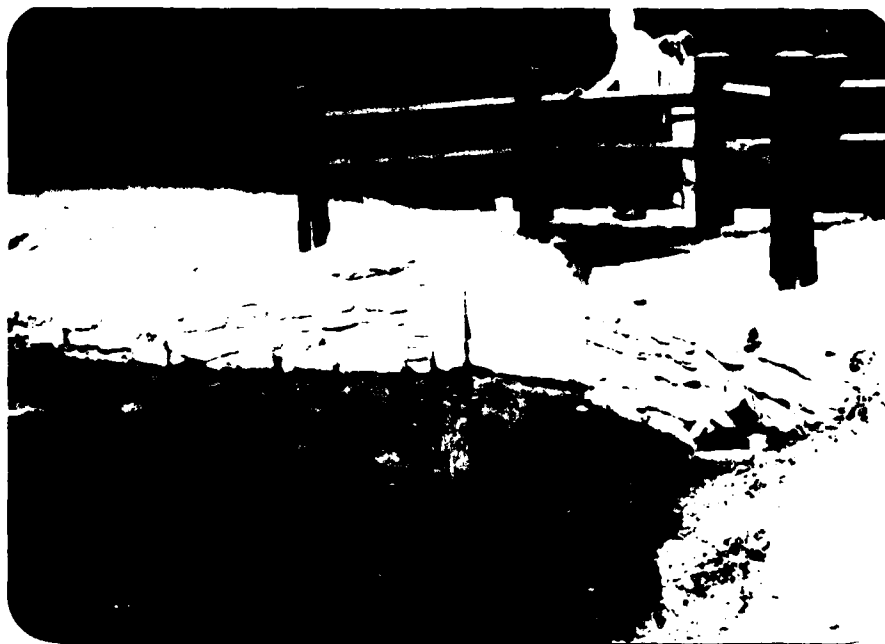
PHOTO NO. 8

The spillway itself appears to be in good condition. There was some small leakage between and around the ends of the flashboards. Several stones were missing in both the upstream and downstream stone masonry walls, Photos 8 and 9. A small amount of seepage was noted at the base of the left downstream wall. Some erosion was also noted around the ends of the walls.

SPILLWAY FROM UPSTREAM  
RIGHT ABUTMENT
