**CONNECTICUT COASTAL BASIN  
STONINGTON, CONNECTICUT**

**MYSTIC RESERVOIR-SOUTH DAM  
CT. 00613**

**PHASE I INSPECTION REPORT  
NATIONAL DAM INSPECTION PROGRAM**

**FEBRUARY 1981**

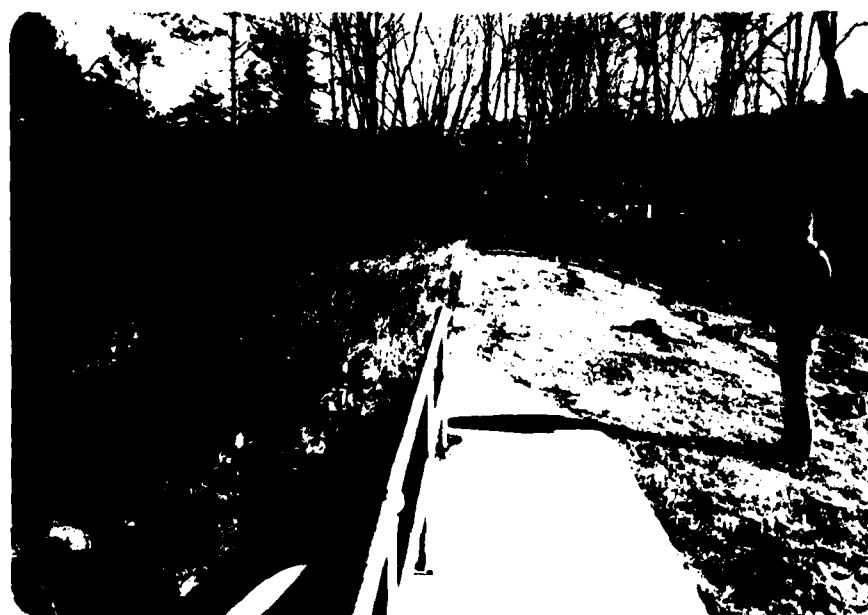
2. Crest. The crest of the dam is shown on Photos C-1, C-2, and C-3. The crest of the earth embankment section is 7 feet wide with the concrete core wall extending to the surface. The crest of the concrete gravity section has transverse hairline cracks spaced regularly 10-15 feet apart and at all construction key joints. Larger transverse cracks 1/32 to 1/16 inch were observed at Stations 2+50 and 2+95 (Photo C-9). Some spalling of a thin slush coat of concrete was observed on the crest

PHOTO C-2: Left abutment and dam crest.

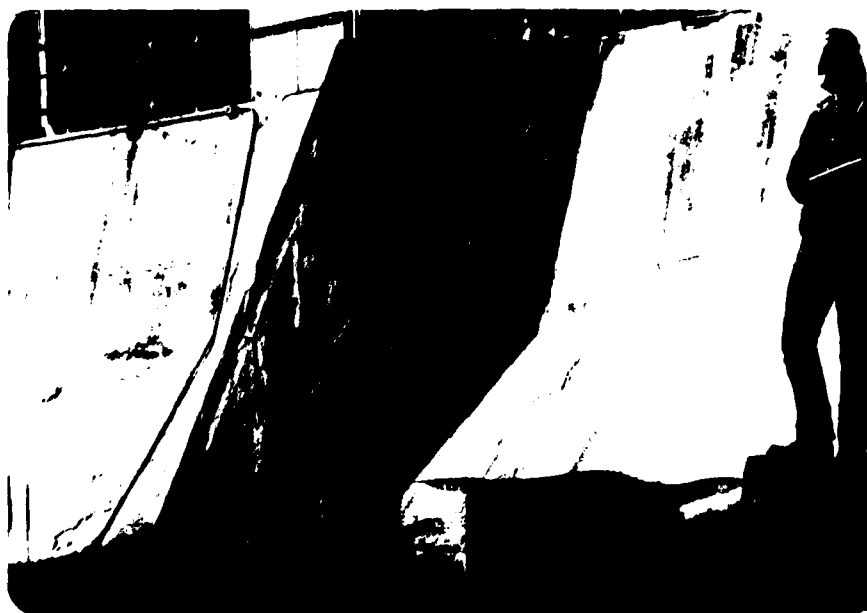
PHOTO C-10: Downstream face of gravity section. Note cracking and efflorescence of concrete.
