BLACKSTONE RIVER BASIN
MILLBURY, MASSACHUSETTS

RAMSHORN POND DAM
MA 00145

**PHASE I INSPECTION REPORT
NATIONAL DAM INSPECTION PROGRAM**

JULY 1978

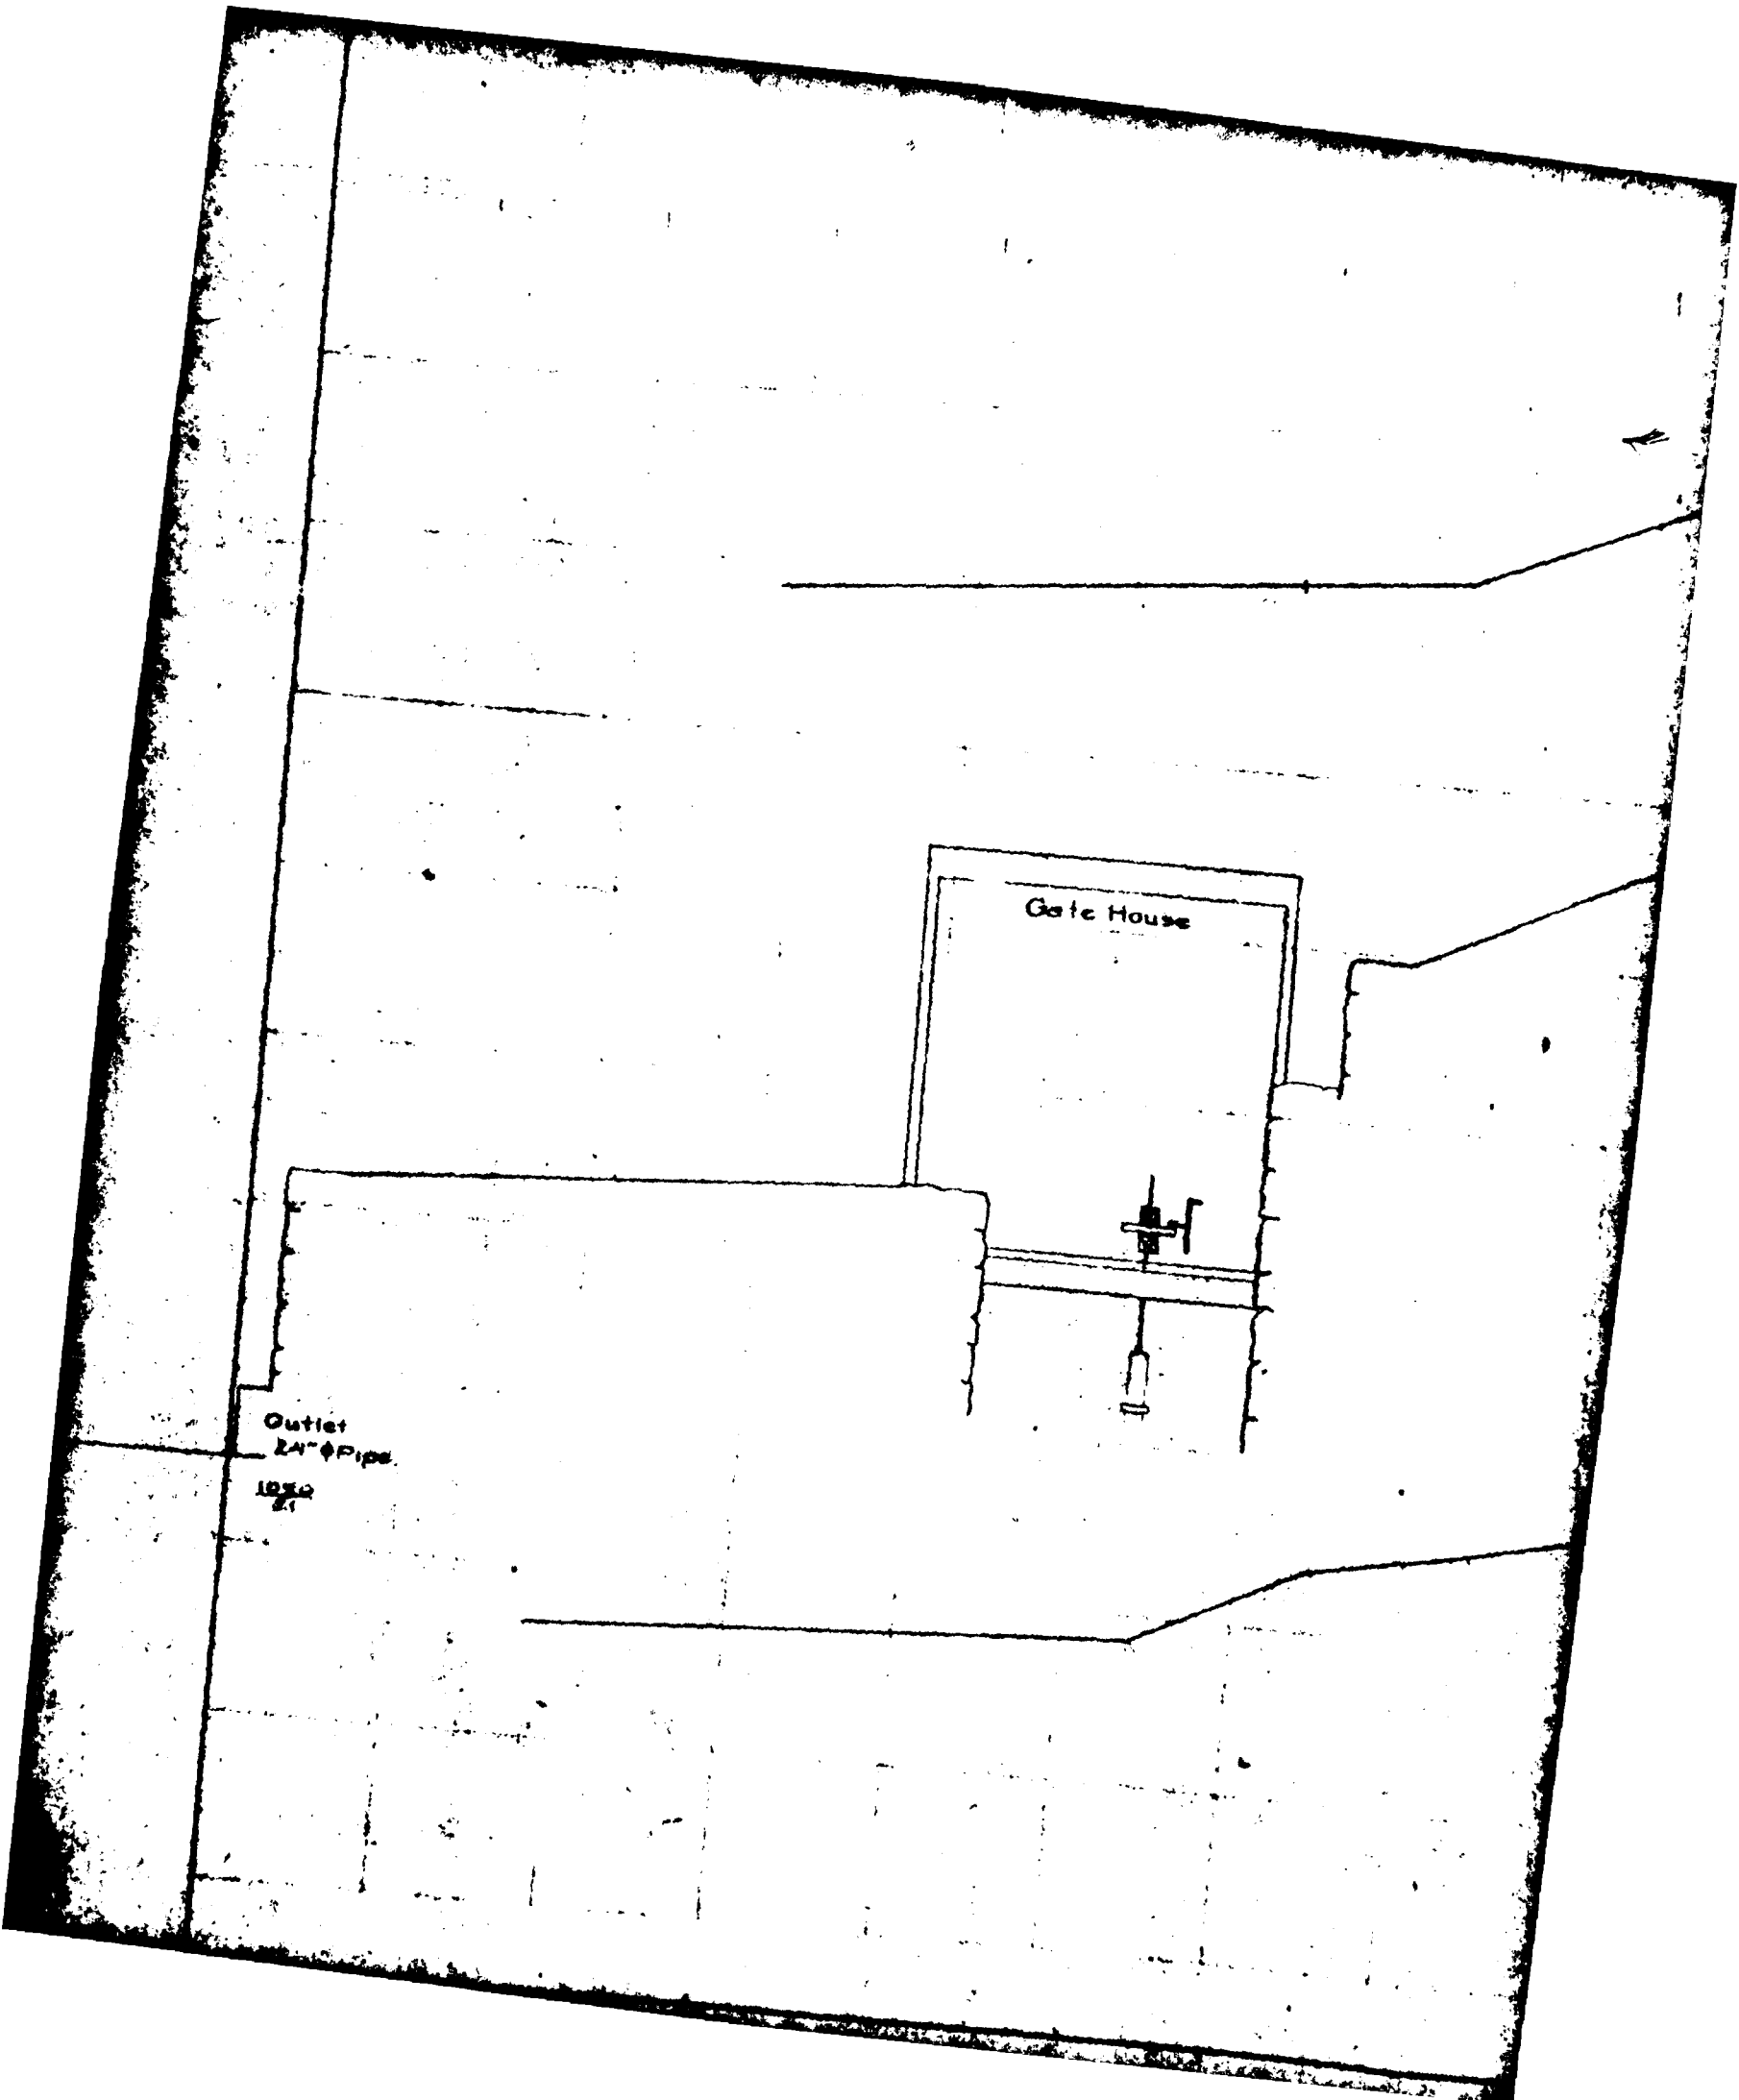
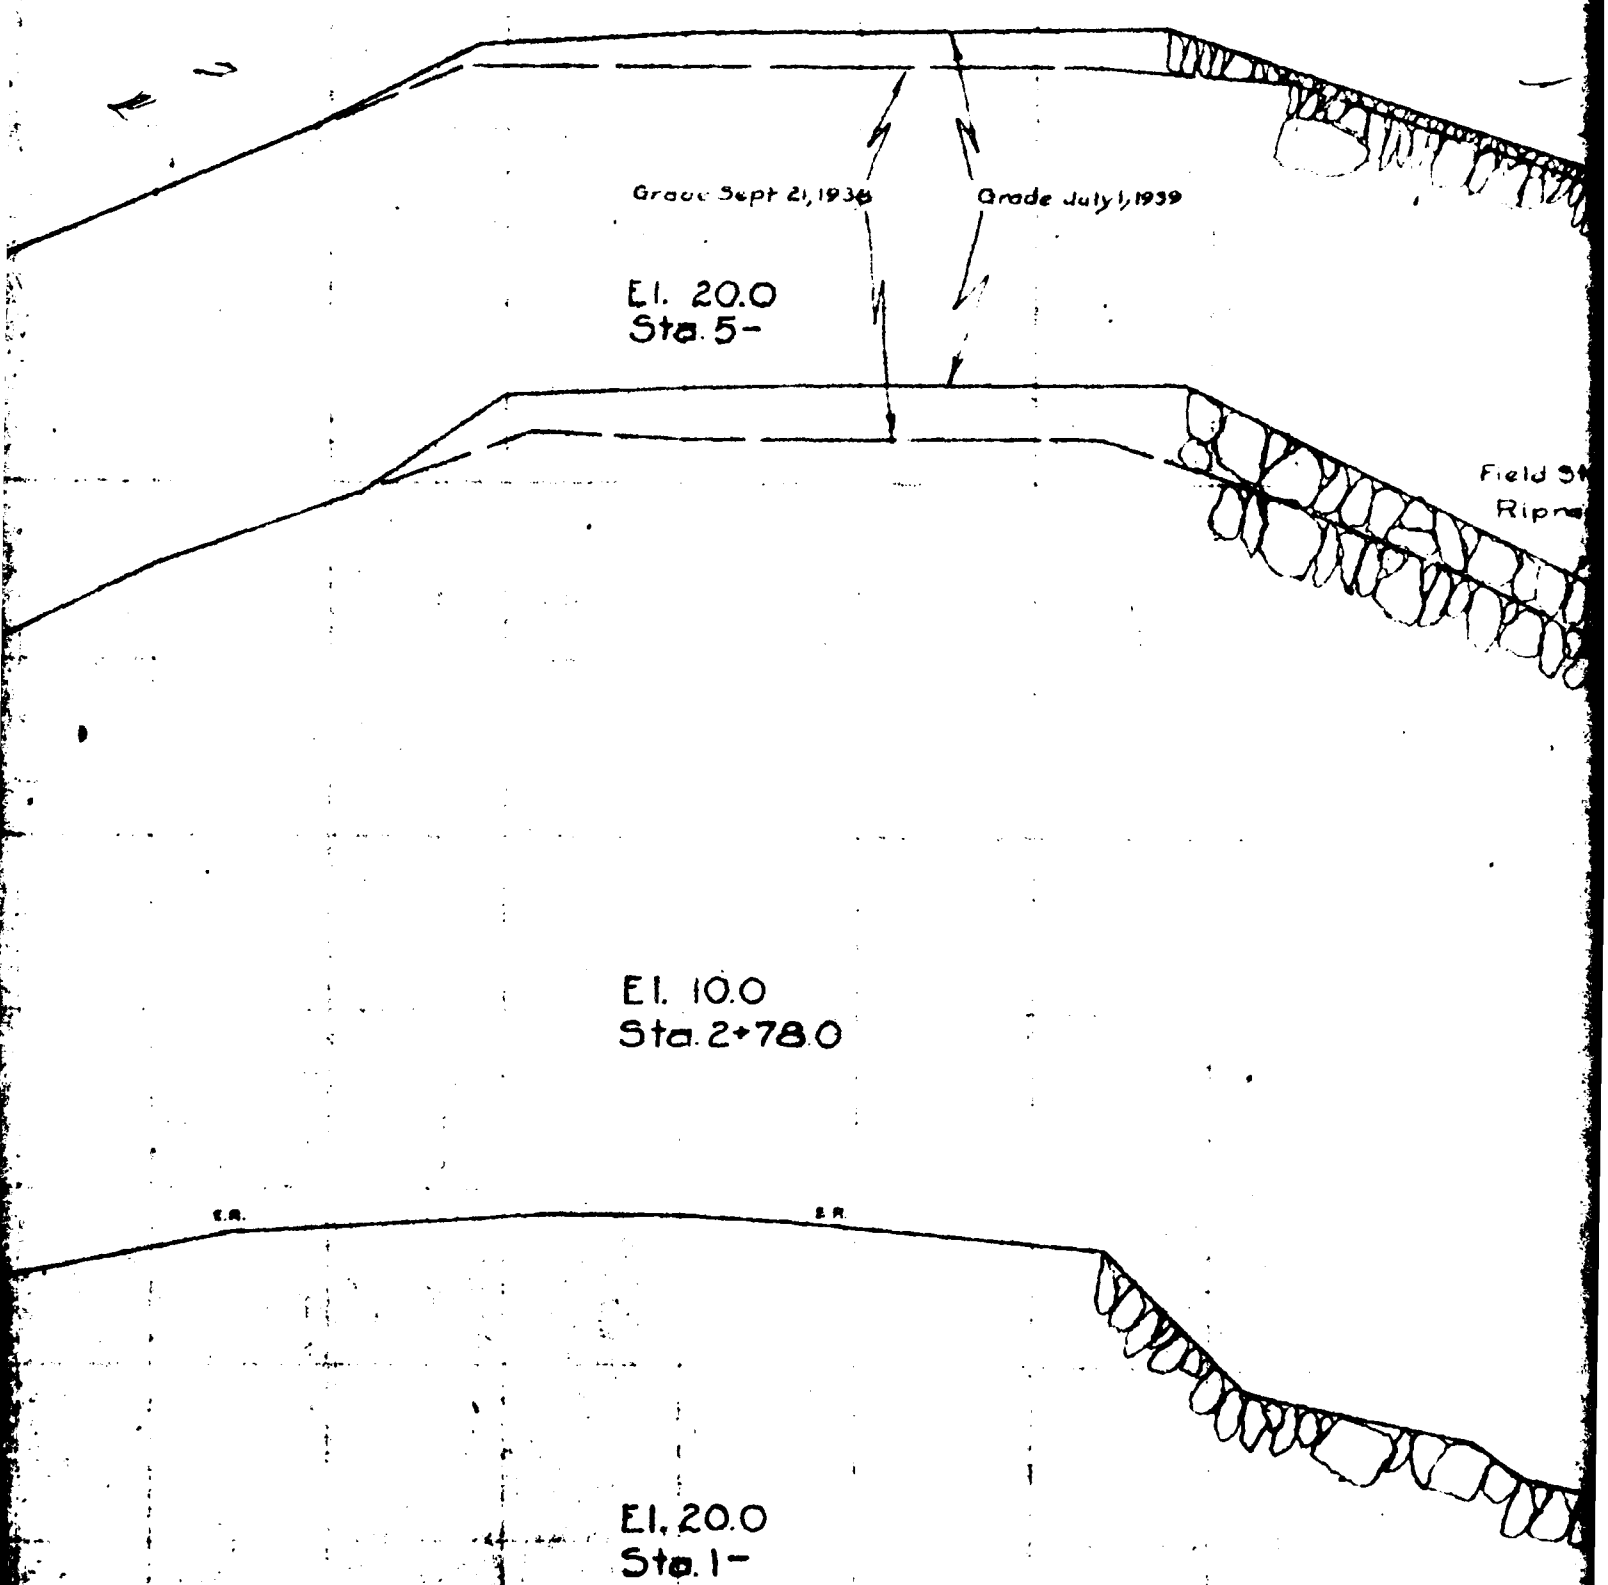
FIGURE B-3

- d. Overtopping Potential. Overtopping of the dam is expected under an outflow test flood of 2,670 cfs; as noted previously, however, the records on overtopping indicate that the dam was overtopped during the 1938 flood but was not overtopped in 1955. Figures B-2 and B-3 in Appendix B show the dam was raised about 2 feet in 1939.

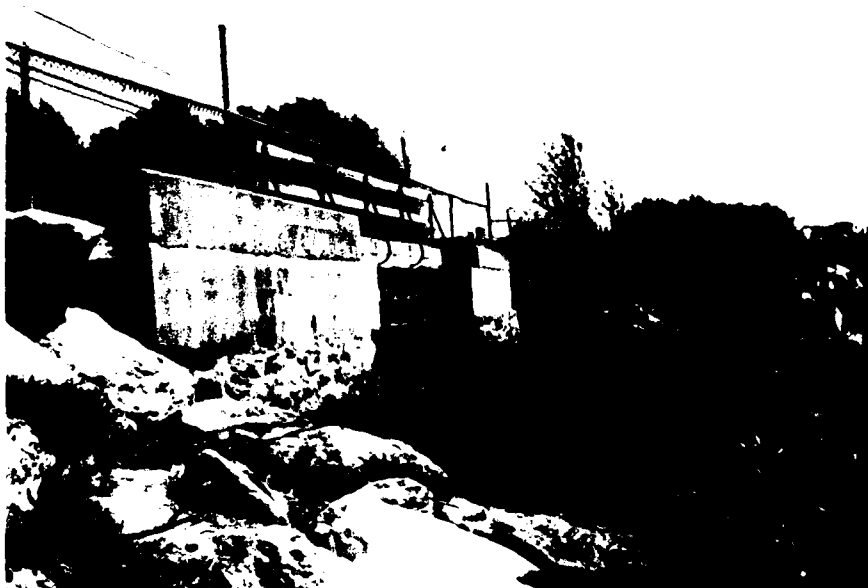
The spillway headwall has minor cracks in the concrete (see Photographs C-1 and C-2, Appendix C). Two flashboards (bottom 11-inches high, top 8-inches high) were braced by five evenly spaced iron pins. There were gaps between the flashboards where water is spilling through. There is also minor erosion on the concrete at the southern end of the flashboards. The concrete under

NO. 1 - SPILLWAY INLET AND HEADWALL
