NATIONAL PROGRAM FOR INSPECTION OF NON-FEDERAL DAMS
NAGOG POND DAM MA 001..(U) CORPS OF ENGINEERS WALTHAM
MA NEW ENGLAND DIV NOV 78

4. TITLE (and Subtitle) Nagog Pond Dam		5. TYPE OF REPORT & PERIOD COVERED INSPECTION REPORT
6. NATIONAL PROGRAM FOR INSPECTION OF NON-FEDERAL DAMS		6. PERFORMING ORG. REPORT NUMBER

Nagog Pond dam is located approximately two miles north of Acton center and impounds a water supply for the nearby Town of Concord. The dam is a concrete gravity section keyed into bed-rock. The top of the dam is approximately 168 ft. long and 15 ft. high. This dam was constructed in 1909 to replace an existing dam which was of inadequate construction.

The dam is in good condition, based on a visual examination of the structure. Although some deficiencies were noted, there was no evidence of settlement, lateral movement or other signs of structural failure or other conditions which would warrant urgent remedial treatment.

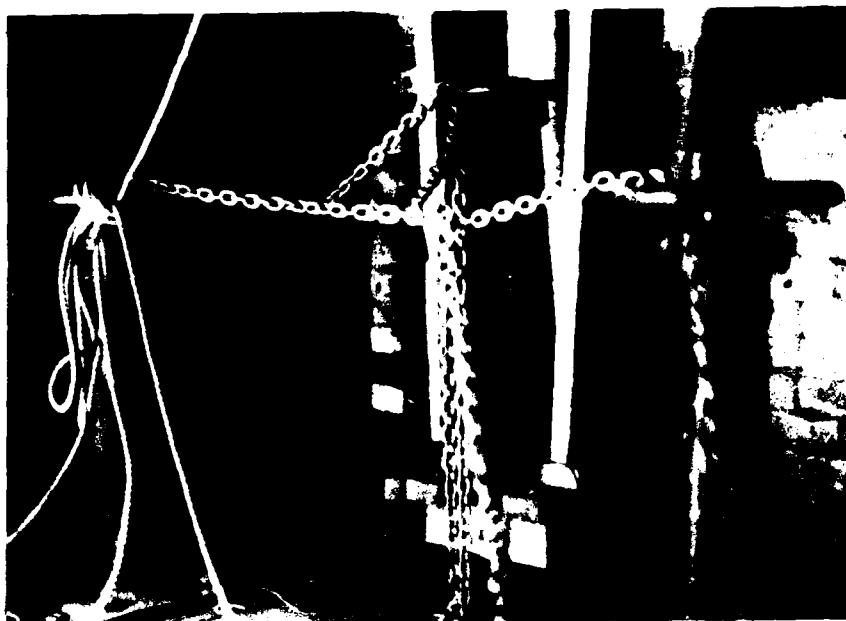
The gate valves within the gate house appear to be maintained and operable. They are currently chained to prevent vandal damage, as shown in Photo No. 8. Two of the gate valve operators are loose, braced by timbers and are apparently located over valve boxes. The blowoff outlets on the downstream face of the dam on the right side of the discharge channel are partially blocked by earth, Photo No. 9.

8. Controls inside gate house

4. Reconstruct the reservoir drain to make it operational and accessible during high reservoir levels.
5. Firmly attach the loose and timber braced gate operators within the gate house to the floor or other rigid support.
6. Clear the brush and trees on the upstream side of the dam, adjacent to the dam and within the spillway to minimize root encroachment into cracks in the masonry and fieldstone discharge channel walls.
7. Regrade the discharge channel to remove the partial blockage of the reservoir drain outlet, the partial blockage of the blowoff outlets and the partial blockage of the channel approximately 20 feet downstream of the spillway.

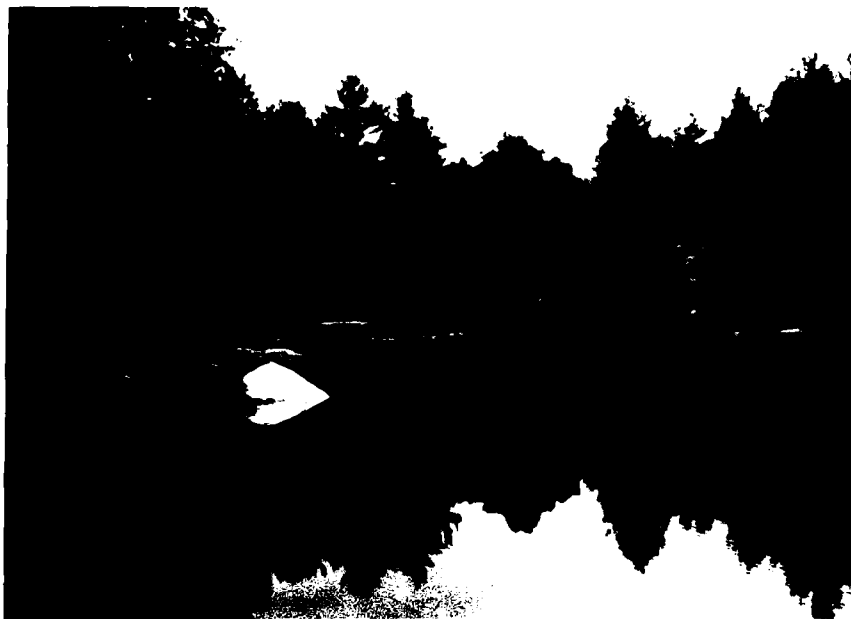
12. Nagog Pond immediately upstream of dam
