NATIONAL PROGRAM FOR INSPECTION OF NON-FEDERAL DAMS  
HAMILTON RESERVOIR DA. (U) CORPS OF ENGINEERS WALTHAM  
MA NEW ENGLAND DIV NOV 78

20. ABSTRACT (Continue on reverse side if necessary and identify by block number) The dam is an earthfill embankment and concrete spillway dam. It is about 100 ft. long and has a maximum height of 17 ft. The project is considered to be in good condition. It is intermediate in size with a significant hazard potential.. It is recommended that the owner retain a competent con- sulting engineer to conduct further studies to determine the measures that are necessary to improve the discharge capacities.

PHASE I INSPECTION REPORT  
NATIONAL DAM INSPECTION PROGRAM  
THAMES RIVER BASIN  
INVENTORY NO. MA 00536  
HAMILTON RESERVOIR DAM  
TOWN OF HOLLAND  
HAMPDEN COUNTY, COMMONWEALTH OF MASSACHUSETTS

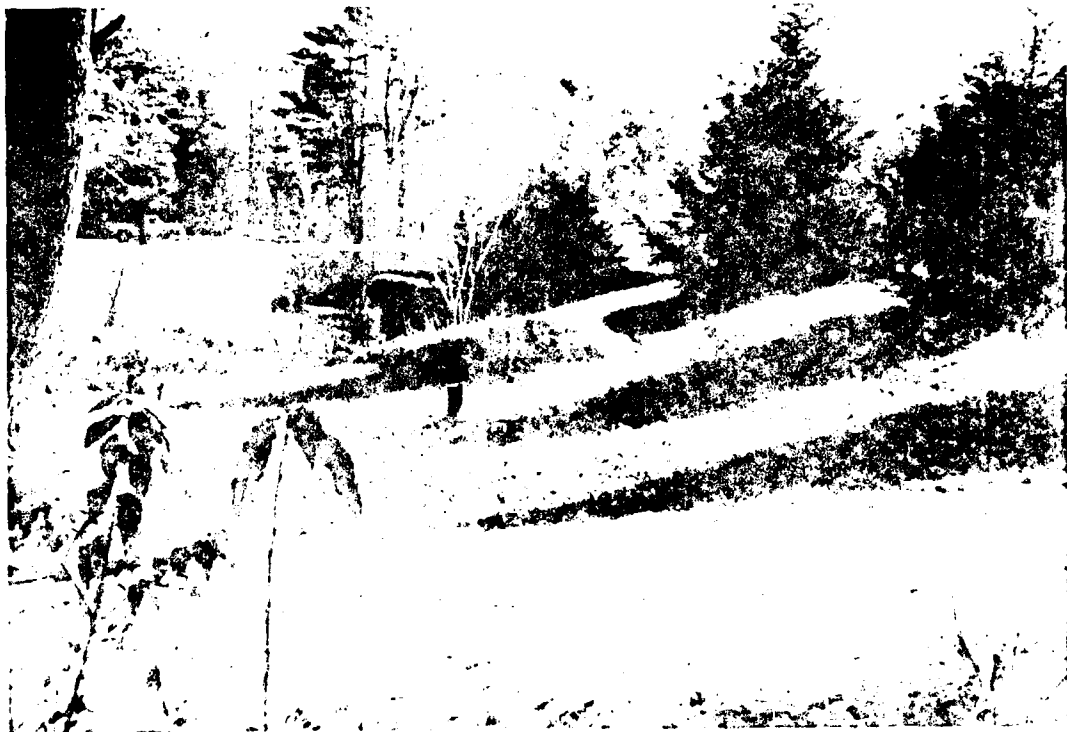
The downstream slope is in generally good condition. The grass is cut, however, there are about four ten foot tall evergreens and a few small fruit trees which have been planted by the owner of the house adjacent to the embankment. (See Photograph No. 4).

4. VIEW OF DOWNSTREAM SCOPE OF EARTH EROSION  
FROM POINT 1.

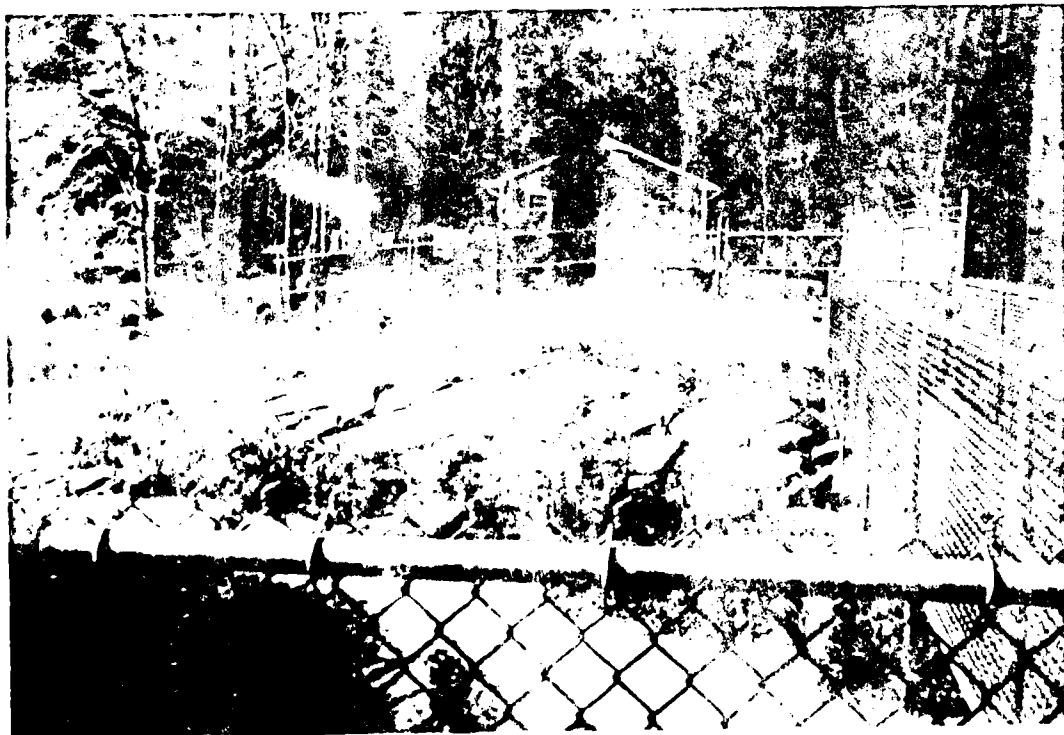
The upstream slope is in generally good condition. The stone rip-rap is sound with some tall grass growing through it. There are no signs of trespassing, sloughing or erosion, (See Photograph No. 5).

5. VIEW OF UPSTREAM DIVERSION OF EARTH  
FROM POINT 1.

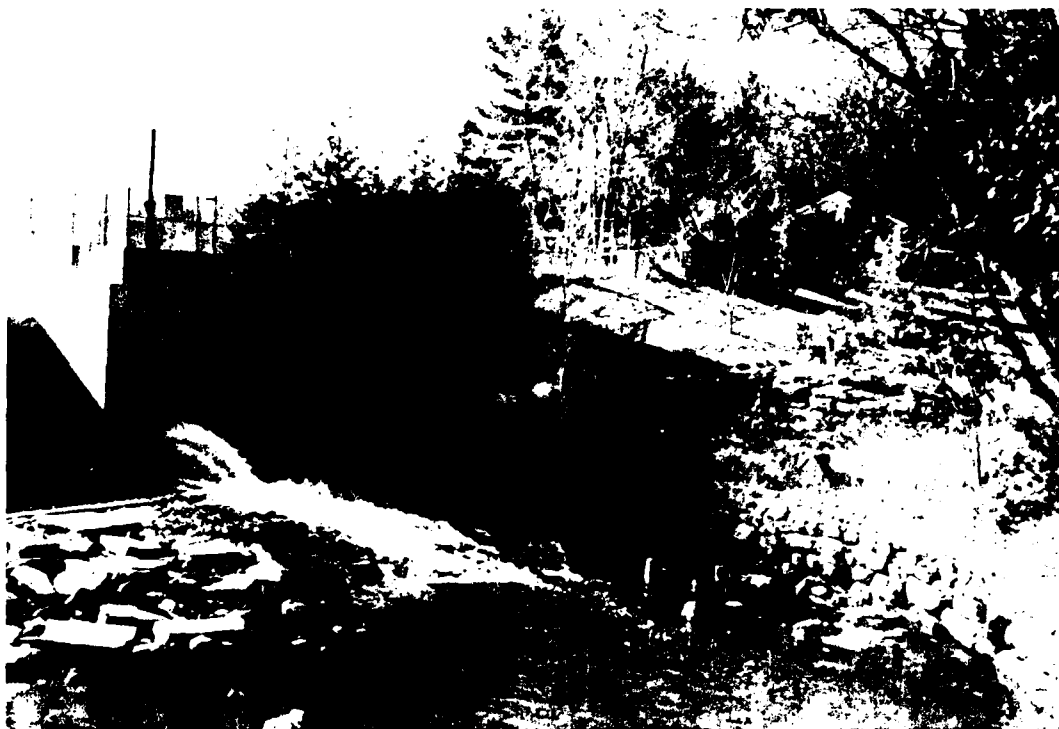
The intake structure is in good condition, the concrete is sound and free of spalled areas. There was no debris, other than some leaves observed at the trash rack. The operating stand is in good condition. (See Photograph No. 10). The operating handle was not in place, but reportedly is kept at the Public Works Dept. At the time of the inspection, the sluice gate was operable and open about two or three inches and the discharge did not appear to be impeded. (See Photograph No. 6).

6. VIEW OF GATEHOUSE, DOWNSTREAM TRAINING WALL AND RIPRAP ON CHANNEL FLOOR.

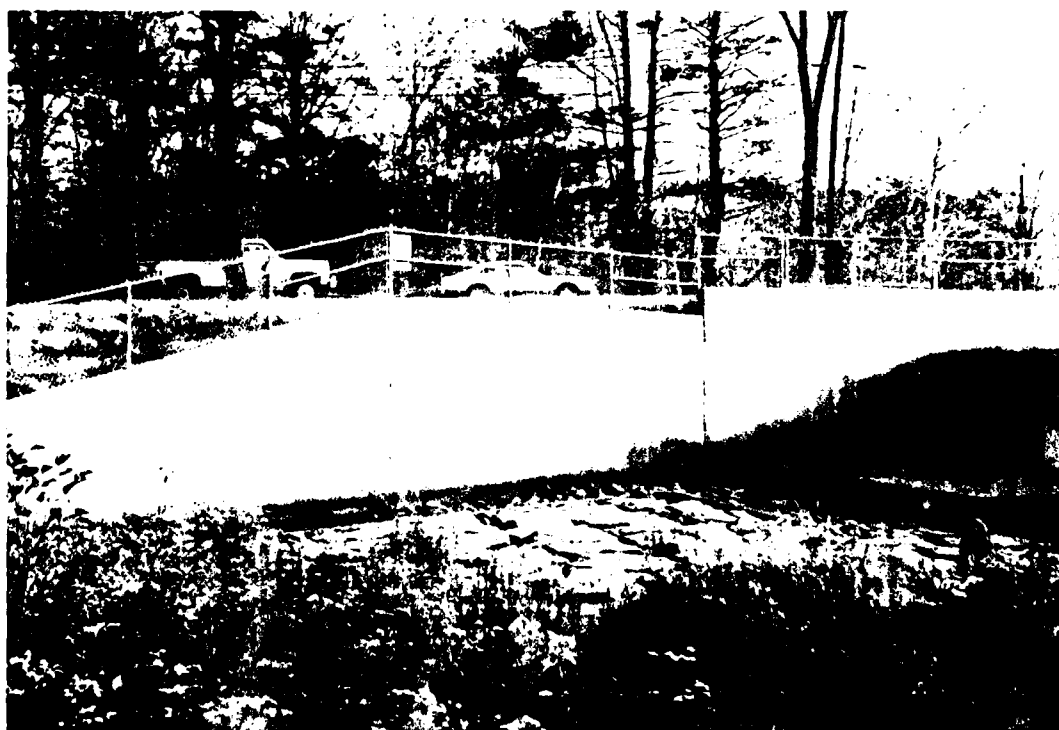
The right abutment concrete training wall is in good condition. The concrete is sound with no spalled surfaces observed. Several of the weep holes located at the base of the wall were running water. The left downstream training wall is in good condition. The lower stone portion of the wall is sound with minimal vegetation growing out of the joints. The upper stone masonry portion

of the wall is in good condition. (See Photograph No. 7).

7. VIEW OF DOWNSTREAM TRAINING WALL, ROAD AND RIPRAP ON CHANNEL FLOOR.

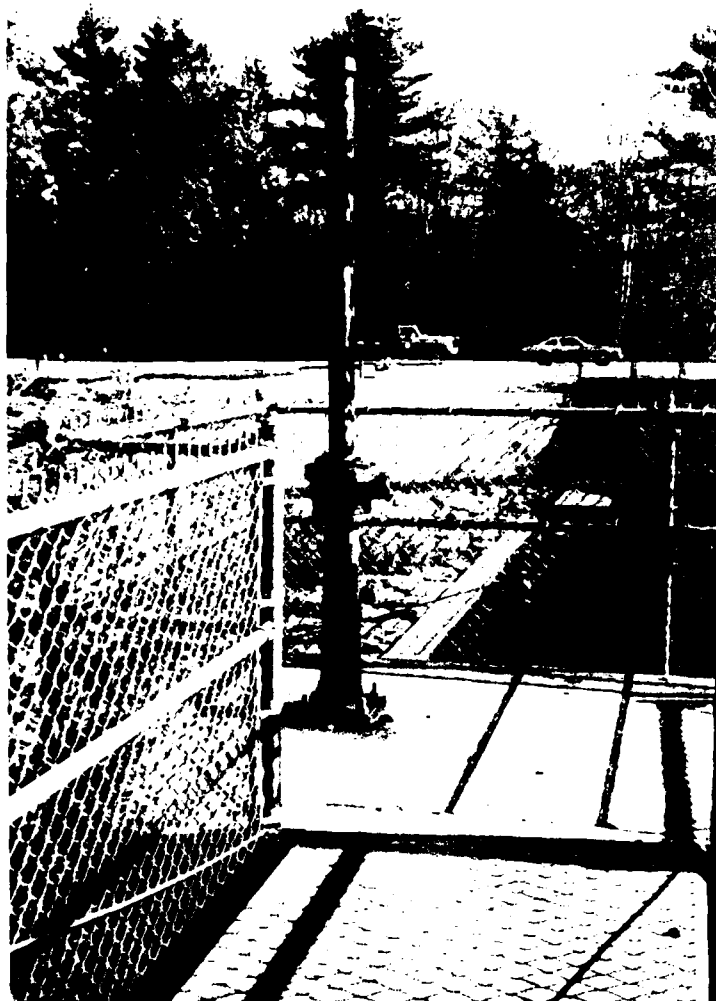
10. VIEW OF LOW LEVEL GATE OPERATING STAND.
