CHARLES RIVER BASIN  
WESTON, MASSACHUSETTS

STONY BROOK RESERVOIR DAM  
MA 00293

PHASE I INSPECTION REPORT  
NATIONAL DAM INSPECTION PROGRAM

JUNE 1979

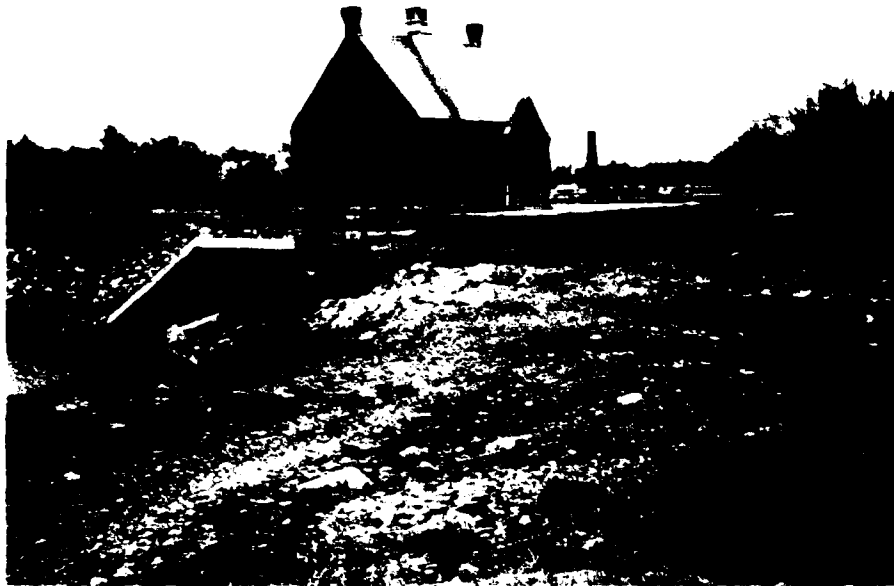
10. OVERVIEW OF SPILLWAY APPROACH CHANNEL AND INLET TO GATE HOUSE.

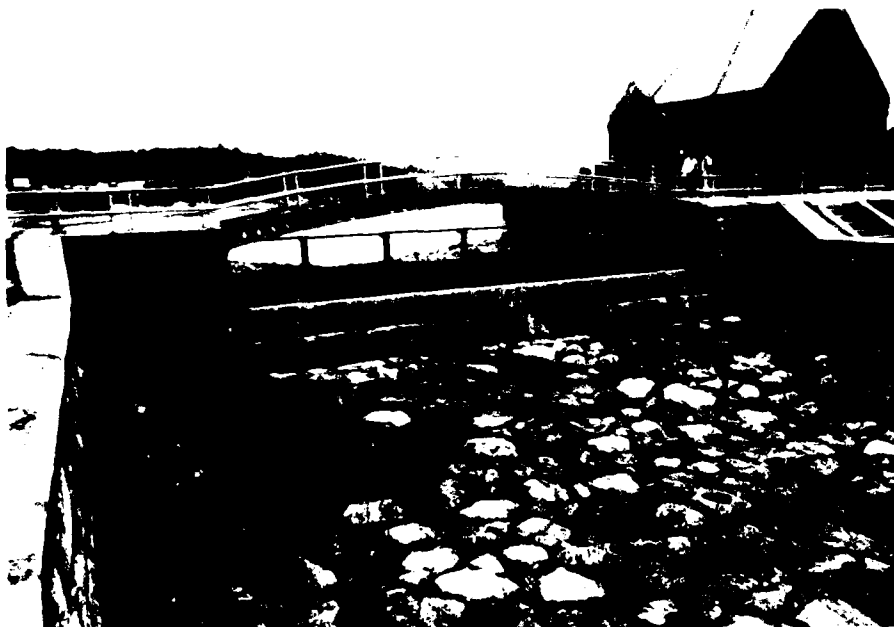
- c. Appurtenant Structures - The stone masonry spillway is in good condition. Some of the masonry joints in the spillway weir as shown in Photo 11 have experienced a loss of mortar and need repointing. The flashboards at the weir crest are in good condition and require no corrective action at present. The spillway discharge channel has some vegetation in the form of brush present as shown in Photos 11 and 12. The masonry side walls need repointing as shown in Photo 13. The pedestrian bridge over the spillway is in good condition.

11. OVERVIEW OF SPILLWAY WEIR FROM RIGHT DOWNSTREAM CHANNEL WALL.

- (3) Repoint stone masonry at the spillway weir, side walls and apron. Repoint gatehouse brickwork.
  - (4) Repair the presently inoperative intake
  - (5) Develop a formal maintenance program, operational procedure, emergency procedures plan and warning system in cooperation with downstream officials.

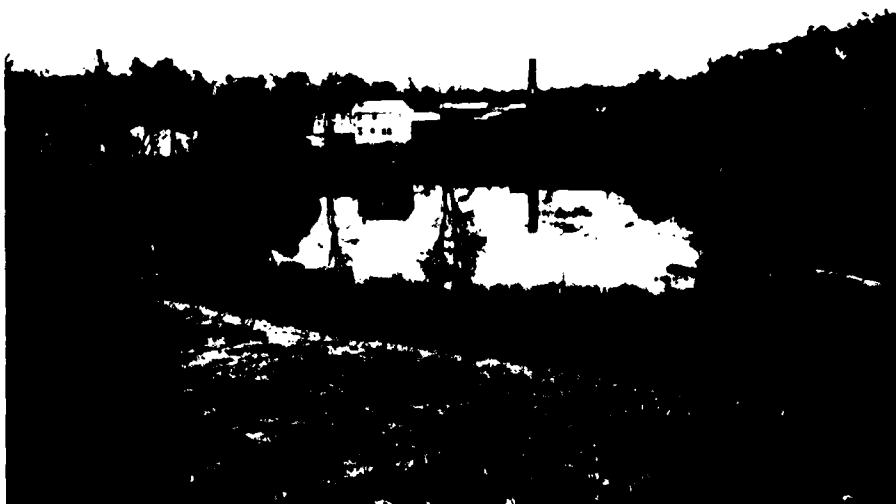
9. CHANNEL AND DEVELOPMENT DOWNSTREAM OF DAM.

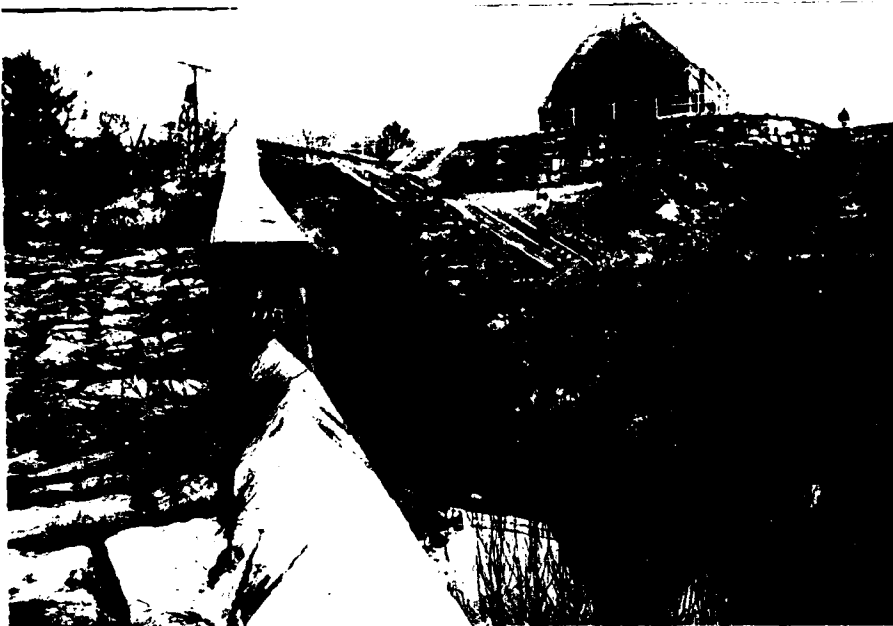
The gatehouse is in generally good condition. The brickwork needs repointing to minimize future deterioration. Only one intake was found to be inoperative at the gatehouse. However, there are two alternate operable intakes present. The low flow discharge channel as shown in Photo 12 is ponding water, and contains random stones and uncut brush and weeds.

12. VIEW OF RESERVOIR OUTLET TUNNEL AND GATE HOUSE FROM SPILLWAY DISCHARGE CHANNEL.
