WATER LOOM POND DAM  
NH 00355  
NHWRB 175.09

PHASE I INSPECTION REPORT  
NATIONAL DAM INSPECTION PROGRAM

FEBRUARY 1979

Identification No.: NH 00355  
NHWRB No.: 175.09  
Name of Dam: WATER LOOM POND DAM  
Town: New Ipswich  
County and State: Hillsborough County, New Hampshire  
Stream: Souhegan River  
Date of Inspection: November 14, 1978

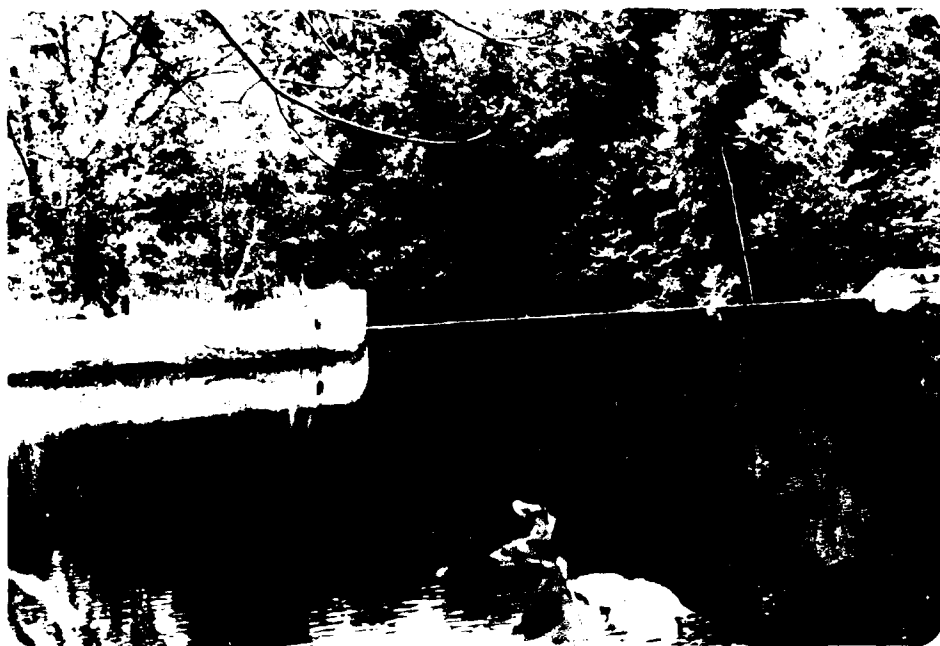
Overview of spillway from upstream left side
