# LYNN RESERVOIR DAM

MA 01285

## PHASE I INSPECTION REPORT NATIONAL DAM INSPECTION PROGRAM

JULY, 1981

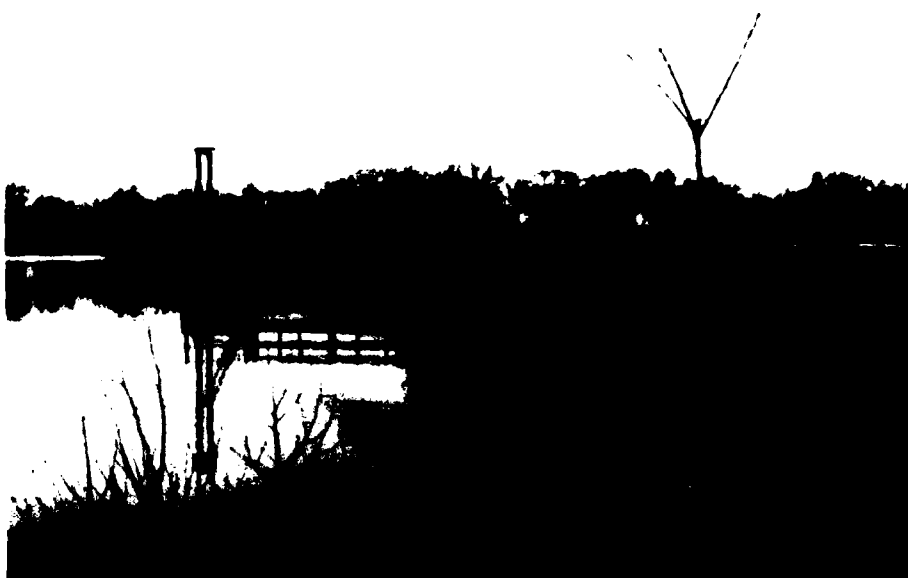
Photo No. 2 - View along interior slope looking at outlet structure.

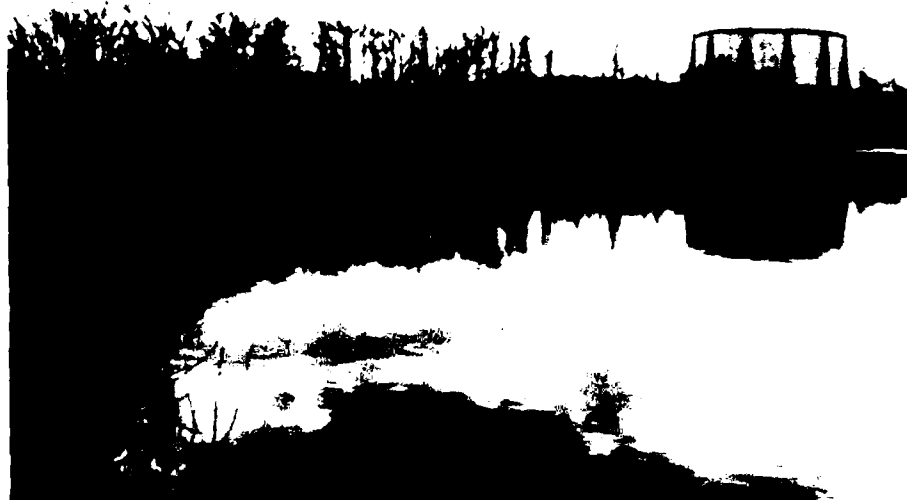
There is riprap on the interior slope from an elevation 1 to 2 feet below the crest of the dam to some unknown elevation beneath the level of the reservoir at the time of the inspection (Photo No. 4). The riprap is in good condition.

Photo No. 4 - Riprap on interior slope.

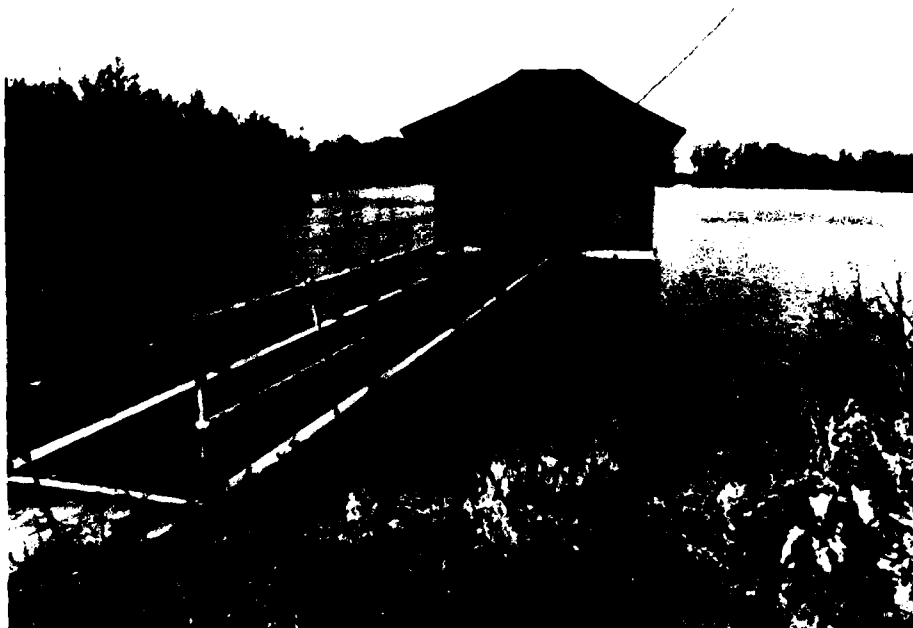
c. Appurtenant Structures. A control building of masonry construction houses the inlet controls to the impoundment (Photo Nos. 6 and 7). This building has a bridge which is used for access to the building. The bridge bears on a concrete footing on the dam side of the bridge, and this concrete exhibited some spalling. The bridge walkway, which is constructed of welded wire mesh, shows evidence of welding repair. The inlet control building and access bridge are structurally sound.

Photo No. 7 - View of gatehouse and service bridge.

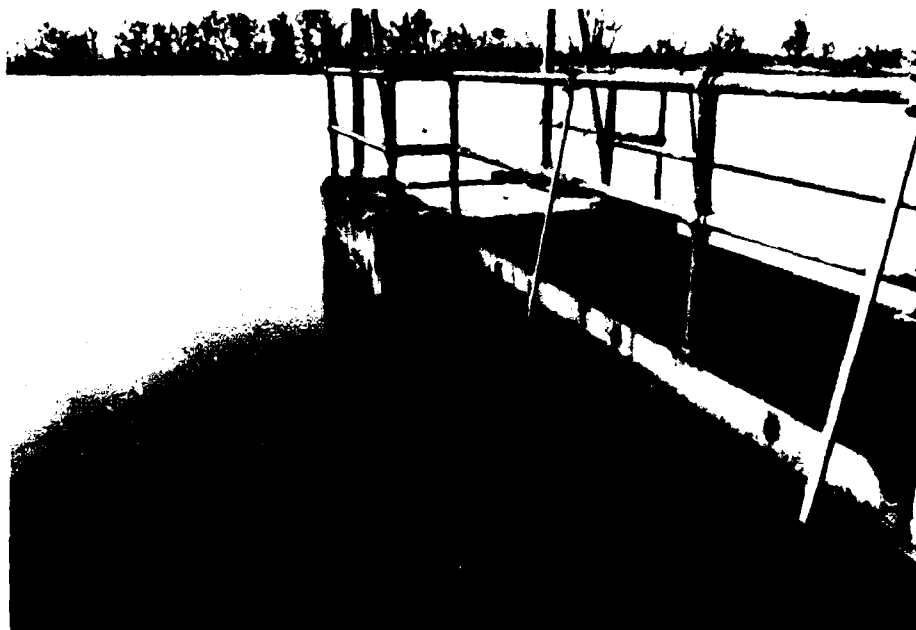
Bearings	Poor (see b. below)
Anchor Bolts	None
Bridge Seat	Poor (see b. below)
Longitudinal Members	Webs & flanges are perforated extensively due to rust
Underside of Deck	Not applicable
Secondary Bracing	None
Deck	Fair to poor condition
Drainage System	Not applicable
Railings	Fair condition & functional
Expansion Joints	Not applicable
Paint	Railings have been painted, but stringers have not

Photo No. 10 - Deterioration of the steel mesh walkway  
of the service bridge to outlet structure.
