NATIONAL PROGRAM FOR INSPECTION OF NON-FEDERAL DAMS  
COUNTRY CLUB (MA 0075) (U) CORPS OF ENGINEERS WALTHAM  
MA NEW ENGLAND DIV JUN 79

CONNECTICUT RIVER BASIN  
NORTHAMPTON, MASSACHUSETTS

COUNTRY CLUB  
MA 00756

PHASE I INSPECTION REPORT  
NATIONAL DAM INSPECTION PROGRAM

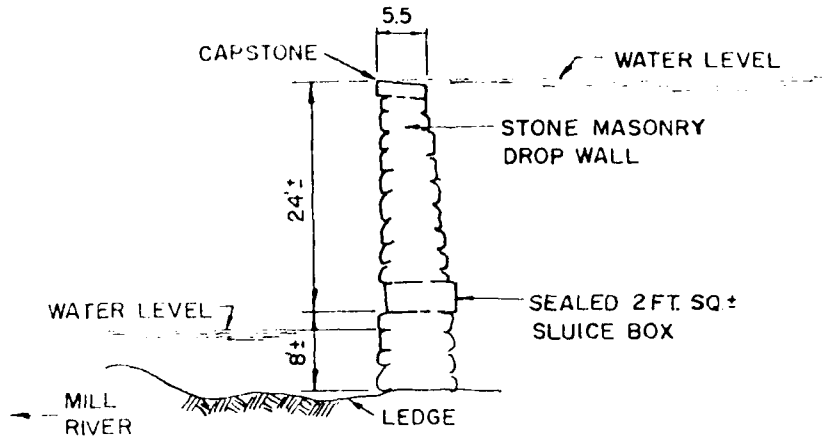
SECTION A A

BRICKED UP OPENING IN LOWER RET. WALL  
APPARENT LOCATION OLD PENSTOCK

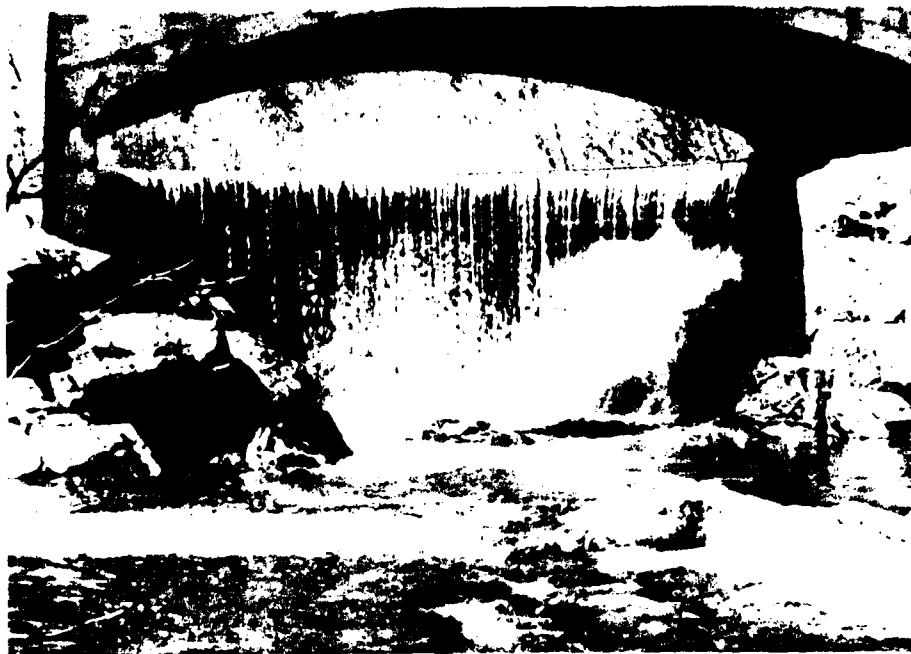
The discharge channels of the main spillway and secondary spillway meet to form the river channel. The discharge channels of both spillways have rock bottoms and are in good condition. The downstream channel is shown by photos 3 and 4. The road bridges do not restrict test flood outflow in the downstream channel.

PHOTO NO. 3 - Downstream face of main spillway  
as viewed from downstream channel.
