TAUNTON RIVER BASIN
AVON, MASSACHUSETTS

BROCKTON RESERVOIR DAM
MA 00786

PHASE I INSPECTION REPORT
NATIONAL DAM INSPECTION PROGRAM

JANUARY 1980

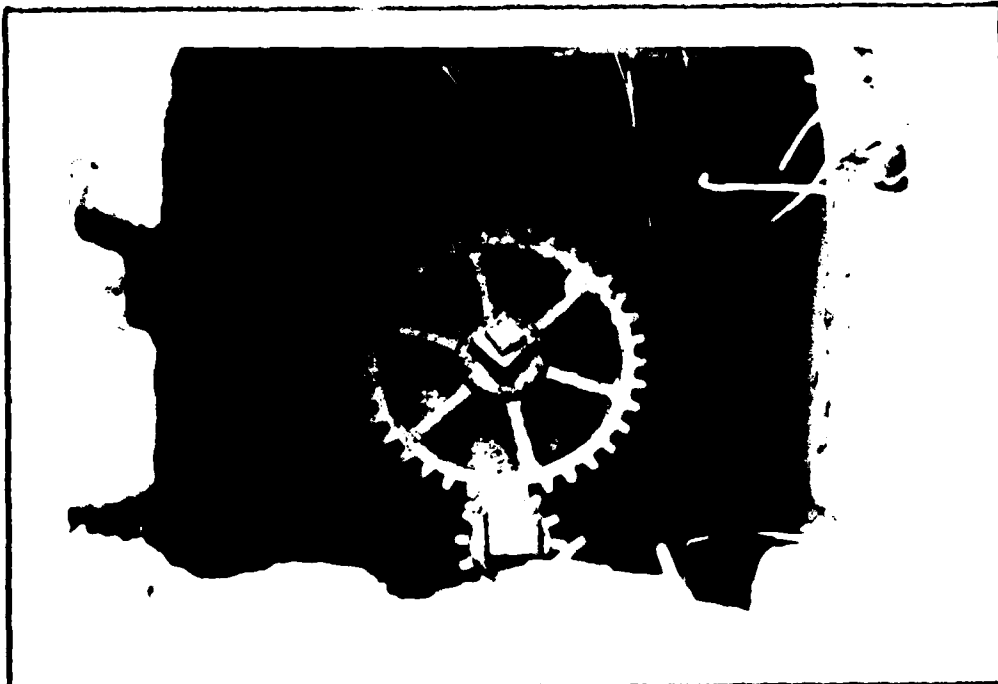
The 20-inch gate valve (invert unknown) located in a stone masonry vault about 30 feet downstream of South Street appeared to be in fair condition. Although the valve key was not available at the time of inspection, Mr. Feroli stated that the valve is operable.

10. VALVE CONTROL ABOUT 100 FEET DOWNSTREAM OF THE GATEHOUSE.
(10/17/79)
