ROBERTS MEADOW RESERVOIR  
(MIDDLE DAM)  
MA 00761

PHASE I INSPECTION REPORT  
NATIONAL DAM INSPECTION PROGRAM

DEPARTMENT OF THE ARMY  
NEW ENGLAND DIVISION, CORPS OF ENGINEERS  
WALTHAM, MASS. 02154

AUGUST 1978

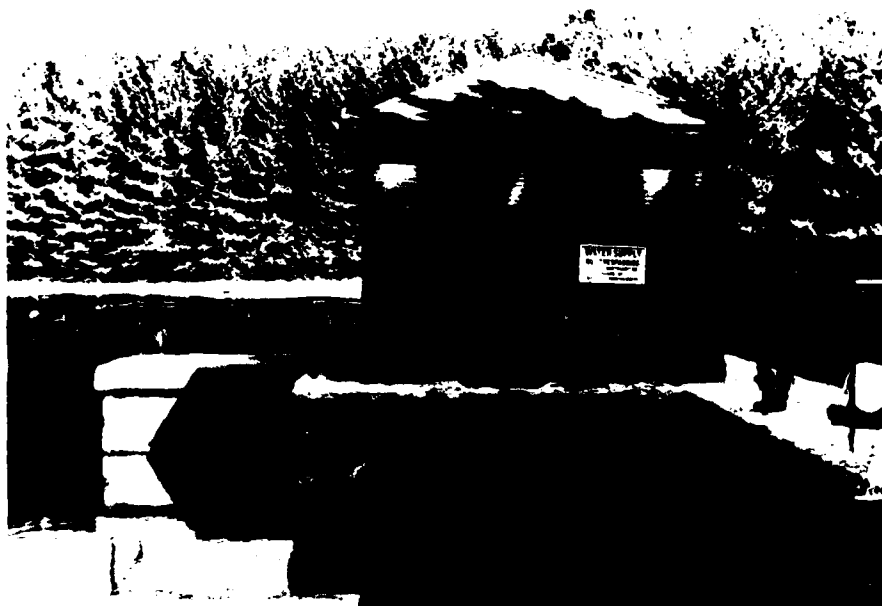
The gate house was inspected to the water surface. The house has a granite masonry substructure with a brick wall and wood roof superstructure. A concrete waste well attached to the rear of the gate house was added in 1933. A crack exists in the left rear corner of this waste well approximately 1/4 inch wide and extends down into the water. Some Spalling exist on the slab of this waste well. The east wall of the brick superstructure shows some cracking of the brick.

PHOTO NO. 12 - General view of Gate House.
