SUPPLY POND DAM

NH 00123

PHASE I INSPECTION REPORT
NATIONAL DAM INSPECTION PROGRAM

FEBRUARY 1979

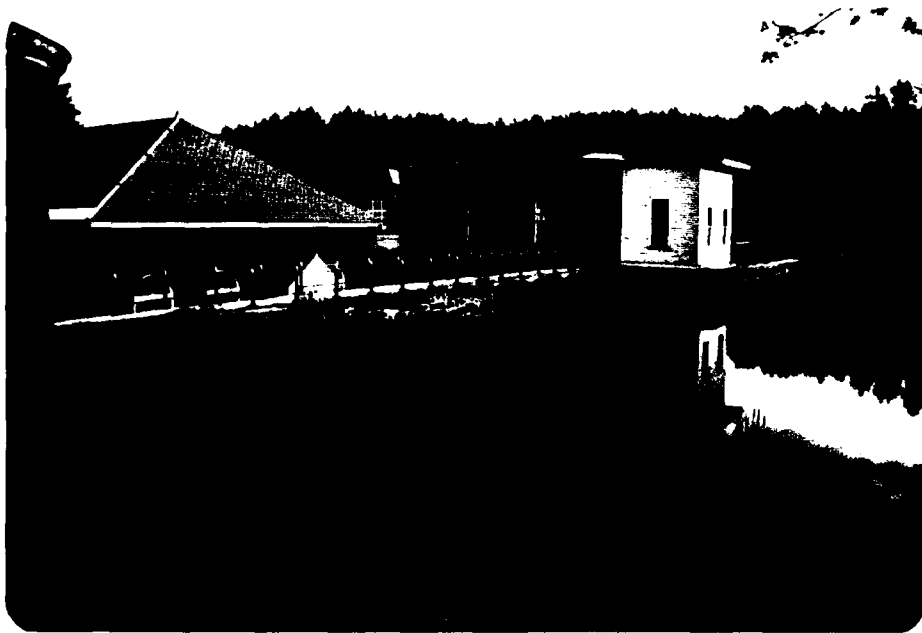
Overview of dam from left upstream side

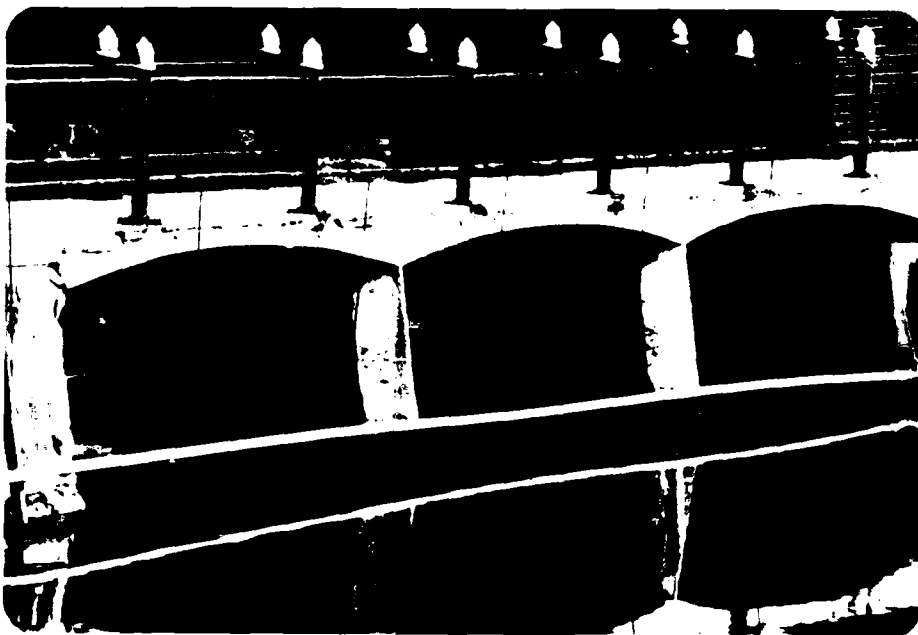
The three span service bridge structure deck exhibits minor surface spalling and a transverse crack. The spalling can be attributed to excessive surface trowelling of concrete and the random cracks can be attributed to expansion of the concrete deck. There is also considerable random surface cracking and efflorescence on the underside and at the fascias of this service bridge.

4. View of concrete deterioration on spillway
piers and service bridge
