MERRIMACK RIVER BASIN  
BRISTOL , NEW HAMPSHIRE

INTERNATIONAL PACKINGS CORPORATION  
UPPER DAM  
NH - 00315

PHASE I INSPECTION REPORT  
NATIONAL DAM INSPECTION PROGRAM

APRIL 1979

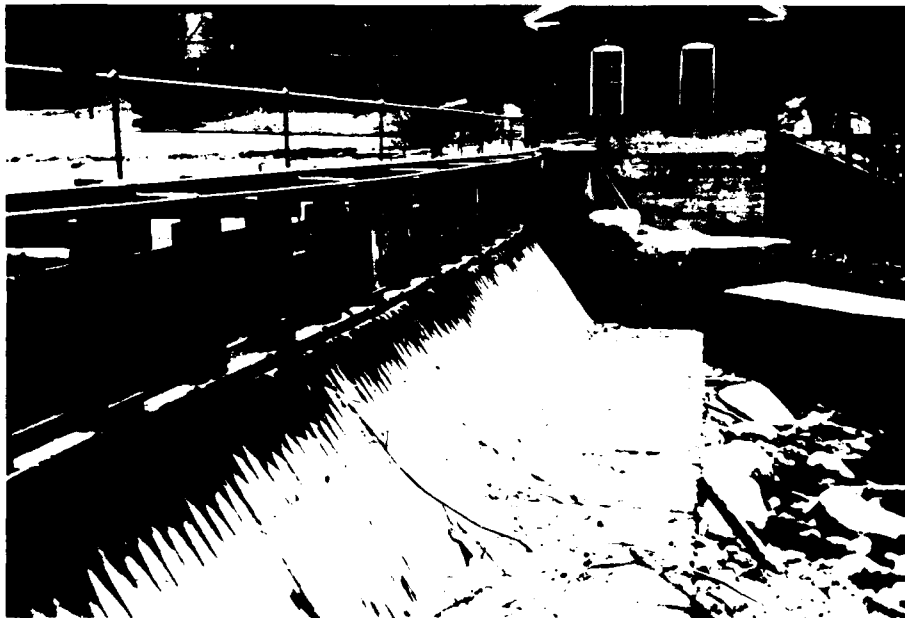
1

- (e) The timber deck and the downstream face of the spillway were found to be in poor condition (see photograph 1). Many of the planks are broken and badly worn. The downstream cribwork has lost a substantial amount of its stone fill, particularly near the east end. Most of the timber crib members appear to be in reasonably good condition, although some cracked logs were noted (see photograph 2).

- (f) The stop log support columns, steel support beam and cable appear to be in good condition (see photograph 1). It was noted, however, that the support beam is bowed about 6 to 8 inches downstream.

VIEW OF SPILLWAY STRUCTURE SHOWING CONDITION OF TAIL  
APRON; POWER HOUSE IN BACKGROUND

- (1) Repair spalled concrete throughout the structure.
- (2) Refill the cribwork with stone where loss has occurred.
- (3) Replace deteriorated timber, particularly the deteriorated planking and plywood on both the upstream and downstream faces of the structure.
- (4) Curtail the leakage that is taking place through the ceiling of the powerhouse tailrace.
- (5) Cut trees and brush on embankment sections of the dam and remove root systems and rehabilitate embankment.
- (6) Repair eroded portions of the discharge channel below the controlled outlet and the embankment upstream of that structure.
- (7) Repair areas of localized settlement between the masonry walls along the easterly embankment and monitor this area for any future settlement.
- (8) Repair or replace stop log lift hooks as needed.

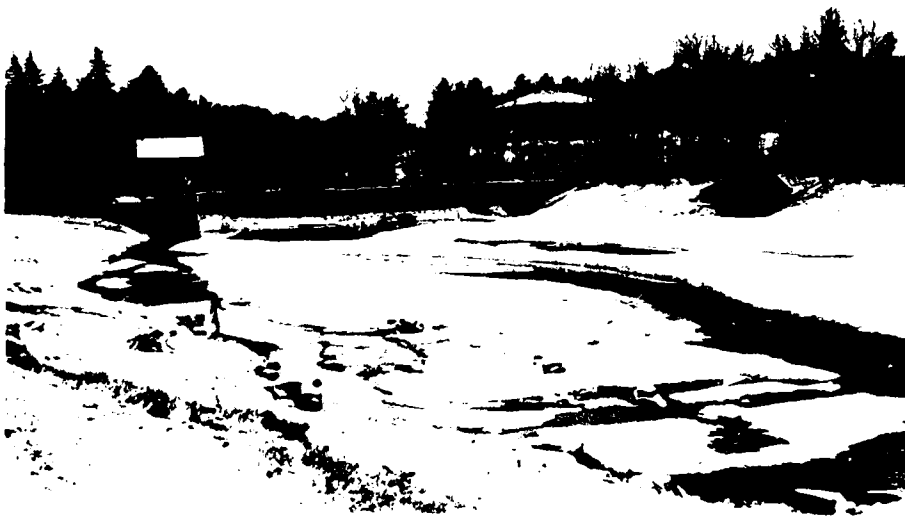
6

A controlled outlet with stop log bays is located in the westerly embankment of the dam (see photographs 6, 7 and 8). This discharges to an earth channel below the embankment. This structure is in fair condition, but the hoisting equipment for the stop logs is deteriorated and unusable so that the stop logs must be manually removed. Severe deterioration of the concrete on the outlet side of the structure was observed.

VIEW OF UPSTREAM FACE OF DAM. INLET TO CONTROL  
OUTLET STRUCTURE IS AT RIGHT.

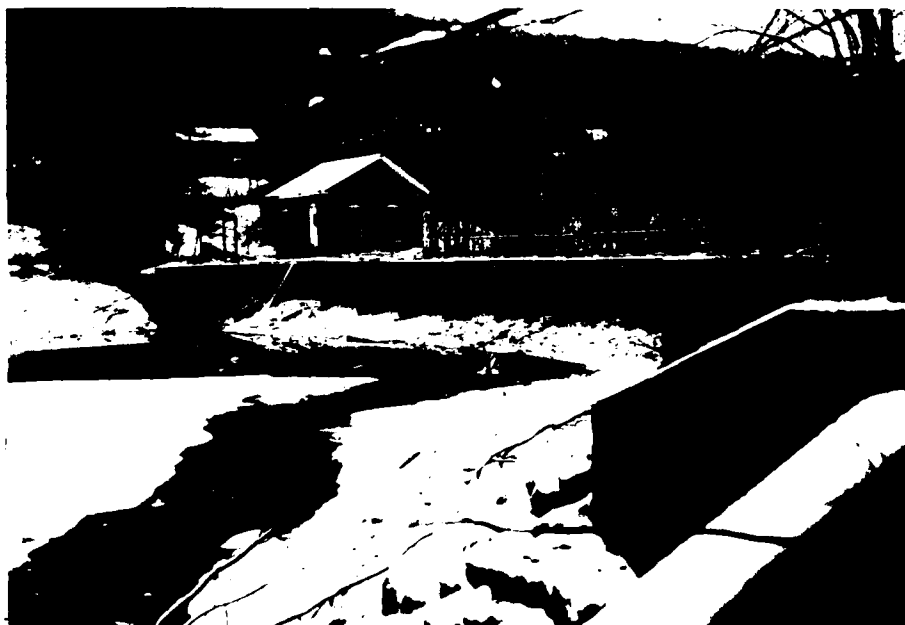
10

of freeboard was noted between the top of the stop logs and the embankment sections (see photograph 10). Evidence of overtopping of the embankment was observed.

VIEW OF UPSTREAM FACE OF DAM FROM CONTROL OUTLET.  
HIGHWAY CAN BE SEEN IN BACKGROUND AT LEFT; NOTE  
LACK OF FREEBOARD OVER TOP OF DAM.

It is recommended that further evaluation of the underseepage and limited freeboard be made by qualified engineers, and that recommendations for mitigation of these conditions be formulated and implemented. It is also recommended that a qualified engineer evaluate the possibility of modifying the existing spillway to allow for automatic release of stop logs if overtopping of the dam occurred.

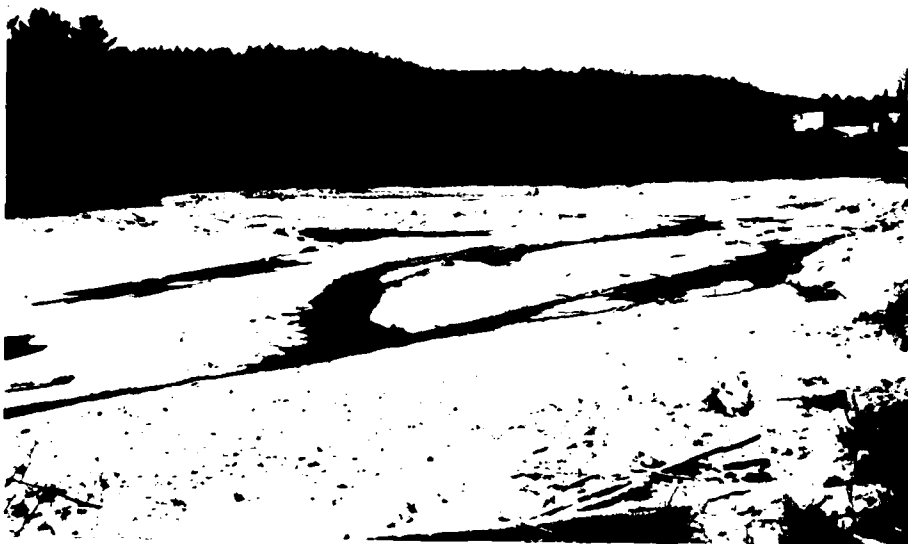
11

VIEW UPSTREAM FROM NEAR POWER HOUSE; RESERVOIR IS AT  
LOW WATER DUE TO CONTROL OF FLOW FROM NEWFOUND LAKE
