TODD LAKE DAM

NH 00288

PHASE I INSPECTION REPORT  
NATIONAL DAM INSPECTION PROGRAM

AUGUST 1978

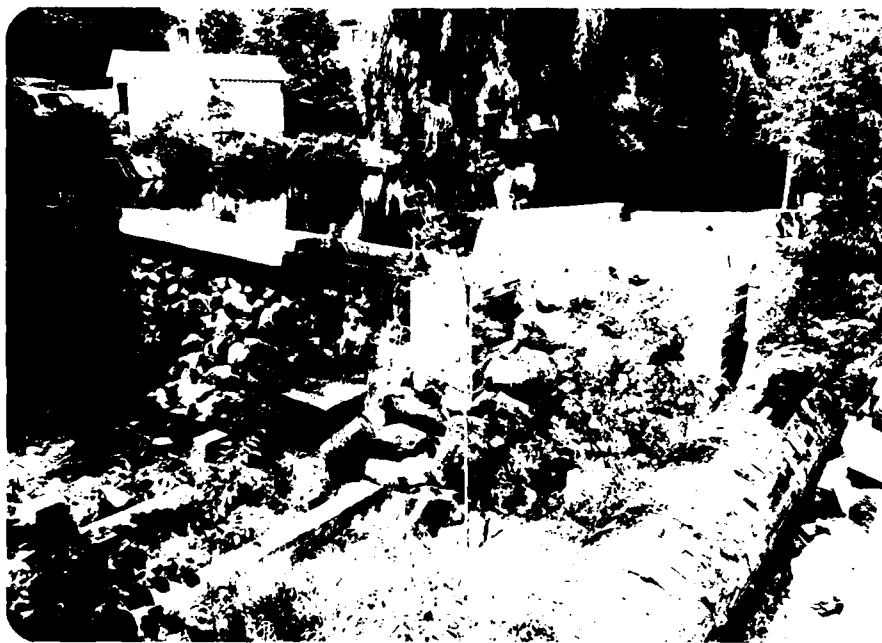
Overview from left side downstream (8 July 78)

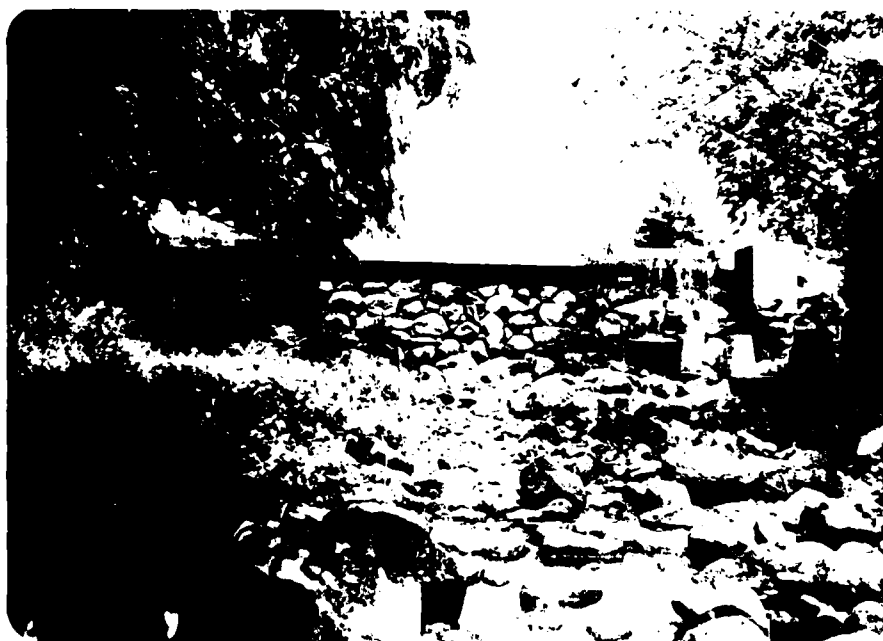
Overview from downstream channel (8 July 78)
