MERRIMACK RIVER BASIN
SALEM, NEW HAMPSHIRE

TAYLOR DAM
NH 00026

PHASE I INSPECTION REPORT
NATIONAL DAM INSPECTION PROGRAM

NOVEMBER 1978

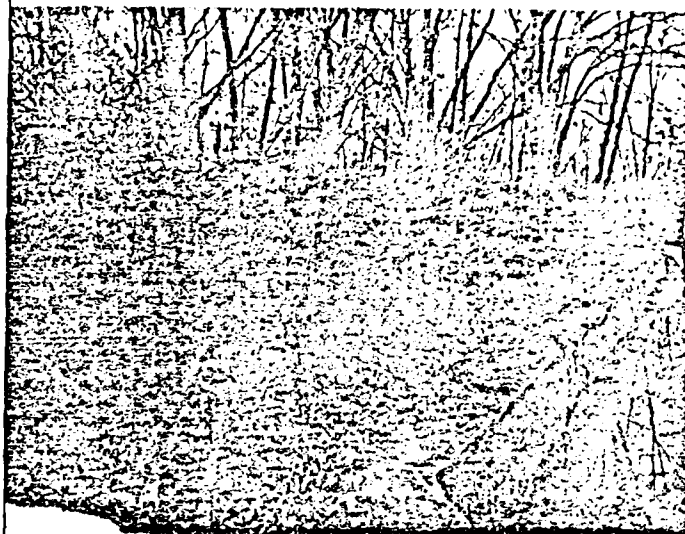
Showing erosion of concrete.

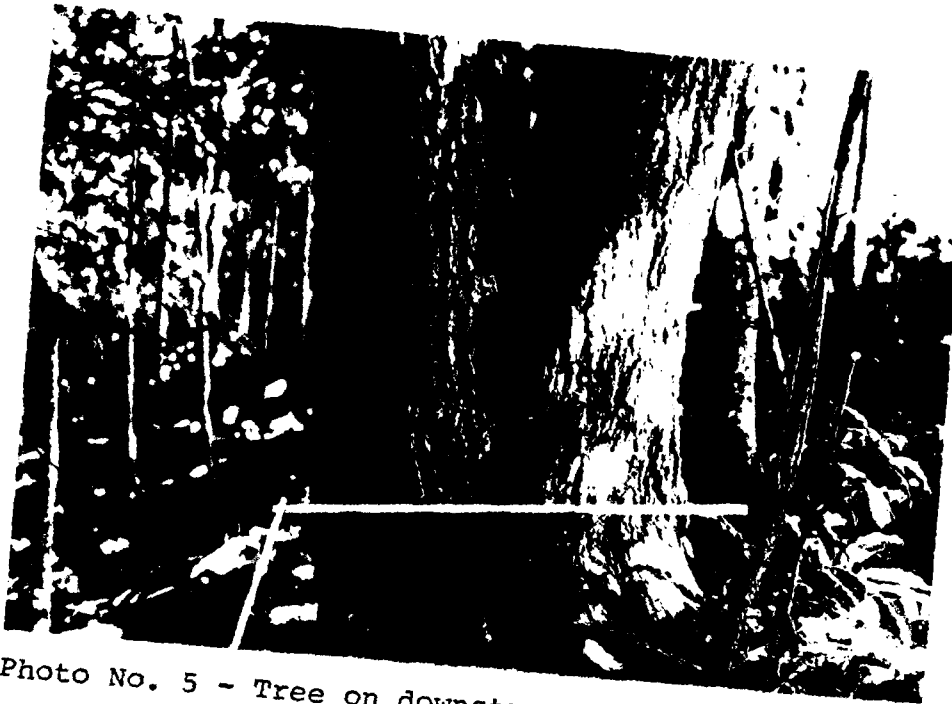
Photo No. 5 - Tree on downstream slope 12 feet from crest of dam. Horizontal rule equals 3 feet.

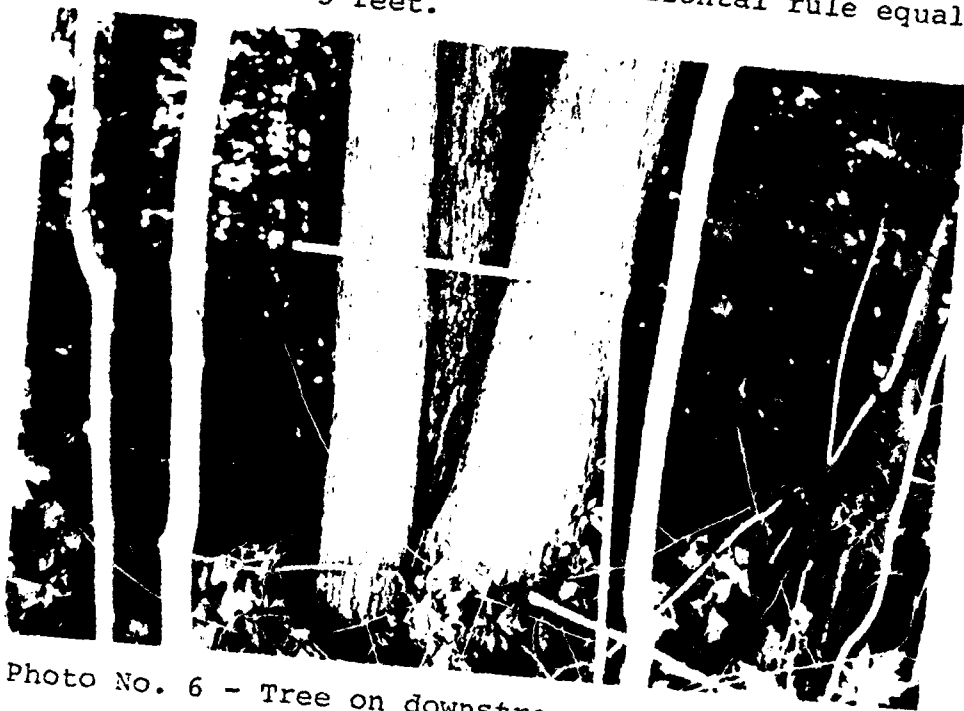
Photo No. 6 - Tree on downstream slope 8 feet from crest of dam. Horizontal rule equals 2 feet.

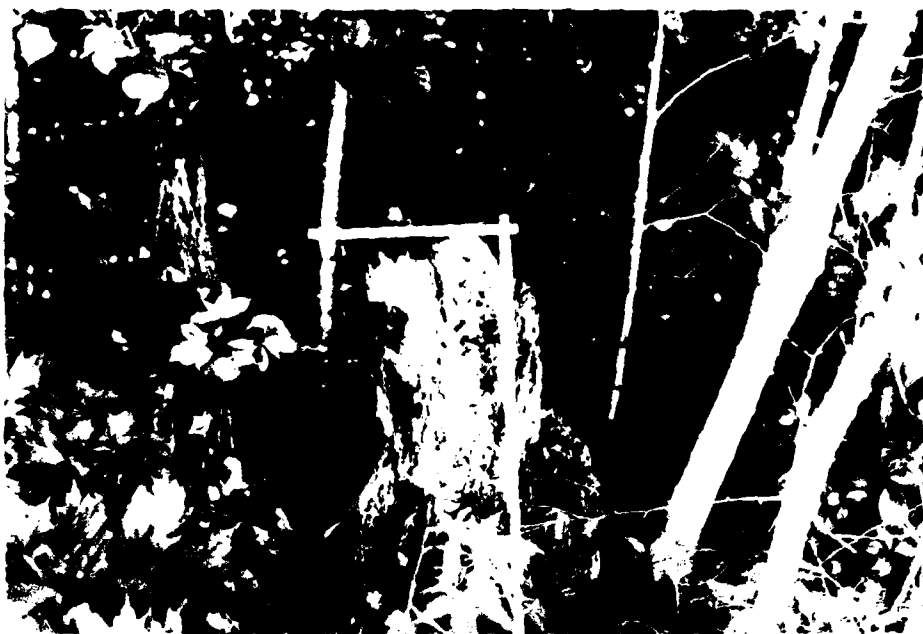
Photo No. 7 - Rotting tree stump 8 feet downstream
of concrete face of dam.

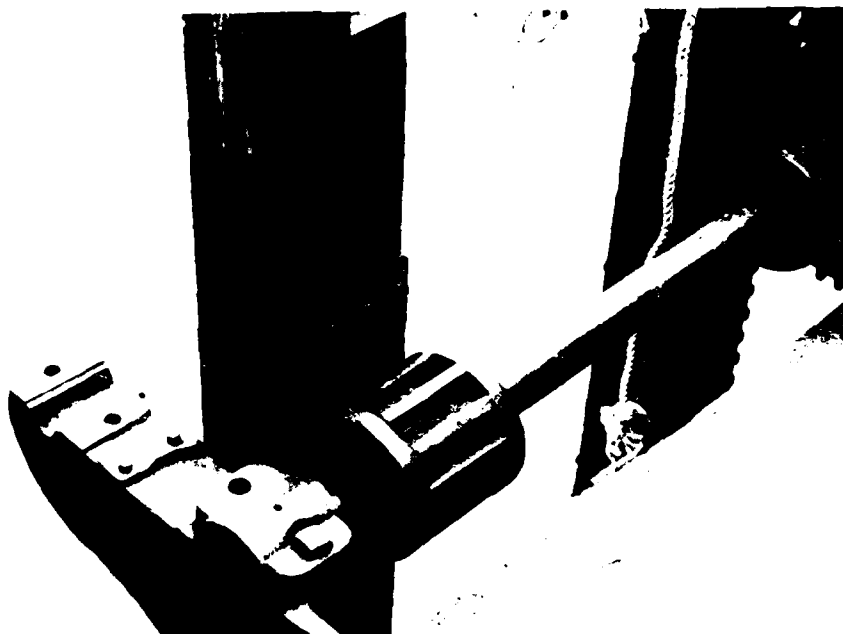
i. Normal Operating Procedure. No written operational procedures were disclosed. The normal operational procedure for this dam is to have the outlet gate closed and a one foot flashboard installed at the spillway crest. No adjustments to water level or other operations have been made over the past several years. The gate has not been operable for many years due to broken gear mechanism.

Photo No. 15 - Outlet works gate, manually operated.

(b) Provide the repair or replacement of the inoperable gate to provide for reservoir draining.
