UNDERMATER FACILITIES INSPECTIONS AND ASSESSMENTS AT
TRIDENT REFIT FACILITY (U) CHILDS ENGINEERING CORP
MIDDLETOWN, CT SEP 83 CNES/NAUFAC-FPO-1-83(36)

The objective of the Underwater Facility Assessments conducted at the Trident Refit Facility, Naval Submarine Base, Bangor, Washington is to provide a generalized structural condition report of various elements of the Drydock. The inspection was performed by a team of engineer/divers using visual/tactile and non-destructive techniques. Typical and unusual conditions were photo-documented.

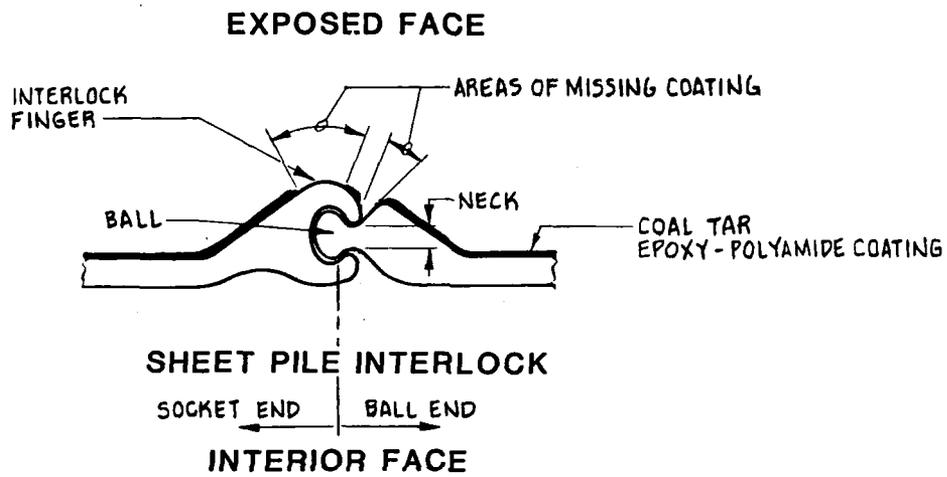
**COATING CONDITION
SHEET PILE INTERLOCK**

The major anomaly noted was the loss of coating on the sheet pile interlocks. Specifically, the exposed curve of the finger and the intersection of the finger and the neck (see Figure 6 and Photos 5 through 9). The worst coating loss on the exposed interlock finger is at Cell 7, Cell 9 and Arc 8/9 where 50% of the coating on the finger is missing between elevation +4.0 and the mudline. At Cell 8 only 25% of the coating is missing from the interlock finger. Over the remaining cells and arcs coating loss on the interlock fingers ranges from 5 to 15 percent and is sporadically located between elevation +4.0 and the mudline. Maximum coating loss on the webs of the sheet piling was also observed between Cell 7 and Cell 9. Loss of coating was found over 3% of the web area between elevation +4.0 and the mudline. Over the remaining cells and arcs coating loss on the webs was less than 1% of the surface area (see Photo #10).

In general, coating loss at the intersection of the interlock finger and the neck (see Figure 6 and Photo #11) was observed at all sheet pile interlocks.

Several of the areas of missing coating can be explained. The loss of coating at the sheet pile interlock where the finger meets the neck is the result of scraping during installation. The coating voids at the dented or dished areas are probably the result of impact which caused a crack in the coating and eventual loss. The coating loss on the exposed face of the interlock finger is the most difficult to explain. This coating loss could be the result of construction where an external template was used to position sheets during driving and which scraped the coating. It is also possible that during construction, barges were docked against the cells and wave action caused them to chaff against the interlocks, thereby scraping off the coating. Another cause could be high stress in the interlocks developed during cell dewatering, which resulted in expansion of the steel (strain) and caused the coating to crack and eventually fall off. The loss of coating may well be attributed to a combination of these.

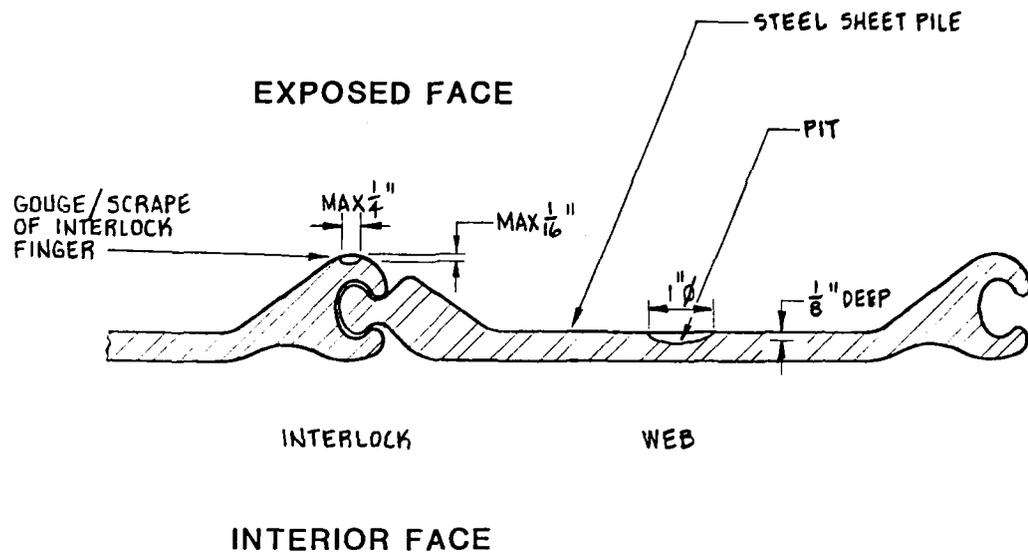
**OBSERVED PIT & GOUGING
OF STEEL SHEET PILING**

The only anomalies noted on the sheet piles were some minor pitting and/or scraping of the steel. One pit, (Cell 7, Sheet 28 clockwise from wye pile, elevation -8.0) was fairly deep, approximately 1/8", and approximately 1" in diameter. The pit did not appear to be the result of corrosion but the result of a deficiency in the steel, perhaps a slag pocket (see Figure 7 and Photo #12).

The fingers of several pile interlocks have long (up to 24") gouges 1/4" wide by up to 1/16" deep (see Figure 7). These gouges are felt to be preconstruction conditions, perhaps the result of the rolling process, since in many cases the coating is intact over the gouge.
