UNDERWATER FACILITIES INSPECTIONS & ASSESSMENTS

U.S. NAVAL
WEAPONS STATION
YORKTOWN, VA

FPO-1-80 (18) SEPTEMBER 1980

OCEAN ENGINEERING AND CONSTRUCTION PROJECT OFFICE
CHESAPEAKE DIVISION
NAVAL FACILITIES ENGINEERING COMMAND
WASHINGTON, D.C. 20374

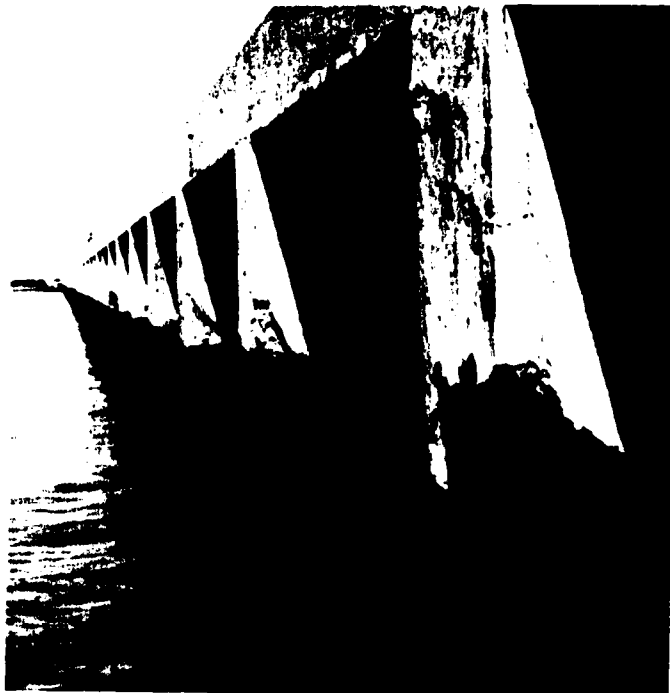
Photo 4-9

Southern approach pier

inboard side
cracked cap ends
exposed aggregate
rebar showing.

Wooden forms visible
around piling (previous
repair)
