# SAN NICOLAS ISLAND BARGE LANDING SITE SURVEY

FPO-1-79(3)  
NOVEMBER 1978

OCEAN ENGINEERING AND CONSTRUCTION PROJECT OFFICE  
CHESAPEAKE DIVISION  
NAVAL FACILITIES ENGINEERING COMMAND  
WASHINGTON, D.C. 20374

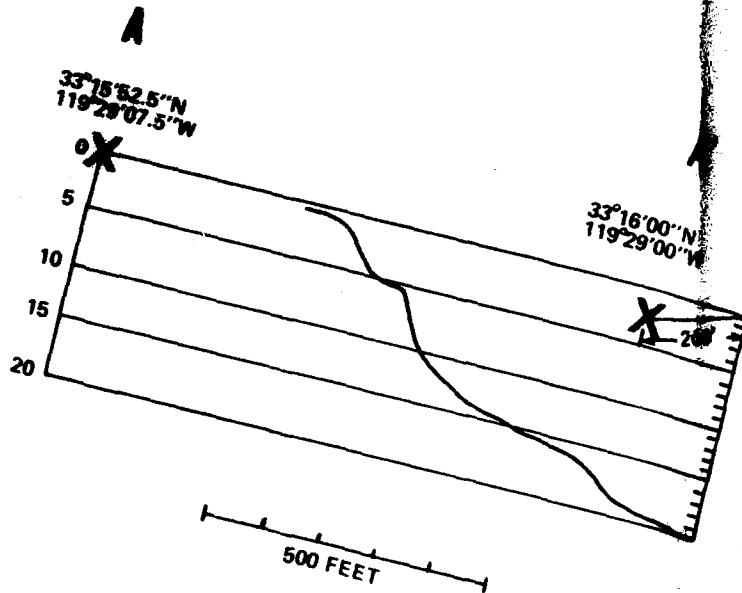
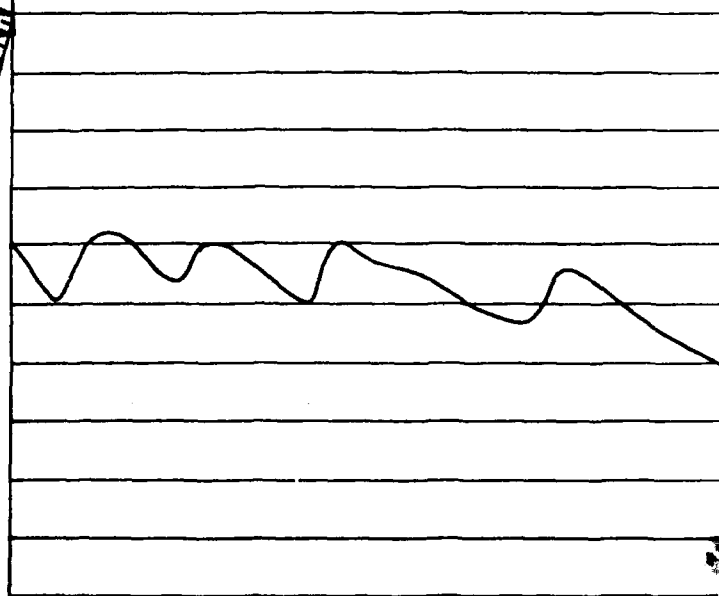
Figure 14. Bottom Profile, A - A'  
(Center of Channel)

The most important profile, A - A' - A'', shown in Figure 14, is that taken down the center of the recommended approach channel. This is not a straight line profile. It has a change of direction about 800 feet from shore. The recommended channel follows this same offset in direction in order to avoid submerged obstacles. The profile shows the channel to be clear of submerged obstacles which might interfere with a YFU hull having a loaded draft of 7 feet. Overlaying the fold-out depth contour chart and the A - A' - A'' profile permits observation of the available channel width clear of obstruction. Near shore, the channel is only 200 feet wide. At a distance of 400 feet from shore, the channel widens becoming a useable 400 foot width at 500 feet from shore. At 1000 feet from shore, the channel width is also 1000 feet. Beyond 1500 feet from shore, no obstructions reach high enough into the water column to restrict the YFU operations.

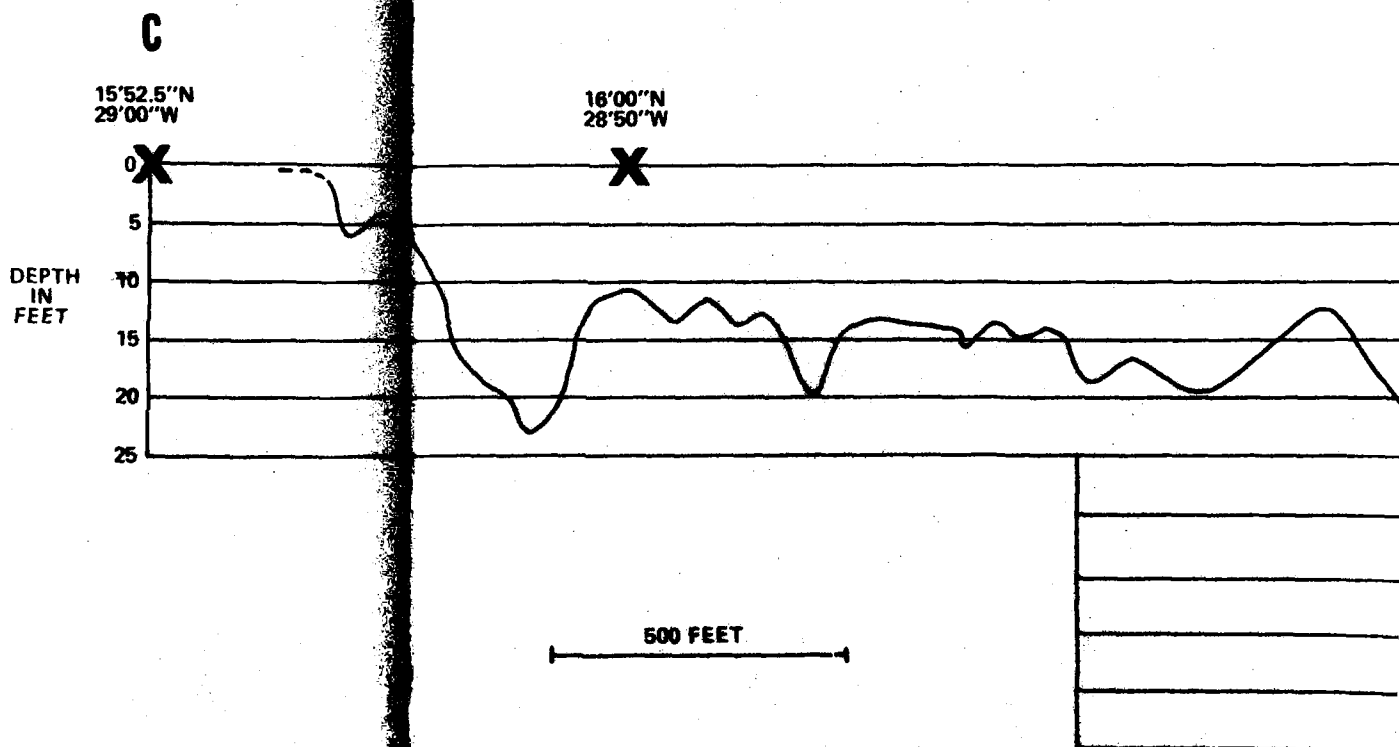
Figure 17. Bottom Profile, C - C'

The profile (Figure 17) transects the ridges in the eastern sector of the survey area, along a line closer to the recommended channel. With the exception of the one near shore prominence, which limits the width of the channel near shore, the profile indicates that the bottom is relatively clear of obstruction. This profile crosses the deeper portions of the ridges of Position 4 and Position 5, which have minimum depths less than 6 feet at MLLW. Hence the profile indication is that one can expect sufficient water depth for the YFU on the side towards the channel but should be suspect on the other side (towards profile B - B').
