Report of the  
**PRESIDENTIAL  
COMMISSION**

*on the Space Shuttle  
Challenger Accident*

*Report to the President*

June 6th, 1986  
Washington, D.C.

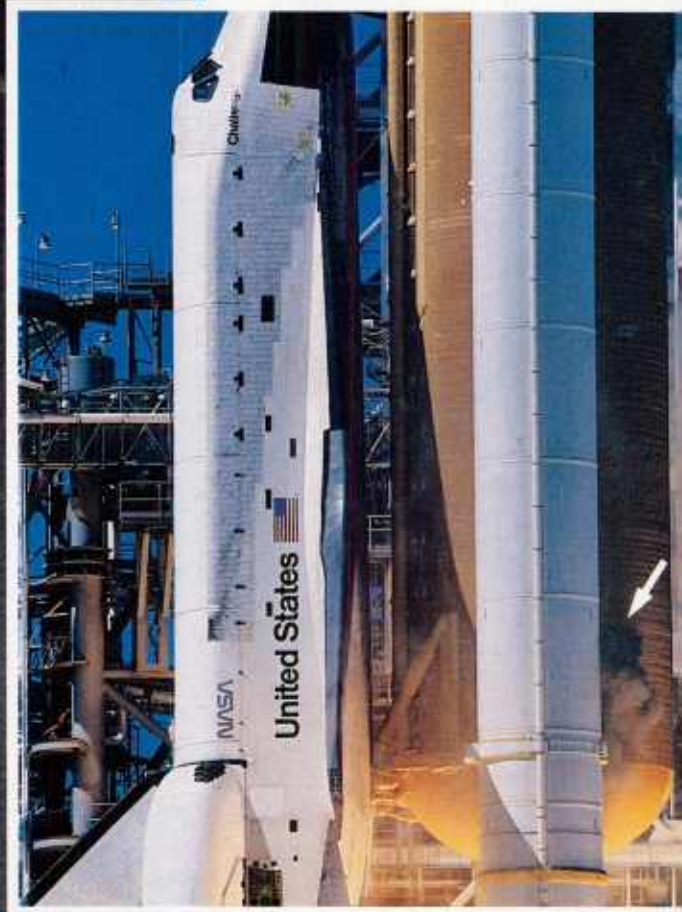
Immediately after solid rocket motor ignition, dark smoke (arrows) swirled out between the right hand booster and the External Tank. The smoke's origin, behavior and duration was approximated by visual analysis and computer enhancement of film from five camera locations. Consensus: smoke was first discernible at .678 seconds Mission Elapsed Time in the vicinity of the right booster's aft field joint.

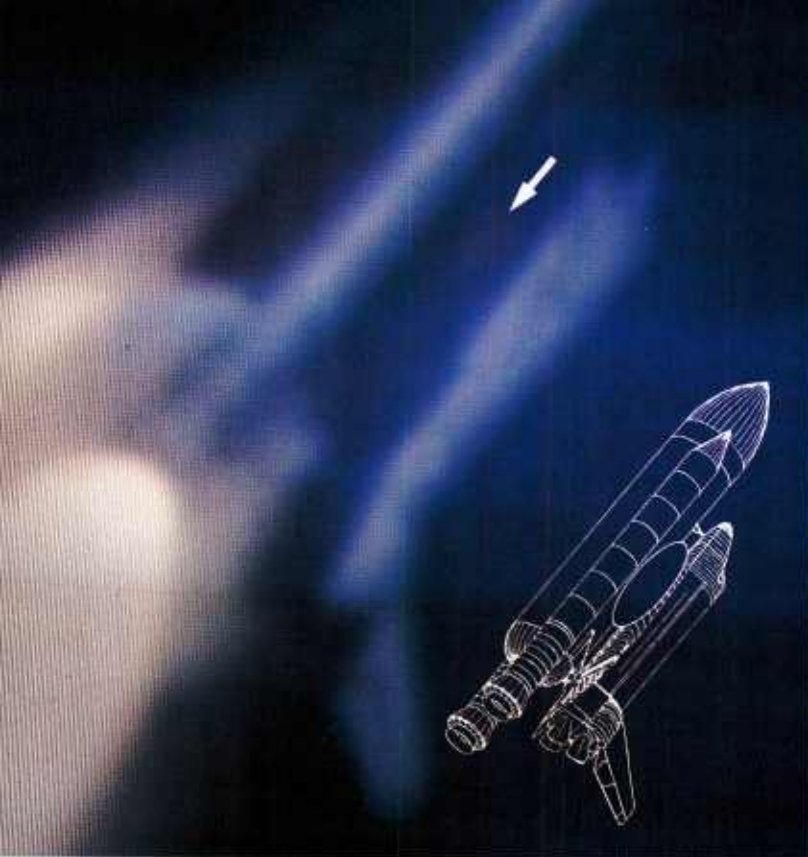
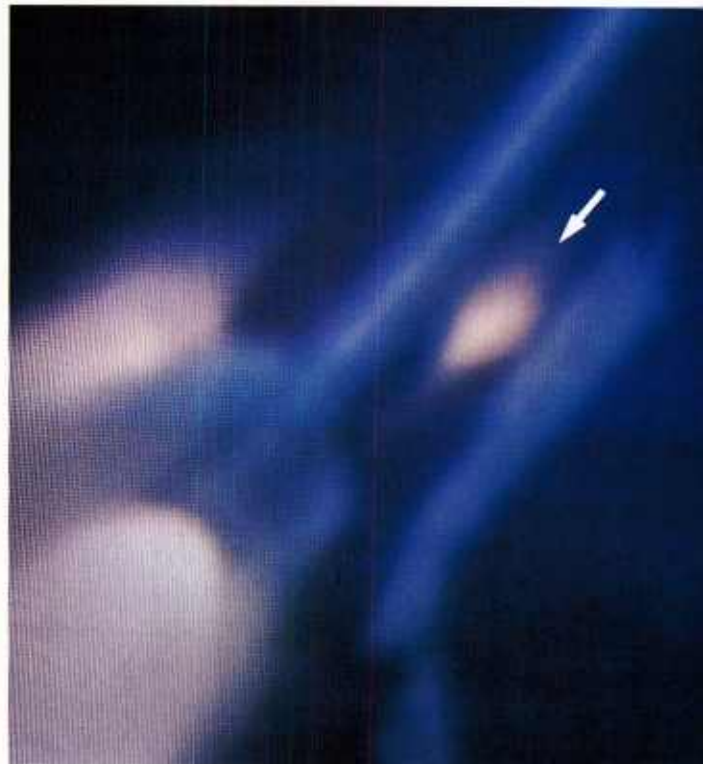
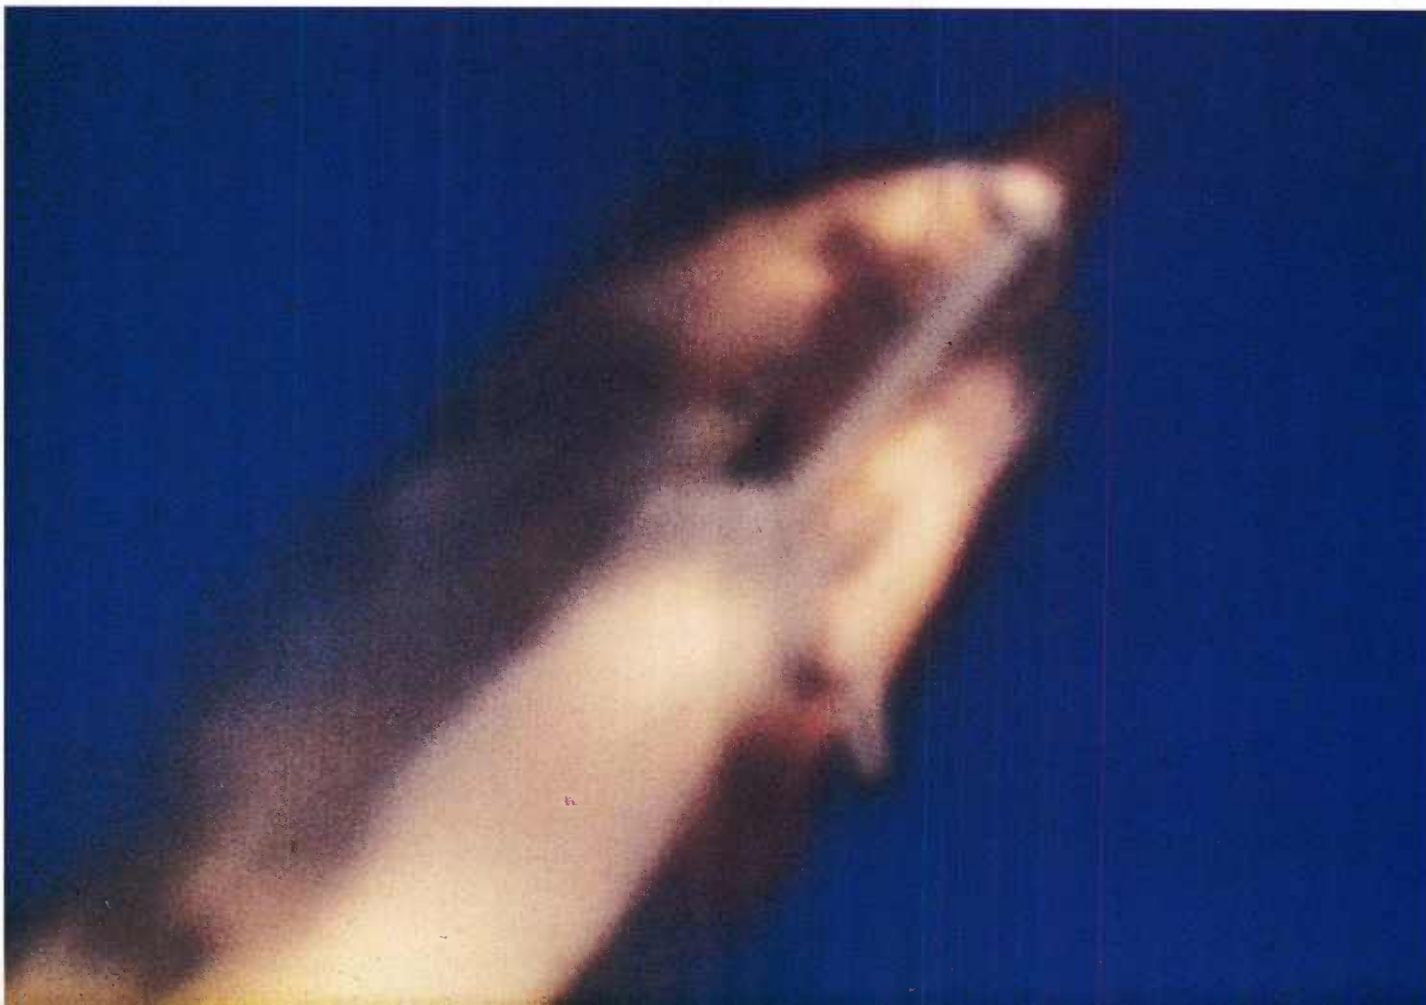
Camera views indicate the beginning of rupture of the liquid hydrogen and liquid oxygen tanks within the External Tank. A small flash (arrows above) intensified rapidly, then diminished. A second flash,

attributed to rupture of the liquid oxygen tank, occurred above the booster/tank forward attachment (below left) and grew in milliseconds to the maximum size indicated in the computer drawing.

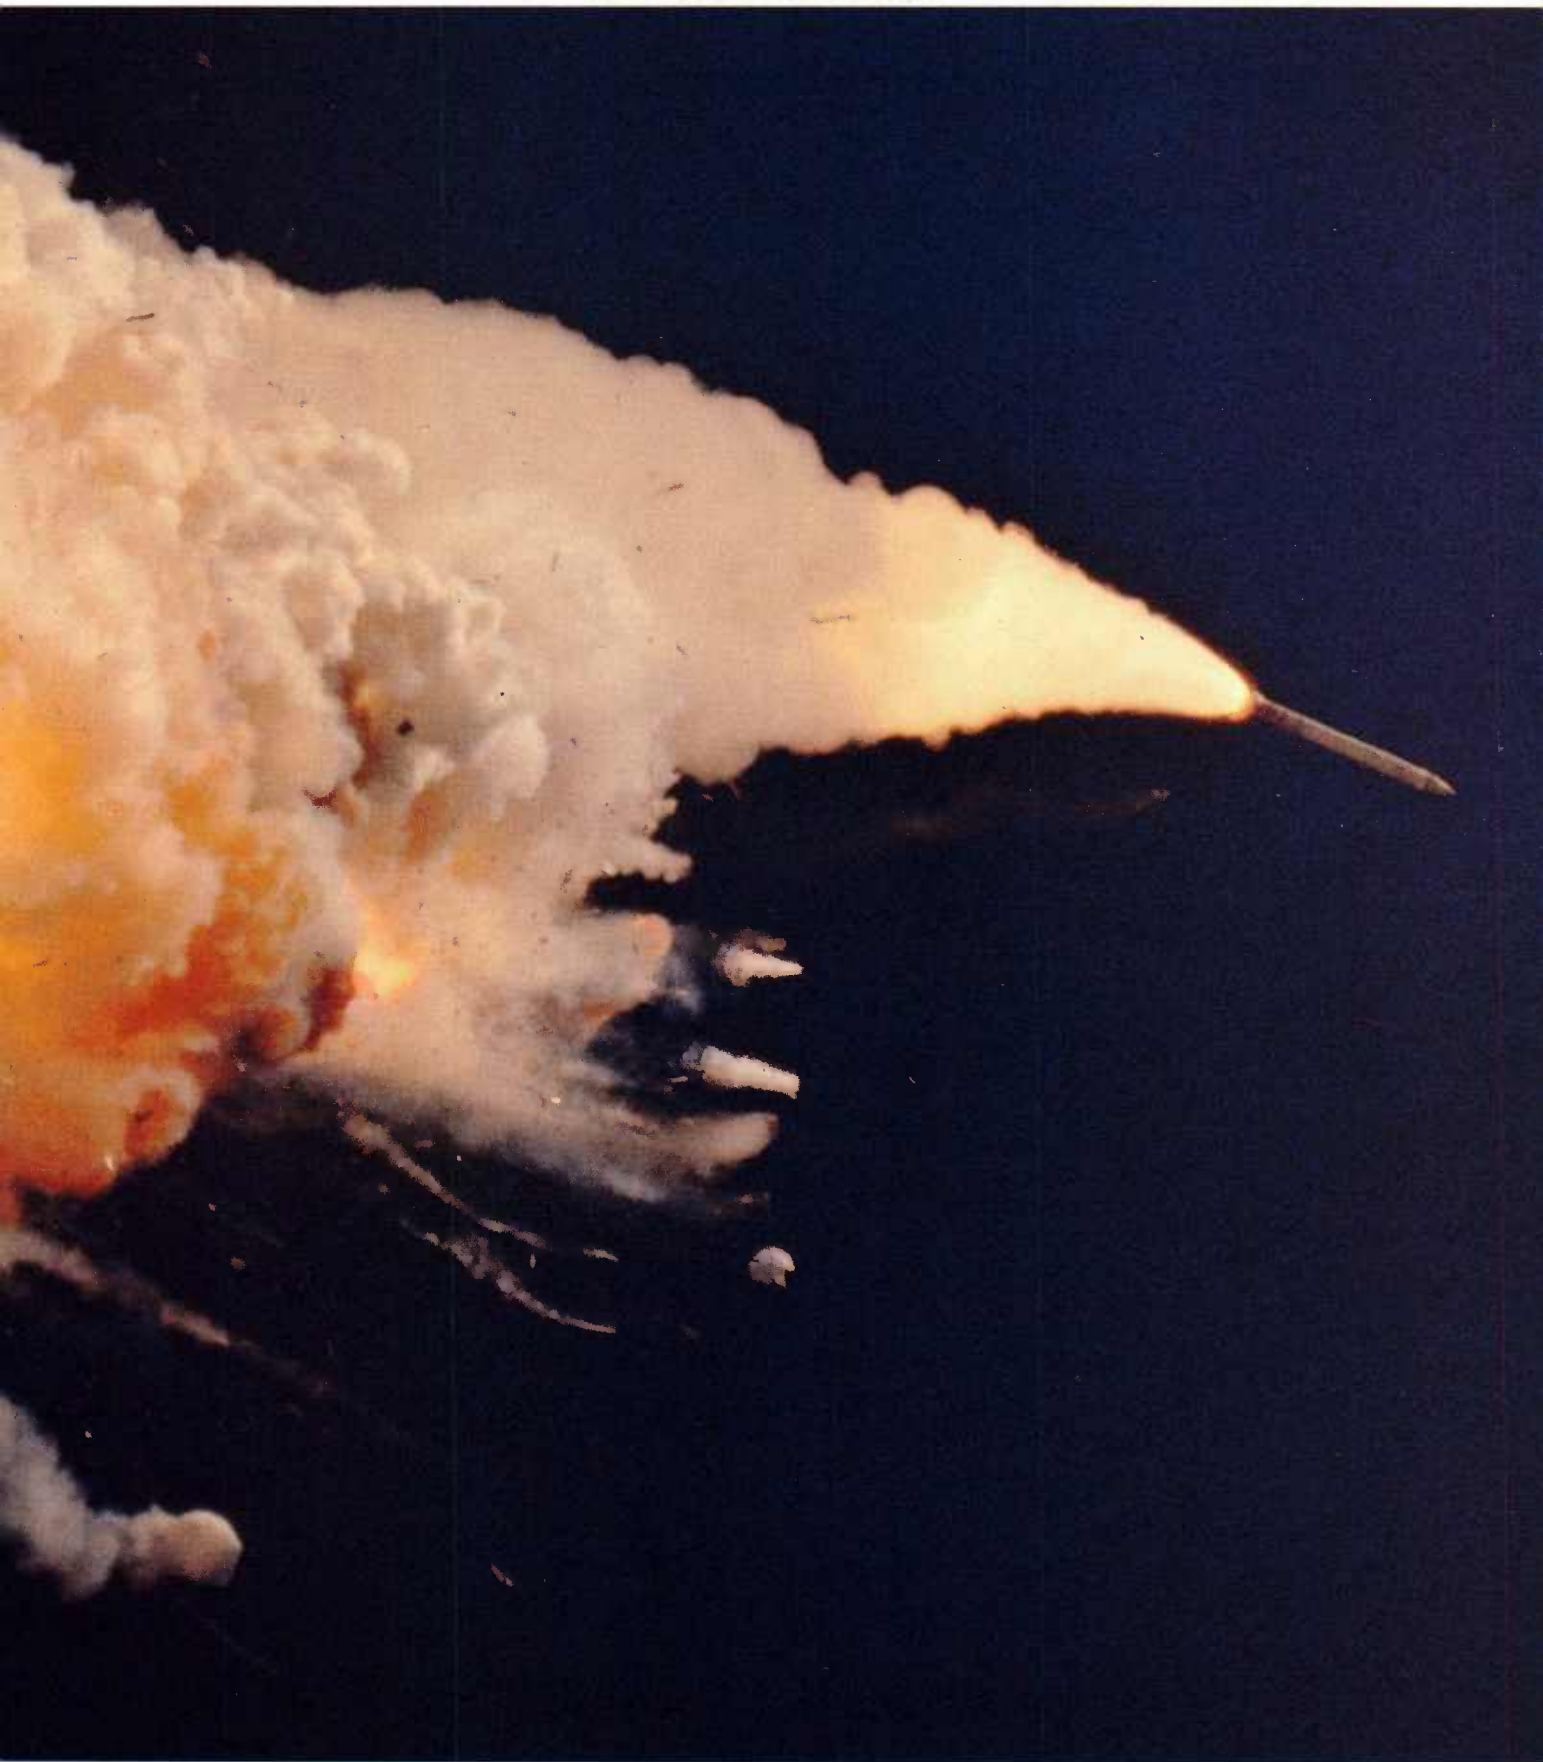
At about 76 seconds, unidentifiable fragments of the Shuttle vehicle can be seen tumbling against a background of fire, smoke and vaporized propellants from the External Tank (left). In the photo at right, the left booster (far right)

soars away, still thrusting. The reddish-brown cloud envelops the disintegrating Orbiter. The color is characteristic of the nitrogen tetroxide oxidizer in the Orbiter Reaction Control System propellant.

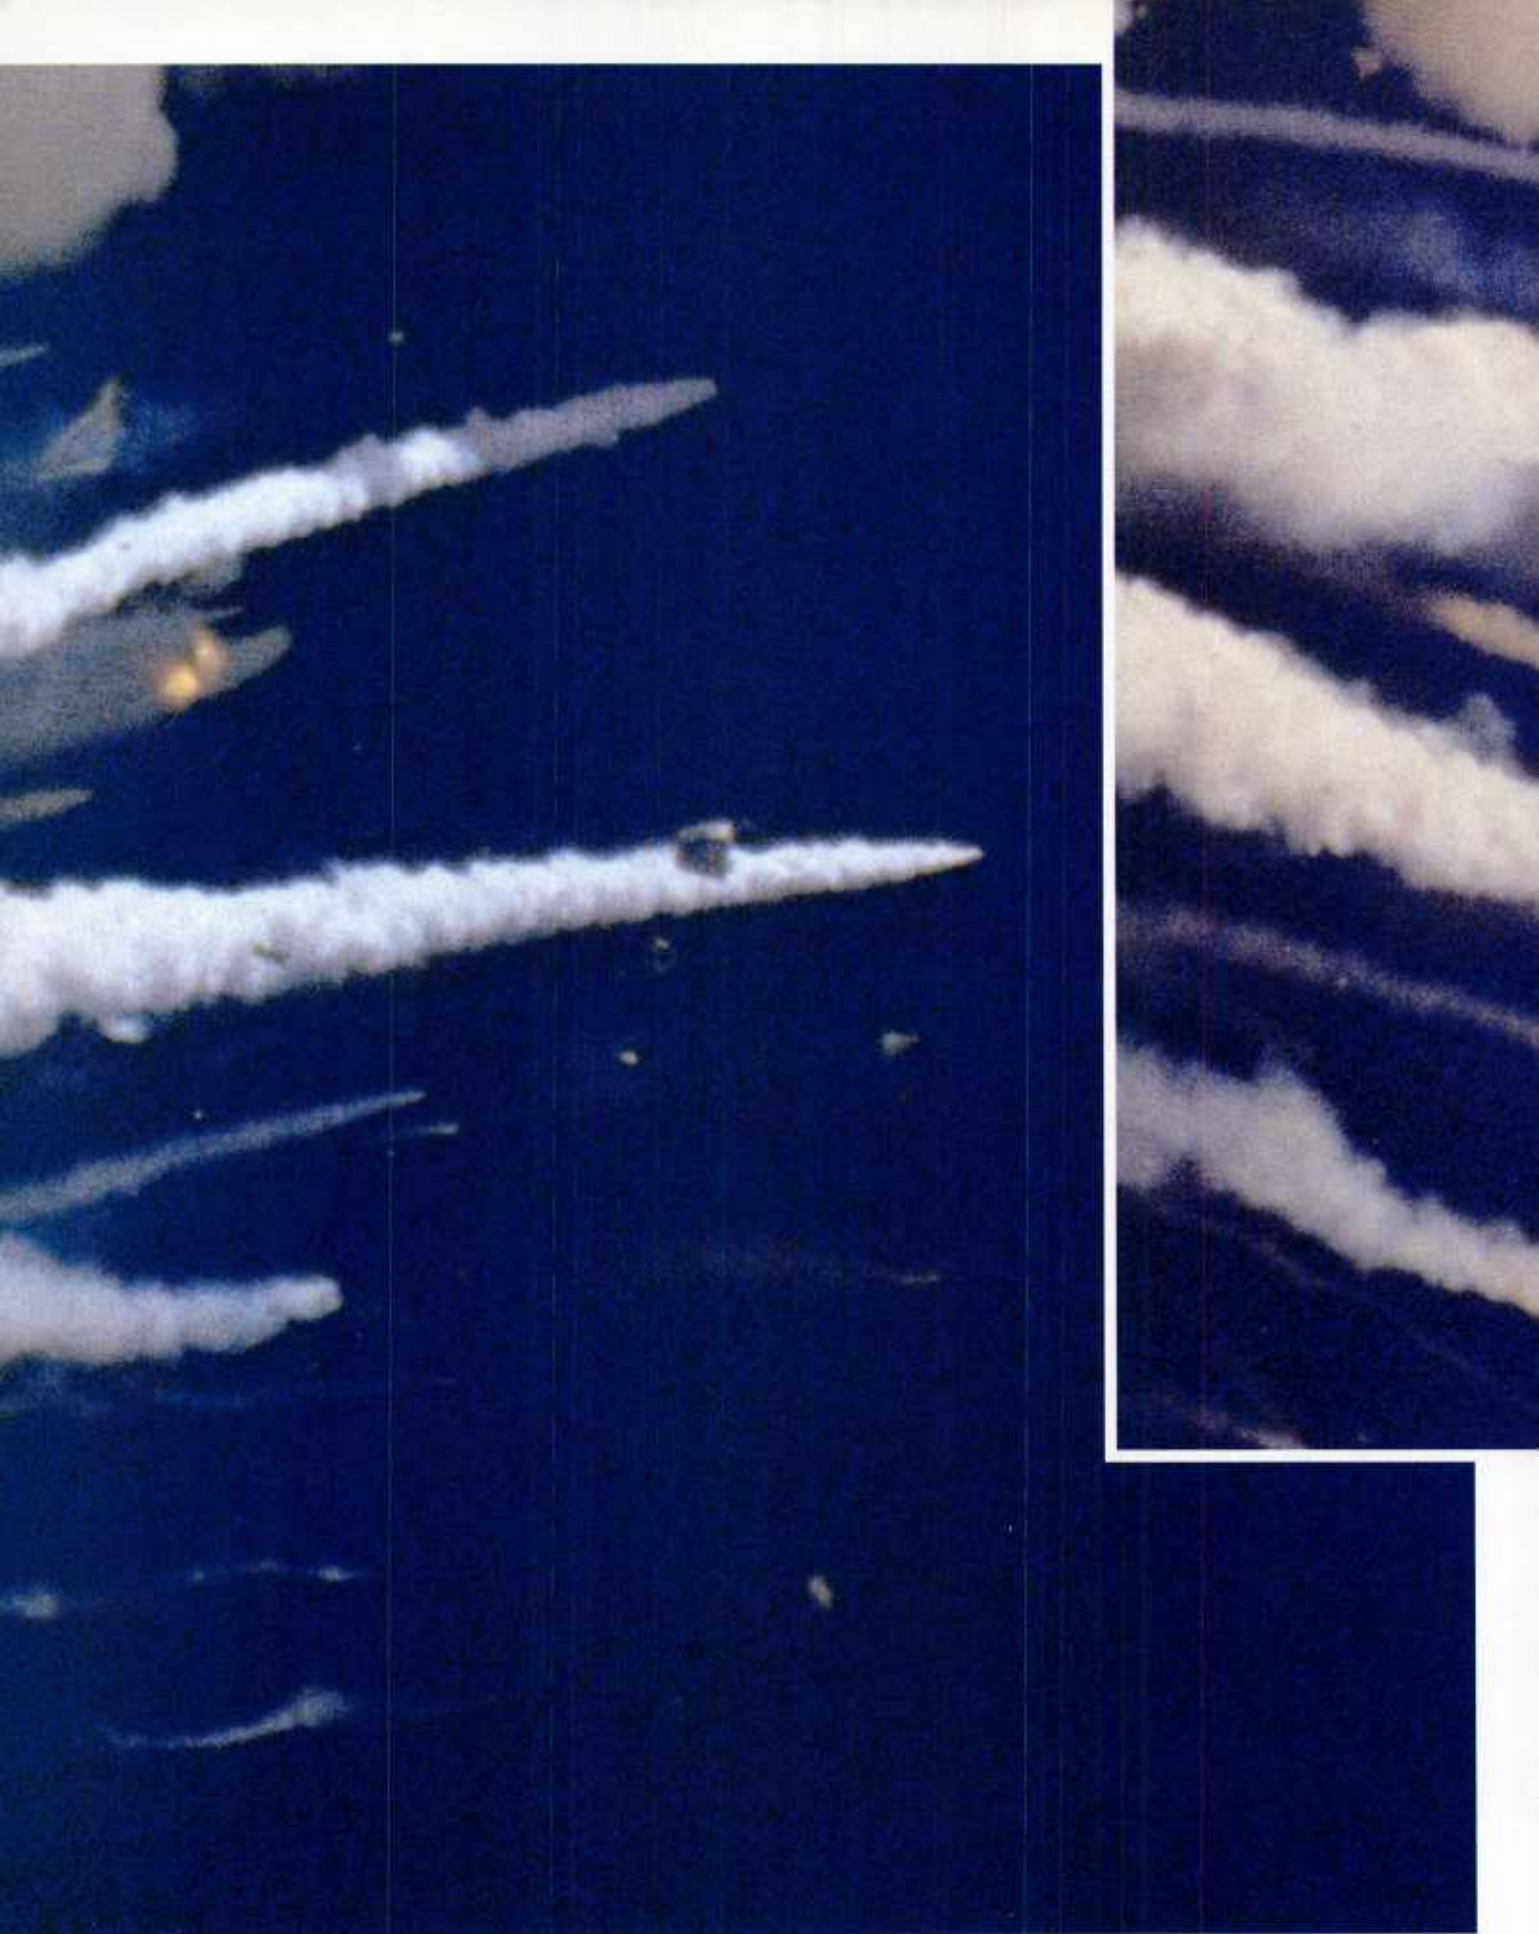
Hurling out of the fireball at 78 seconds (left) are the Orbiter's left wing (top arrow), the main engines (center arrow) and the forward fuselage (bottom arrow). In the photo below, it plunges Earthward, trailed by smoking fragments of Challenger.

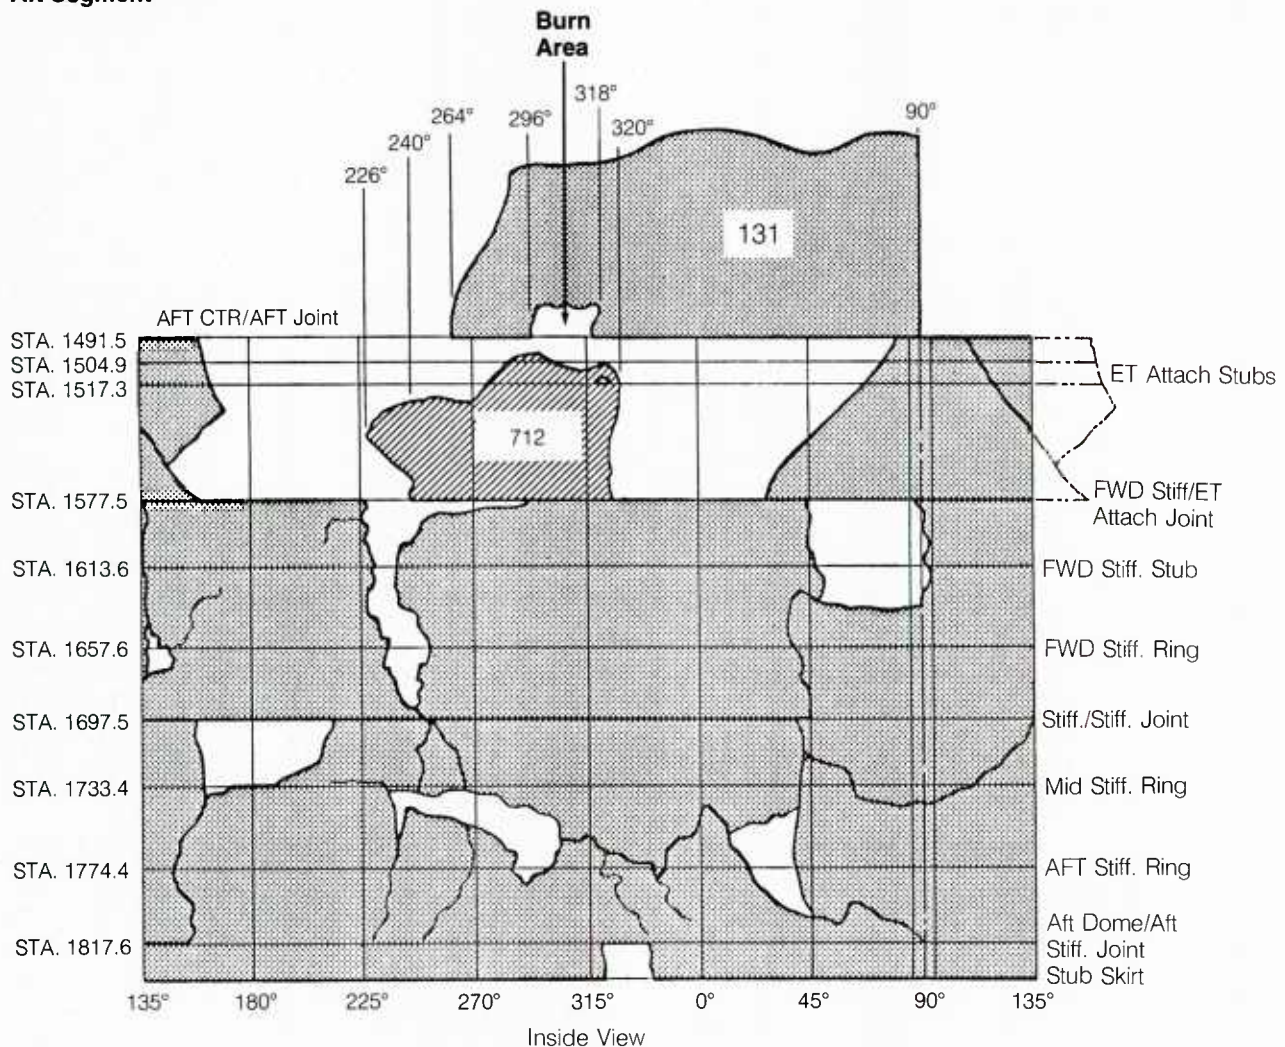
Figure 25  
Drawing depicts pieces of right Solid Rocket Booster aft segment recovered. At top is piece of aft center segment.

strut. This location was within the center of the burned out zone on the right Solid Rocket Booster (photo G). As a matter of interest, the P12 strut is located close to the point on the circumference where the booster case experiences maximum radial deflection due to flight loads. It seems likely that the plume from the hole in the booster would impact near the location of the P12 strut connection and the External Tank. Using geometric considerations alone suggests this strut separated from the External Tank before it separated from the right hand Solid Rocket Booster.

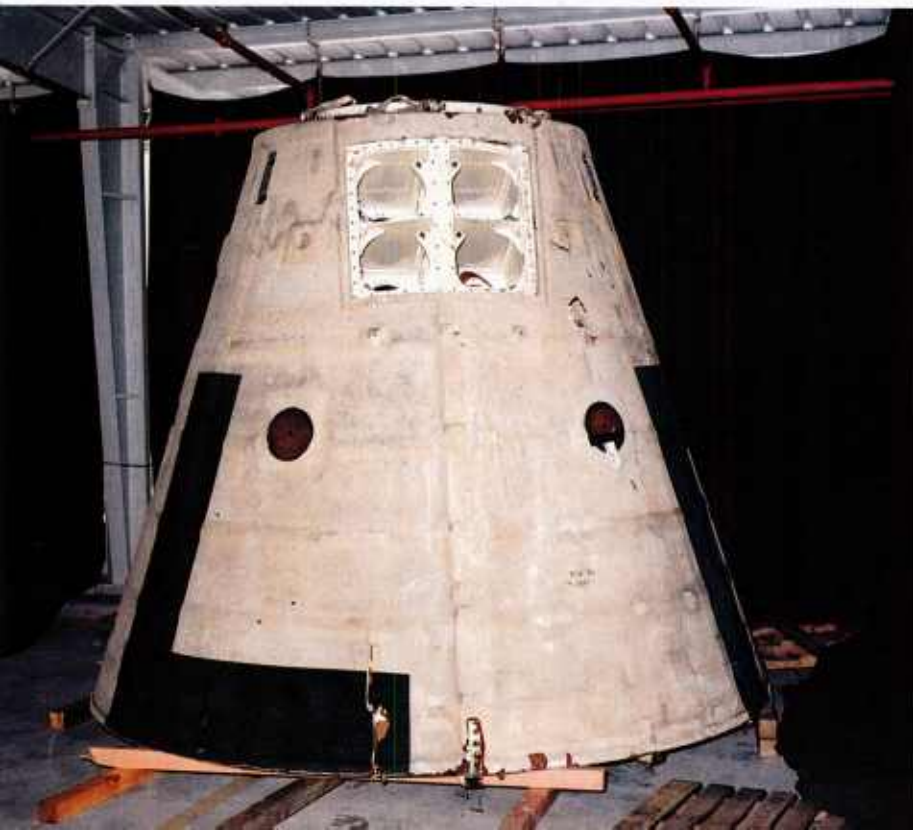
F

The frustums on the left page are parts of the Solid Rocket Booster forward assemblies that contain recovery parachutes, location aids and flotation devices. The frustum of the left hand booster (lower left) is virtually undamaged. The right frustum shows impact damage at top and burns along the base of the cone; evidence indicates it was damaged when it impacted with the External Tank. Shown at right above is another Solid Rocket Motor stack crosshatched to show the burned area of the right booster's aft joint (diagram at right). The flame from the hole impinged on the External Tank and caused a failure at the aft connection at the External Tank.

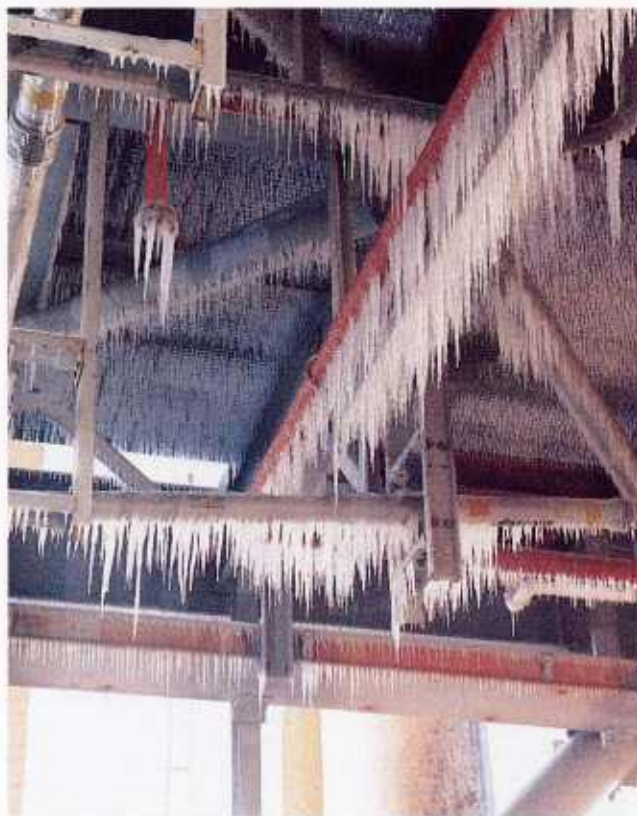
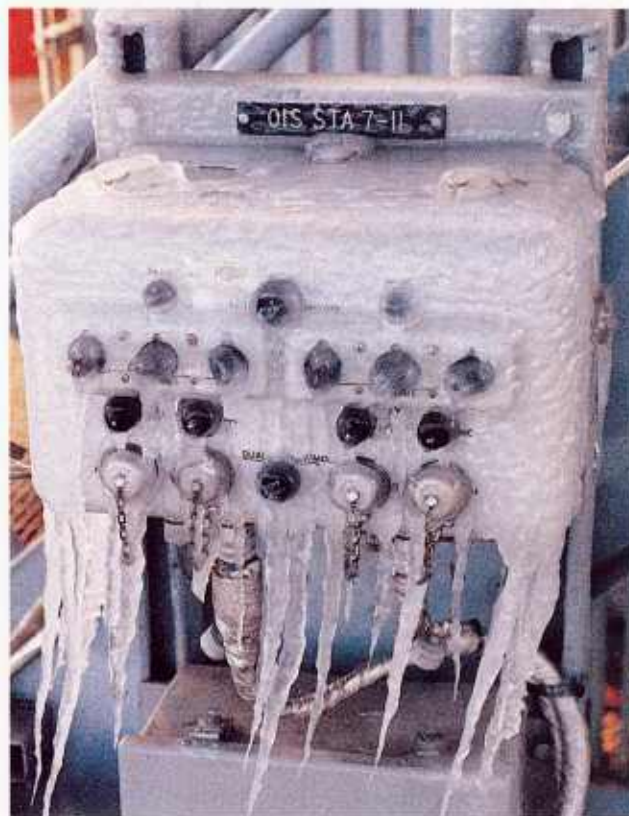
Above, foot long icicles on a lower level of the Fixed Service Structure frame the attachment point where the Orbiter is attached to the external tank (arrow). Icing was even more extensive at upper levels of the service structure (upper right and below). At right below is a ground communications box (not used during launch) rendered inoperable by heavy ice.
