HUMAN FACTORS ASSESSMENT: M9 ARMORED COMBAT EARTHMOVER (ACE)

REPORT DOCUMENTATION PAGE		READ INSTRUCTIONS BEFORE COMPLETING FORM
1. REPORT NUMBER ARI Research Note 88-12	2. GOVT ACCESSION NO.	3. RECIPIENT'S CATALOG NUMBER

4. TITLE (and Subtitle) Human Factors Assessment: M9 Armored Combat Earthmover (ACE)		5. TYPE OF REPORT & PERIOD COVERED Final Report February 1983 - December 1985

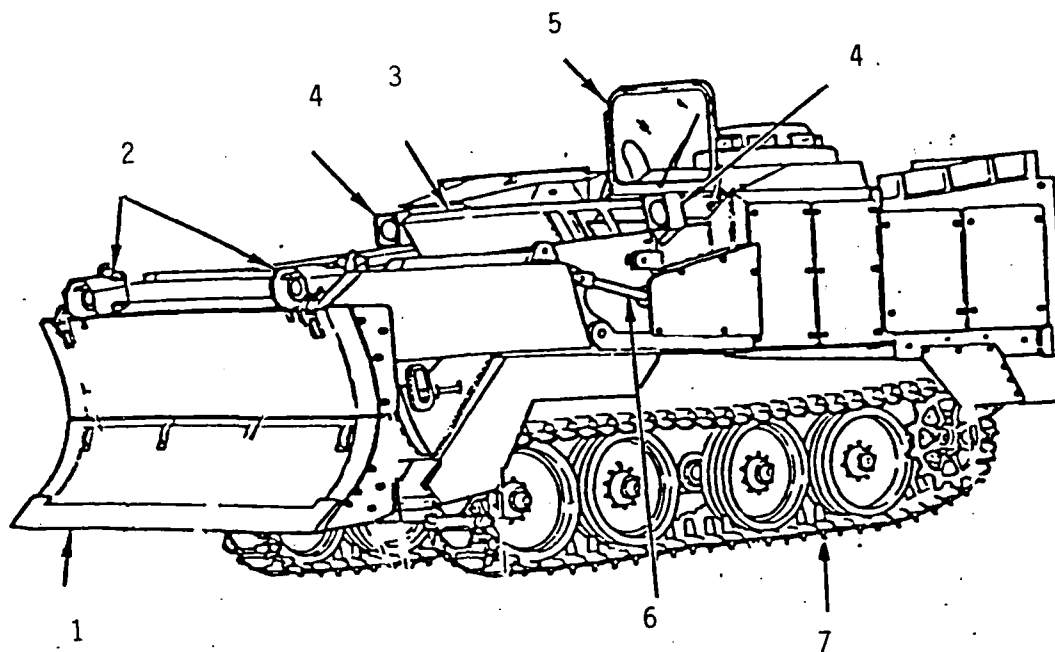
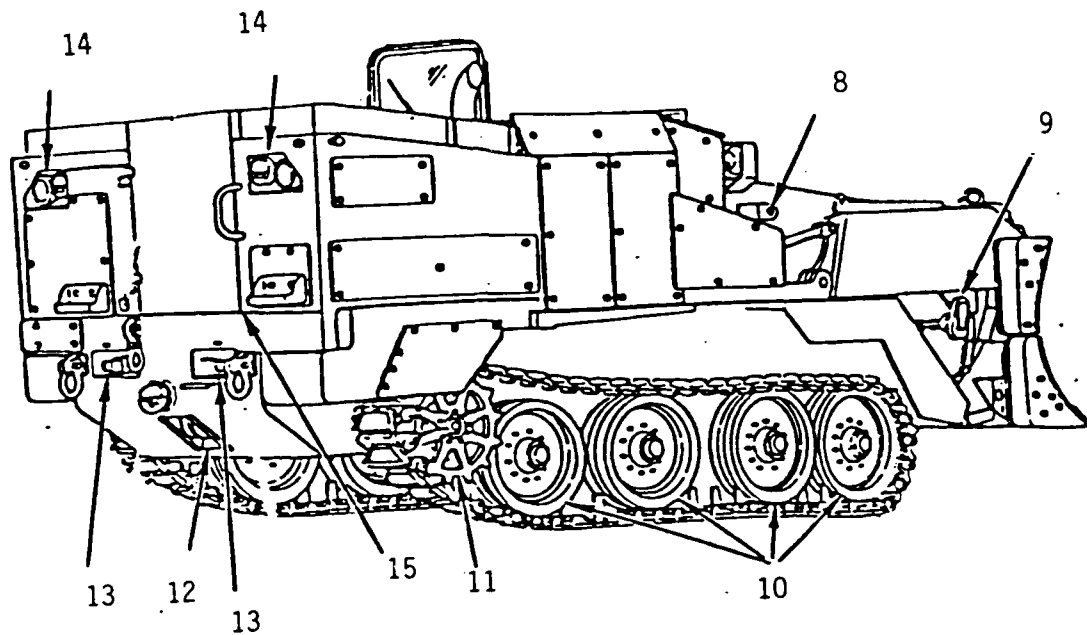
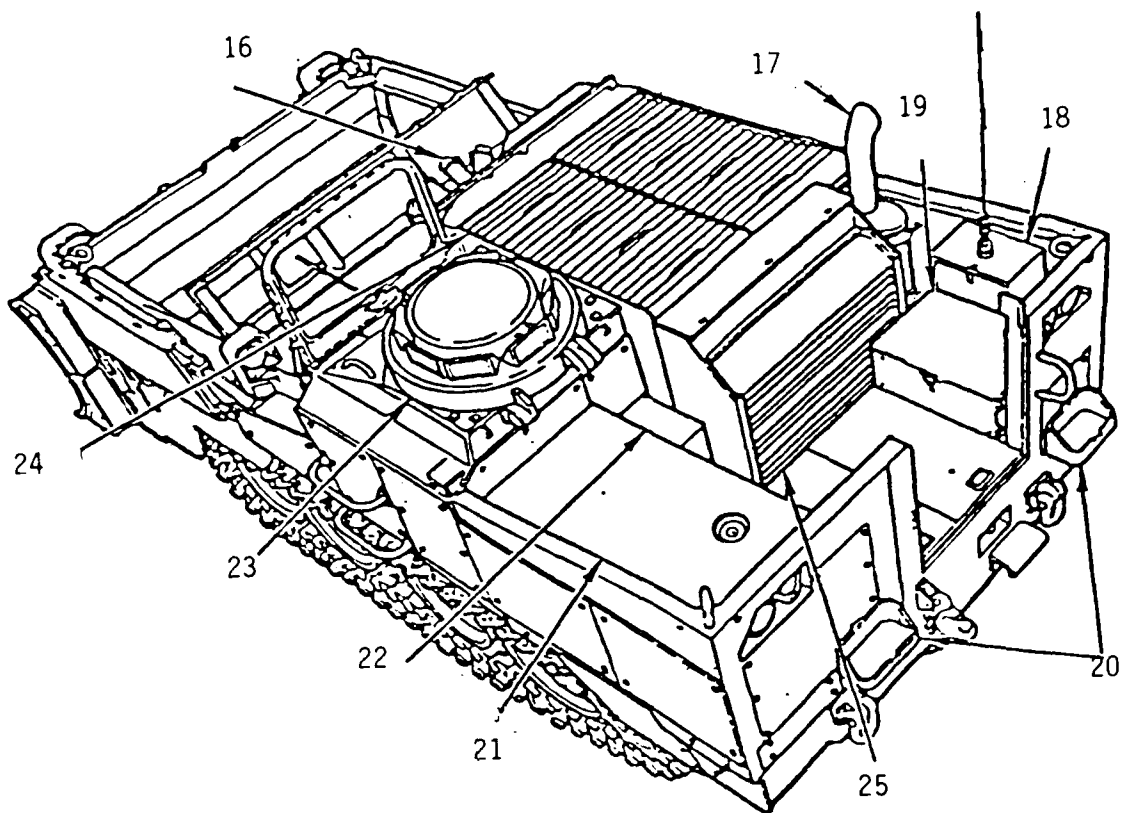
Figure 4 shows the location of the major human factors engineering deficiencies and safety hazards found on the M9 ACE. The deficiencies and hazards are described in the sections that follow for M9 operations and M9 maintenance. Categories such as a description of the deficiency (or safety hazard), the implications for the operator and the equipment, other affected tasks and equipment functions, and potential solutions are used to organize the information.

1. APRON AND DOZER ASSEMBLY. The operator must unsafely crawl beneath the dozer blade in order to prepare it for folding.
2. HEADLIGHTS. The lights do not conform to the Army Secure Lighting Program.
3. EJECTOR. There is no ejector blade lockout device to prevent its being retracted when personnel work in the bowl. The ejector cylinder (not shown) must be removed before other major components can be removed.
4. FLOODLIGHTS. The lights are frequently broken by collisions with trees.
5. WINDSHIELD. The windshield is frequently broken by collisions with trees.
6. APRON CYLINDER. The lubrication points are blocked by an armor panel.
7. TRACK. The track pads frequently wore out and may have increased vehicle vibration.

8. UPPER APRON LOCK PINS. Pin openings must be perfectly aligned in order to insert the pin. Two people are required to perform the task.
9. LOWER APRON LOCK PIN. The pins were difficult to remove due to the tightness of their fit. The pins were deformed by operators hammering them in and out of position.
10. ROADWHEELS. Rubber broke off the roadwheels and may have increased vehicle vibration. Roadwheels are hazardous to remove and replace.
11. FINAL DRIVES. The final drives must be drained in order to check the fluid levels.
12. WINCH ASSEMBLY. The winch is under capacity. The wire rope broke frequently. The wire rope wraps unevenly on the drum. There is no winch brake.
13. REAR STEP. The step was crushed in collisions.
14. TAILLIGHTS. The lights do not conform to the Army Secure Lighting Program.
15. REAR DOOR. The door is difficult to lift when installing or stowing it.

16. SMOKE GRENADE LAUNCHERS. The launchers are difficult to load from the sloped roof of the engine housing.
17. MUFFLER. Debris trapped in the muffler well was caught on fire. The radio cables were burned by heat generated from the muffler.

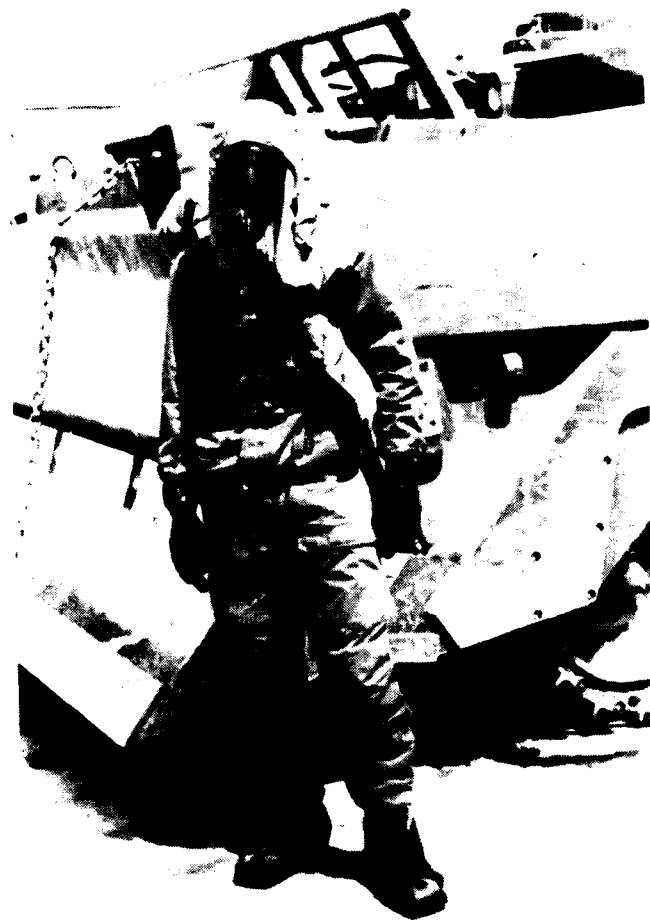
Figure 6. The operator dressed in MOPP IV uniform.

Potential Solutions: Add an NBC microclimate system to the vehicle which includes the cooling vest and controlled air temperatures. A positive air pressure should be maintained in the driver's station during closed hatch operations. The positive pressure should be provided by fans and filtered air drawn from outside of the vehicle. The current ventilation ports draw air from inside of the bowl and ejector blade roller guide housing. This air is often filled with dust and radiated heat from the engine. The ventilation ports should provide air from outside of the vehicle.

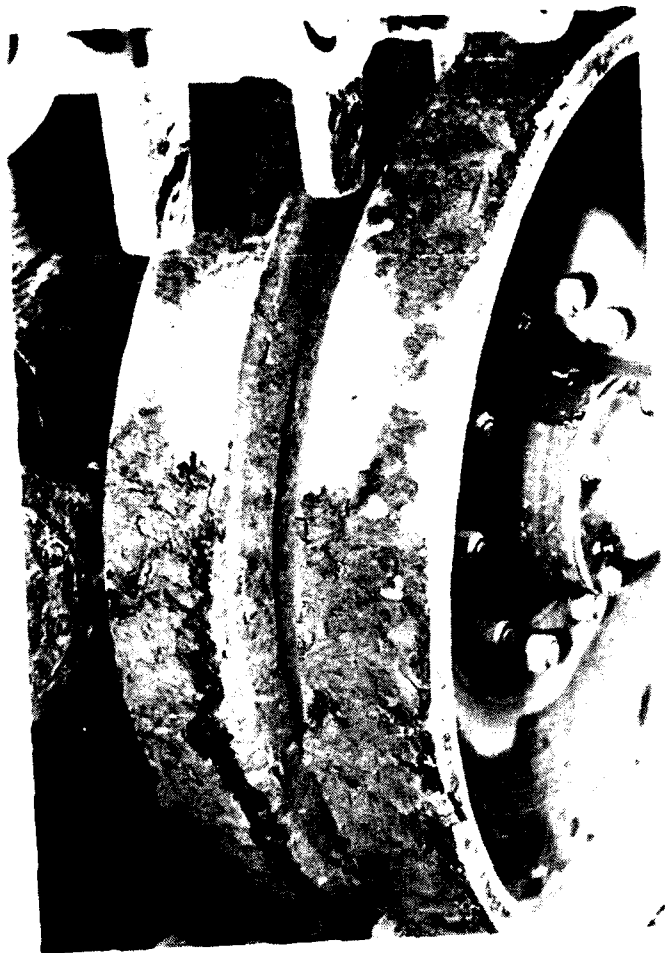
Figure 7. Deterioration of the rubber on the roadwheels.

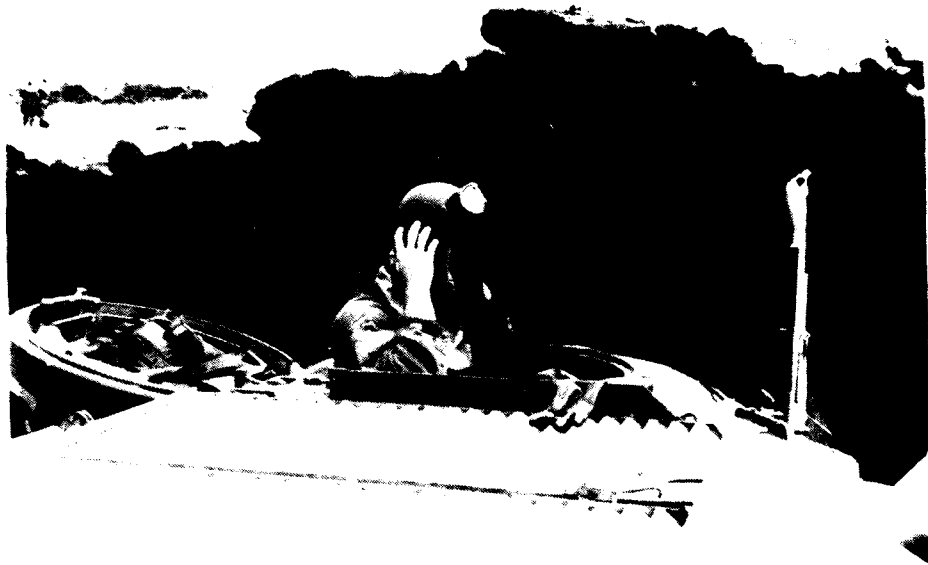
Figure 16. The operator trying to fit the earcups of the CVC helmet while wearing the MOPP mask and hood.

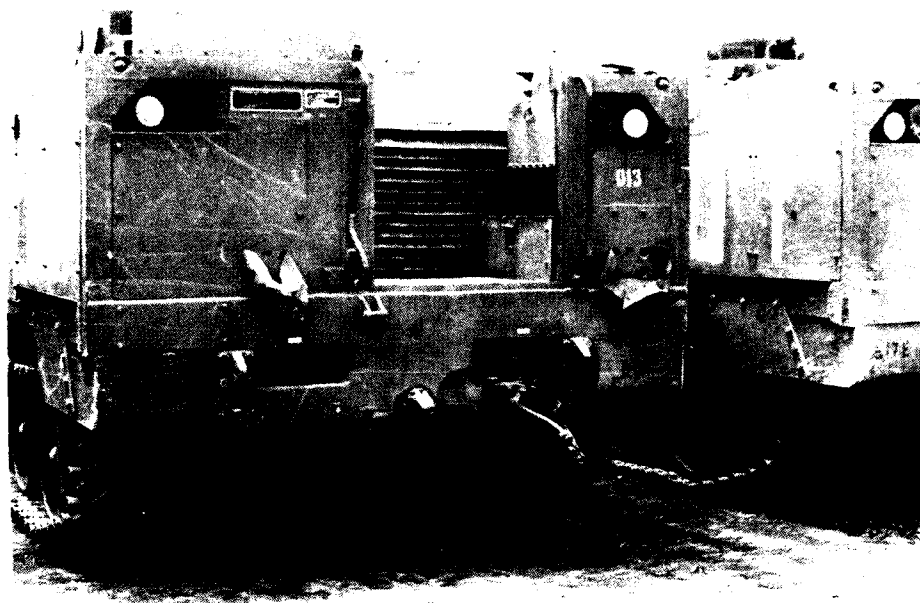
Implications for the Operator and the Equipment: Stowed equipment on the rear of the vehicle was frequently damaged by collisions with objects to the rear of the vehicle. Stowed equipment on the rear deck of the vehicle was affected by the high engine temperature. The stowed equipment blocked the air flow and affected the efficiency of the cooling system. Stowage locations that are difficult to access increase the time it

Figure 18. The damage to the rear of the vehicle. (The winch cable, the rear steps, the jerry can holders, and the handrails are broken.)

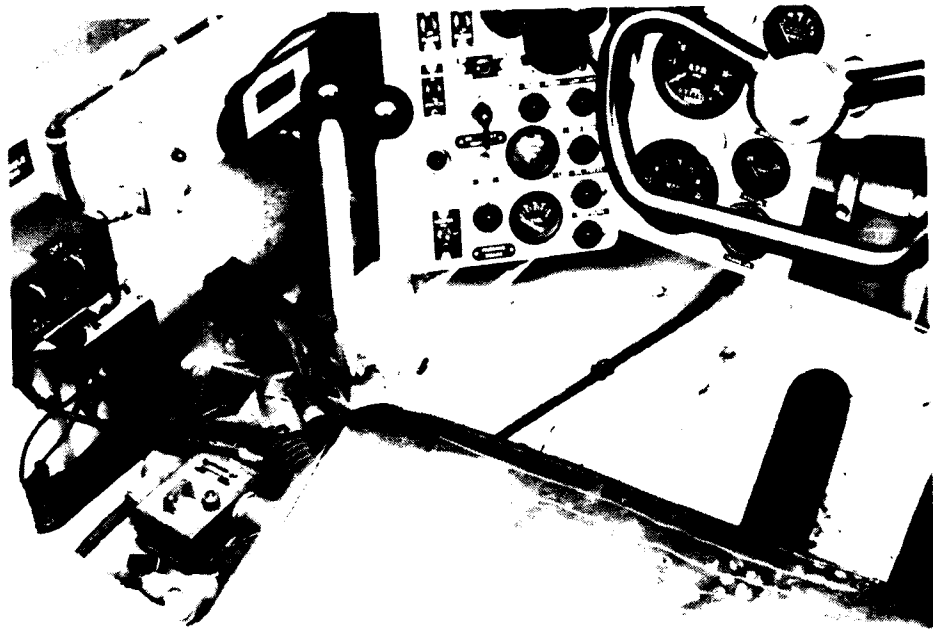
Figure 19. The suspension control levers (center left) that are too close together.

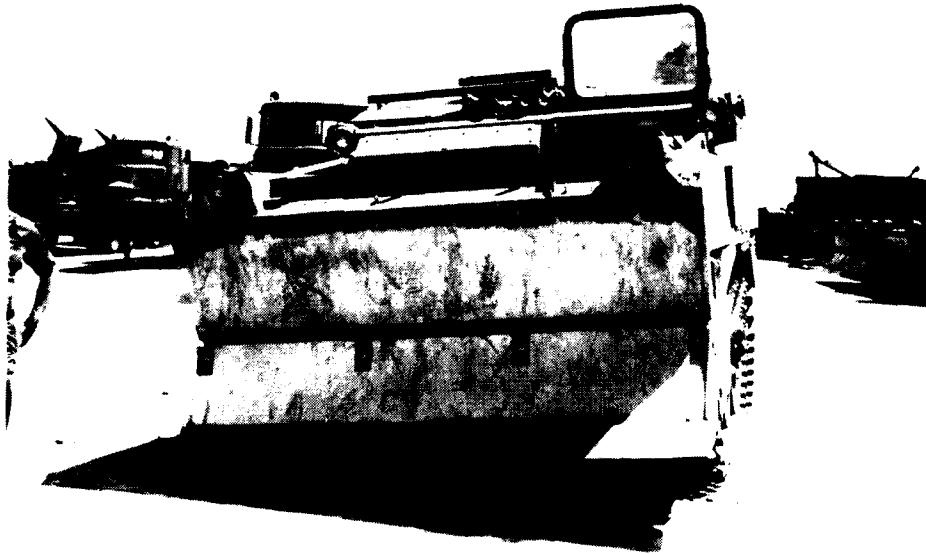
Figure 20. The operator lowering the suspension (unsprung) with one side responding more rapidly than the other.

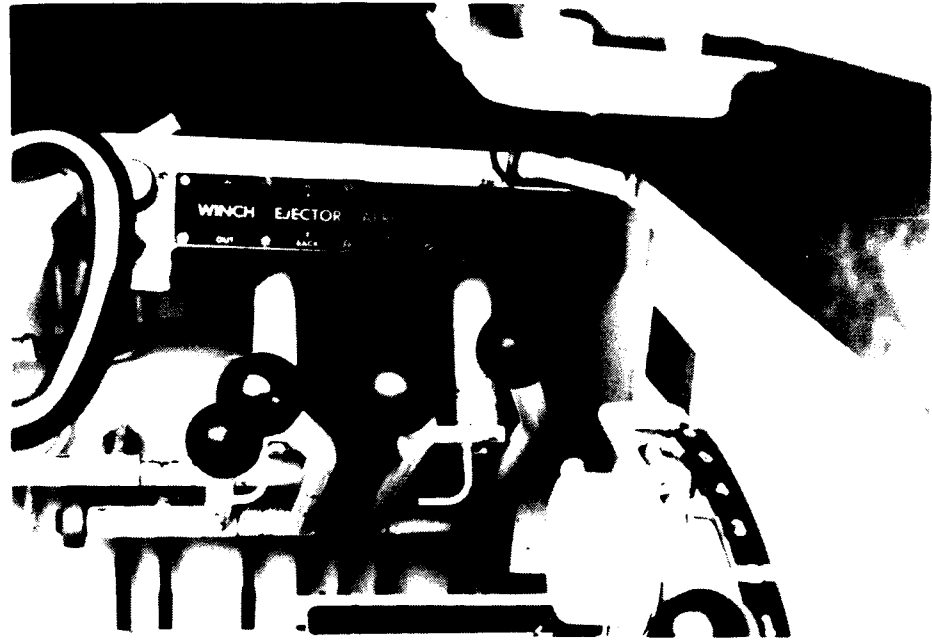
Figure 21. The bilge pump lever (furthest to the right) and the bilge pump light was above the lever but cannot be seen.

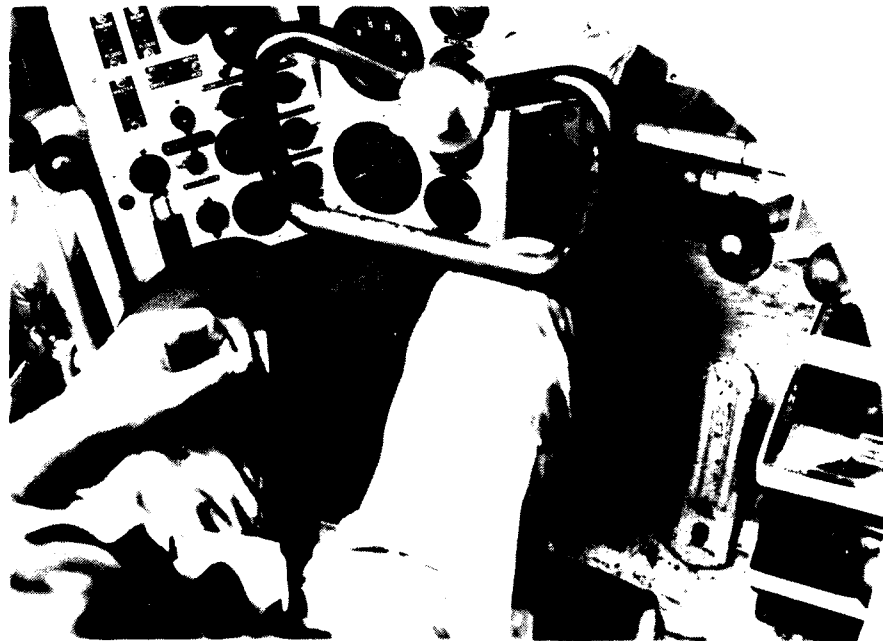
Figure 22. The operator's foot and leg position when using the brake pedal.

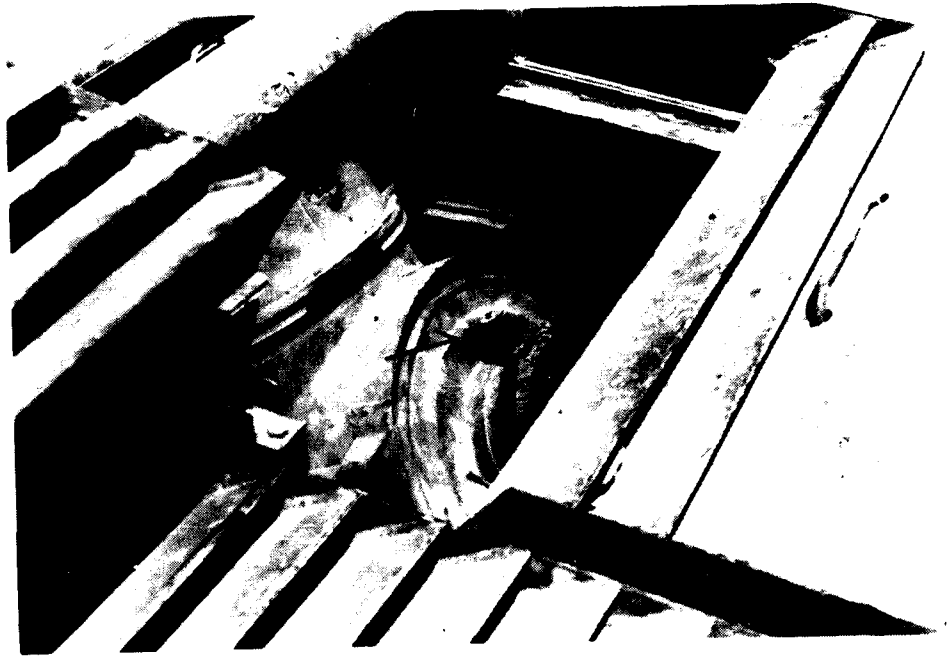
Figure 25. The clogged air filter indicator (the small dark knob on the filter canister).

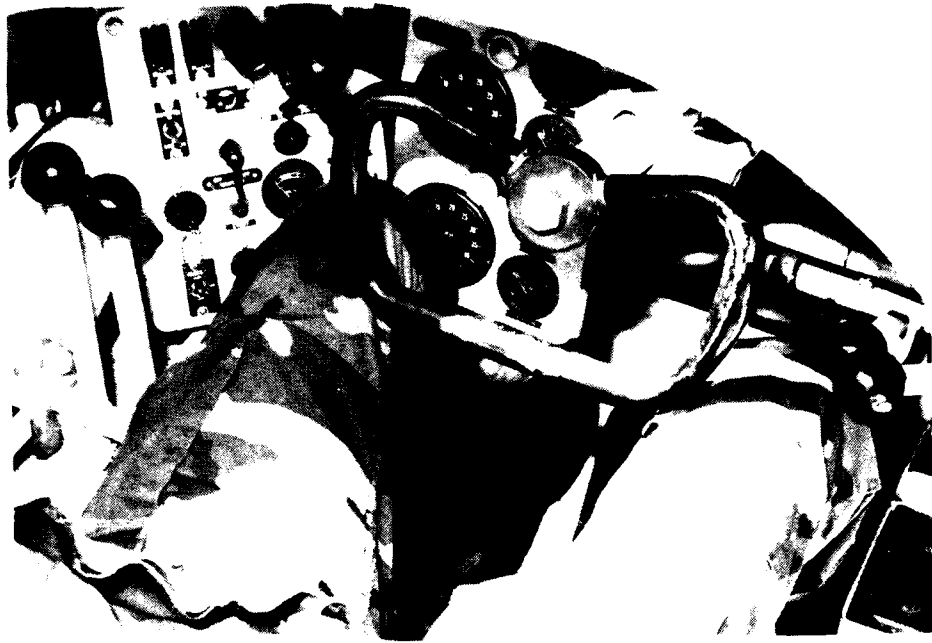
Figure 26. The operator's legs interfering with the steering control.

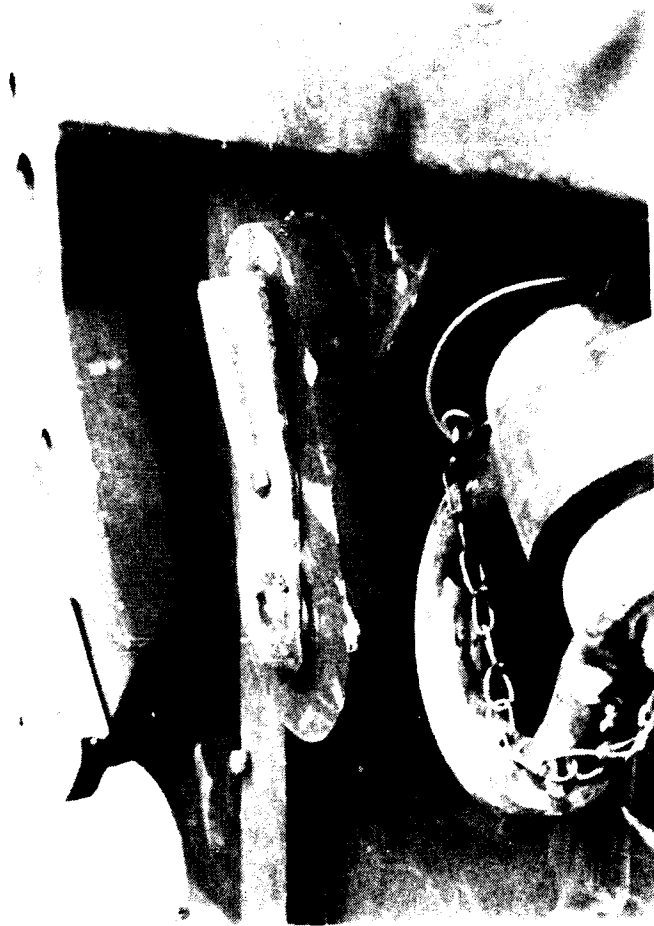
Description of the Deficiency: Figure 27 shows the apron lock pin with marks from hammering on the lower portion of the oval plate. All of the operators reported that the two apron pins, securing the left and right apron to the hull, were driven in and out of place using hammers. The fit of the lock pins into the openings was too tight for easy removal. Continued hammering deformed the pins adding to the problem.

Figure 27. The oval plate of the apron lock pin and hammering marks.

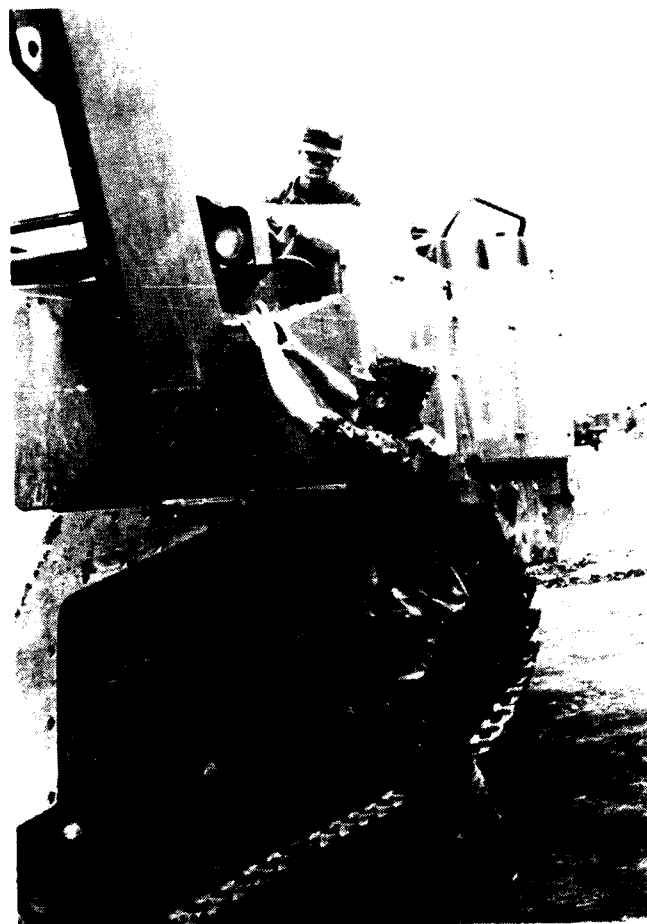
Figure 29 shows a mechanic inserting the apron safety pin while the operator adjusts the height of the apron. Inserting and removing the apron lock and safety pins required two people to perform the task in order to align the pin openings and quicken the procedure. Otherwise, without two people, the one operator must mount and dismount the vehicle repeatedly attempting to align the pin openings until the pins can be inserted. This task may violate the vehicle's design criteria emphasizing that one operator must be able to perform all tasks alone.

Figure 29. A mechanic assisting the operator in inserting the apron safety pin.

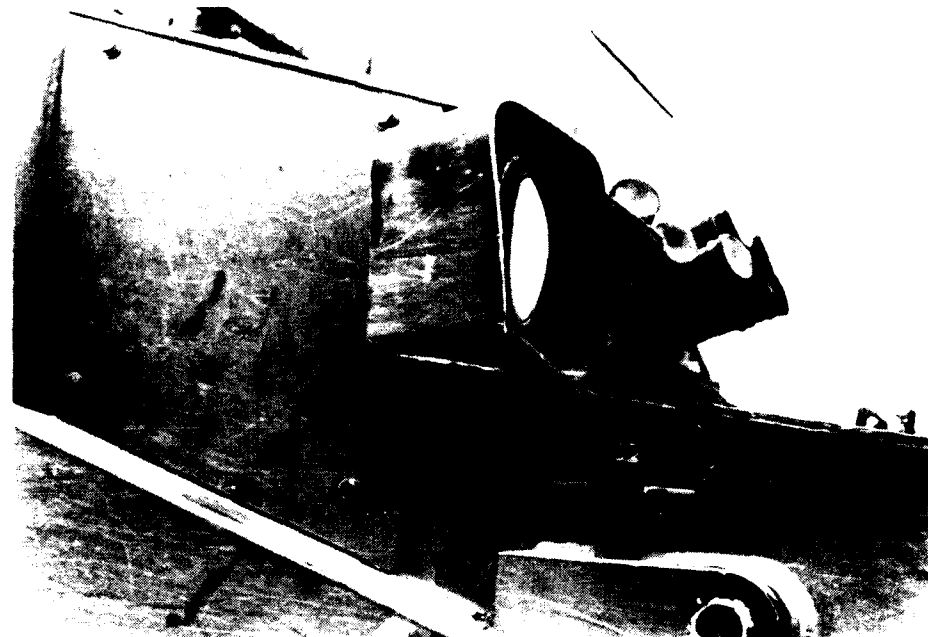
Figure 30. Damage to the floodlight guard

1. Place the side mounted floodlights in protected locations more inboard on the vehicle than the present locations. Perhaps, floodlights could be located inboard at a greater height on a removable stand or fixture.
2. Add lights meeting the requirements of the Army Secure Lighting Program.

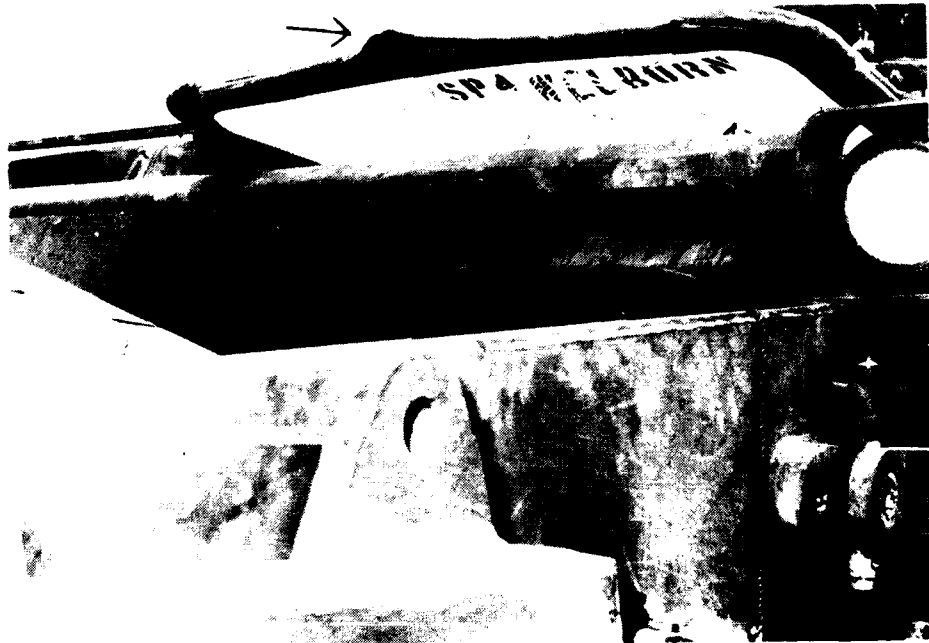
Figure 35. A shattered windshield and damaged windshield frame.

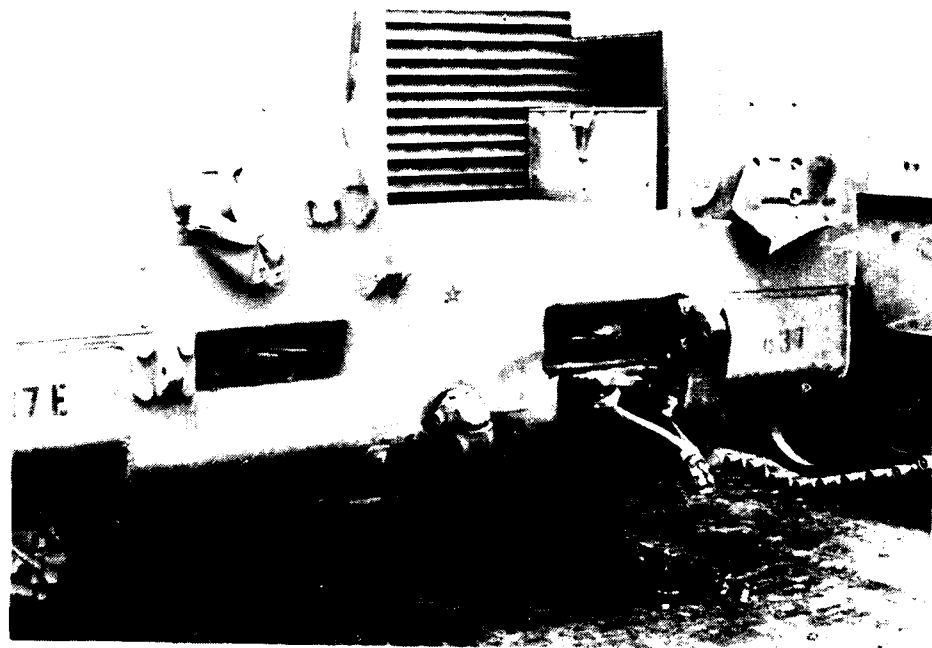
Figure 39. The crushed rear step and handrail.

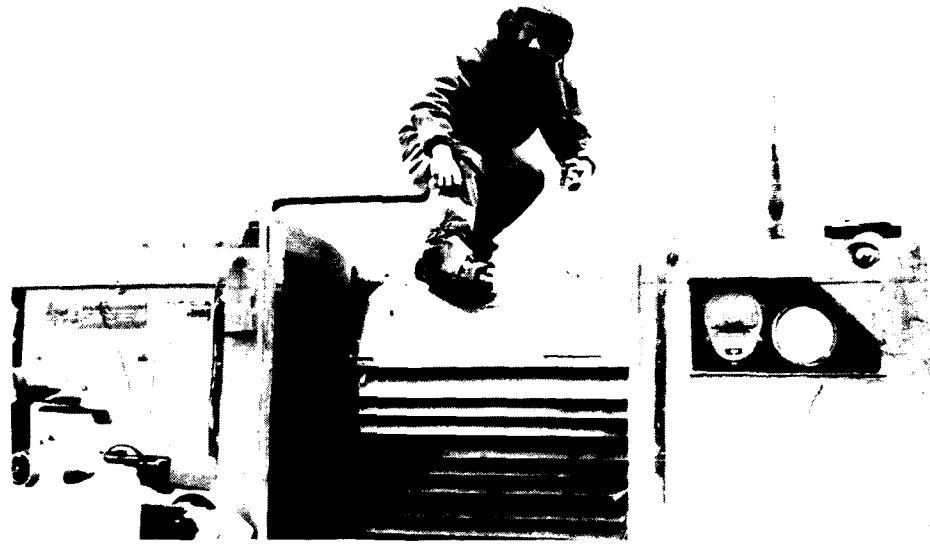
1. The radiator housing. Figure 40 shows an operator trying to step down from the radiator housing.
2. The smoke grenade launcher area including the sloped deck above the tool box.
3. The right and left apron cylinder areas used by personnel to enter or exit the bowl. Figure 41 shows an operator climbing up by the apron cylinder in order to see into the bowl.

Figure 40. An operator stepping down from the radiator housing.
