AEFA Project No. 37-19

**ARTIFICIAL AND NATURAL ICING TESTS OF THE UH-60A  
HELICOPTER CONFIGURED WITH THE XM-139 MULTIPLE  
MINE DISPENSING SYSTEM (VOLCANO)**

**Final Report**

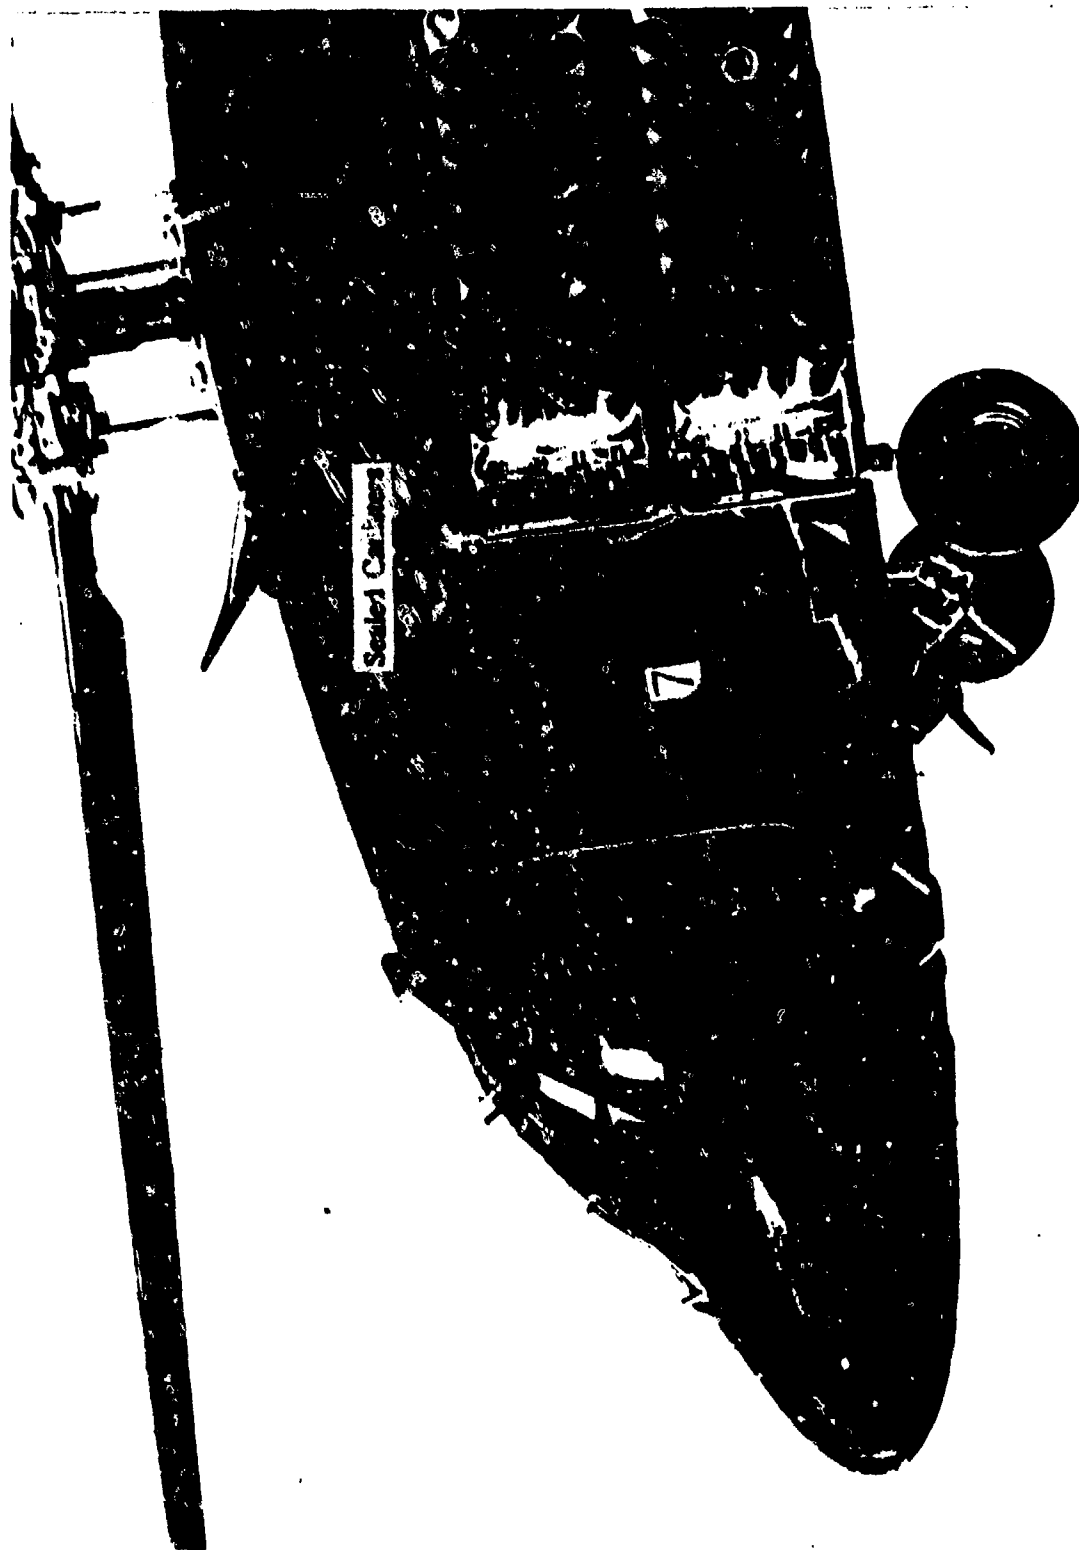
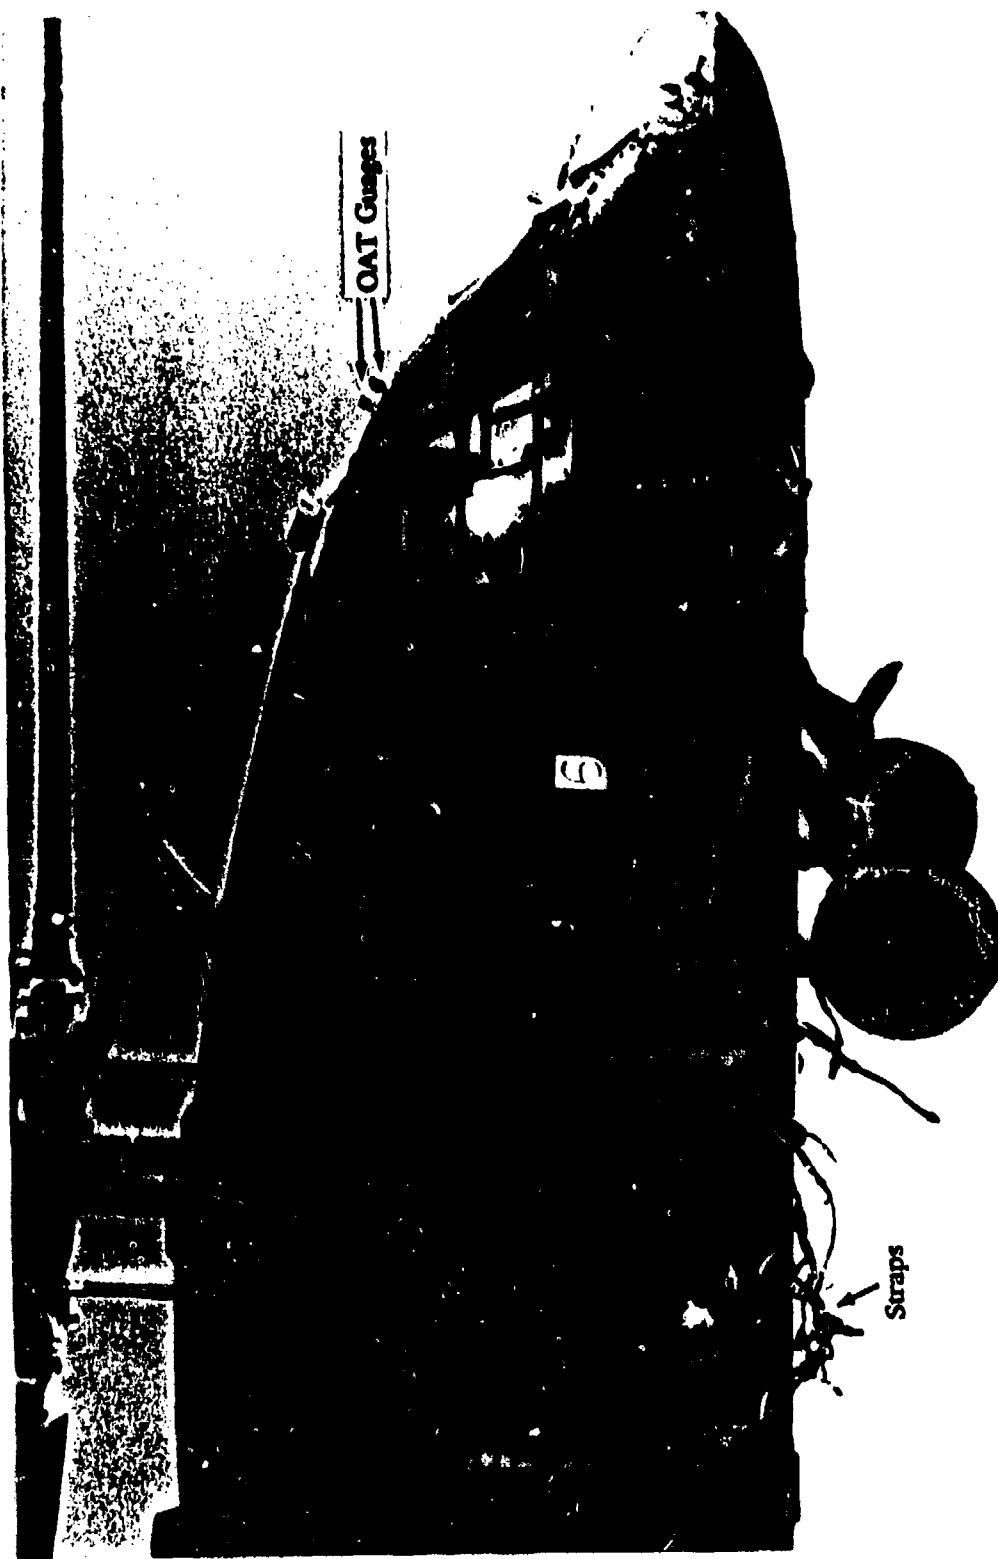
17. The ice accretion and shedding characteristics of the XM-88 mine canisters were evaluated in the pre-launch and post-launch configuration at conditions shown in table 1. Photographs of typical ice accretions are presented in figures H-2 through H-5. Essentially no ice accreted on the exposed canister straps. The primary locations of ice accretion were on the front radius of the first column of canisters and the upper radius of the top row of

canisters installed on both the upper and lower launcher racks. Ice formations of up to approximately five inches were observed in these locations. None of these accretions extended around the outboard end of the canister. Only a light "frosting" of ice was noted on the end caps of the canisters installed near the aft columns. These ice accretions will not interfere with mine launch operations. The ice accretion characteristics of the mine canisters are satisfactory.

18. Ice shedding was observed more frequently from the mine canisters than from other parts of the VOLCANO system. All ice sheds observed went aft and down, away from the helicopter. Due to the shedding characteristics, firing of the mines was not deemed necessary since the shedding should be similar. The ice shedding characteristics of the mine canisters are satisfactory. However, this test did not include high rates of descent into air temperatures warmer than freezing. It is possible that the air flow under these conditions could result in shed ice particles causing FOD to the helicopter, most probably the tail rotor. The following information should be included in paragraph 8-61 of the operator's manual:

d. During flight in icing conditions, shed ice particles may cause FOD to the helicopter, especially main rotor and tail rotor blades and engine compressors. Flight tests have shown that this FOD is difficult to detect during flight. Minimizing descent rates after ice has accumulated on the helicopter or external stores should reduce the probability of FOD because the airflow will carry particles aft and down, away from the helicopter. Normal instrument procedure descents of approximately 1000 fpm or less are preferable. During shutdown, crewmember's should be alert for unusual engine damage. The helicopter should be alert for unusual engine noise (high pitched whine) that indicate engine compressor damage. The helicopter should be visually inspected prior to further flight.

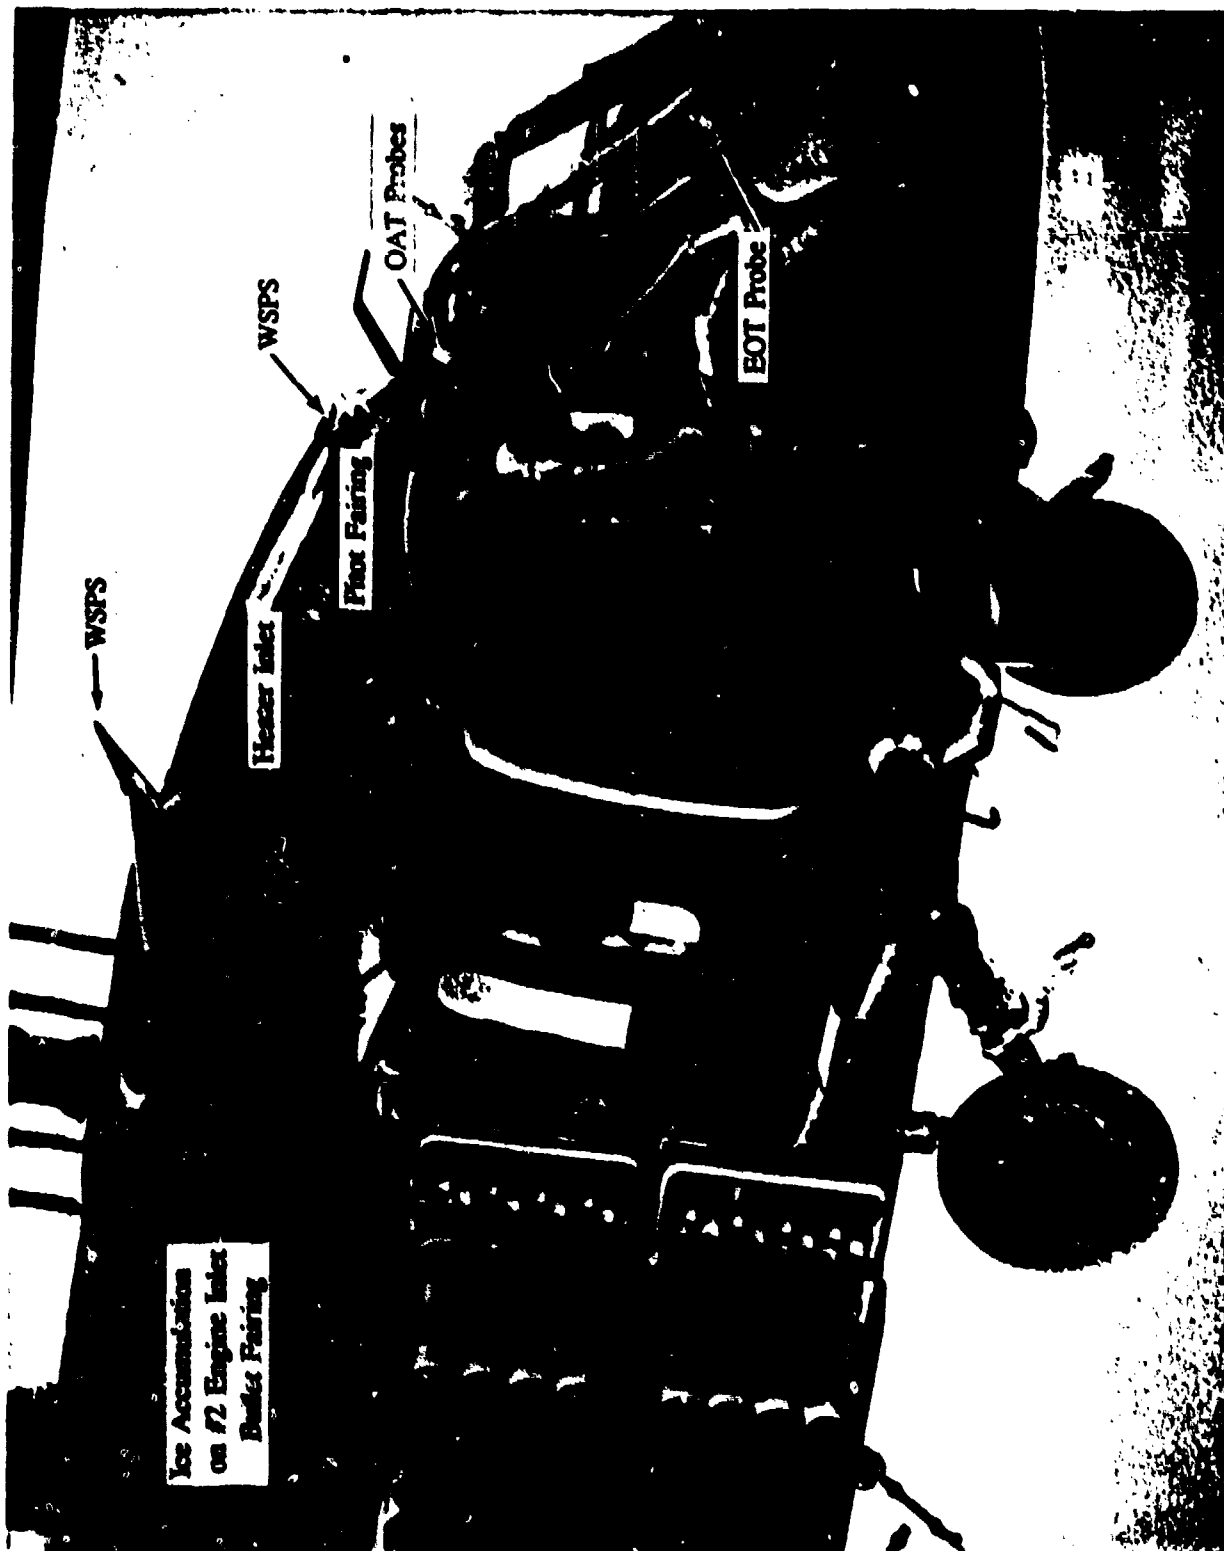
25. The control access fairing ice accretion and shedding characteristics were evaluated at conditions presented in table 1. Photographs of typical ice accretions on the control access fairing are presented in figures H-8 and H-9. Ice accreted in the heater air intake port and on the rear alignment pin bracket hardware. The location of these ice formations, directly in front of the engine inlet, increases the probability of engine FOD from ice shedding. However, no ice shedding was documented from these locations and no evidence of engine FOD was detected during this test. The ice accretion characteristics of the control access fairing are a shortcoming because of an increased probability of engine FOD. The design of the control access fairing on the UH-60 helicopter should be improved to eliminate ice accretion in front of the engine inlets.
