# The Prevention and Repair of Gel Coat Blisters

*This report is the product of work accomplished under  
U.S. Coast Guard Grant #1601.82*

*Sponsored by the American Boat Builders and Repairers Association, Inc.*

| 9. Performing Organization Name and Address<br>Department of Chemical Engineering<br>University of Rhode Island<br>Kingston, Rhode Island 02881 | | 10. Work Unit No. (TRAIS) | |

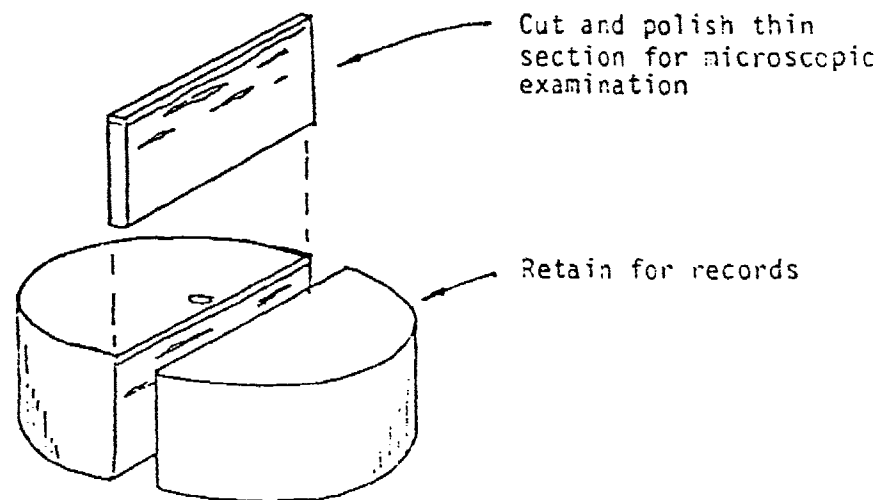
A. Thin Section Test

A core plug sample must be taken in a representative area. This plug may then be sectioned by making two parallel cuts, one to two millimeters apart, so that a thin cross section of the hull can be obtained for microscopic study. While this is the best method, an alternative is to cut the plug in half and sand the plug perpendicular to the hull surface to expose a flat cross-section. (See Fig. 1) After sanding, a red dye penetrant (such as Spotcheck, Magnaflux Corporation, Chicago) should be sprayed on the surface. Let the surface dry and sand to remove superficial red dye. Observe the cross-section and the damage (blisters, osmotic disk cracks, delaminations, and extensive glass debonding) will be strongly marked in red.

Figure 1. Preparation of core samples for damage evaluation
