U.S. Army Research Institute
for the Behavioral and Social Sciences

Research Report 1524

MANPRINT Evaluation: AN/TRC-170 Digital Troposcatter Radio System

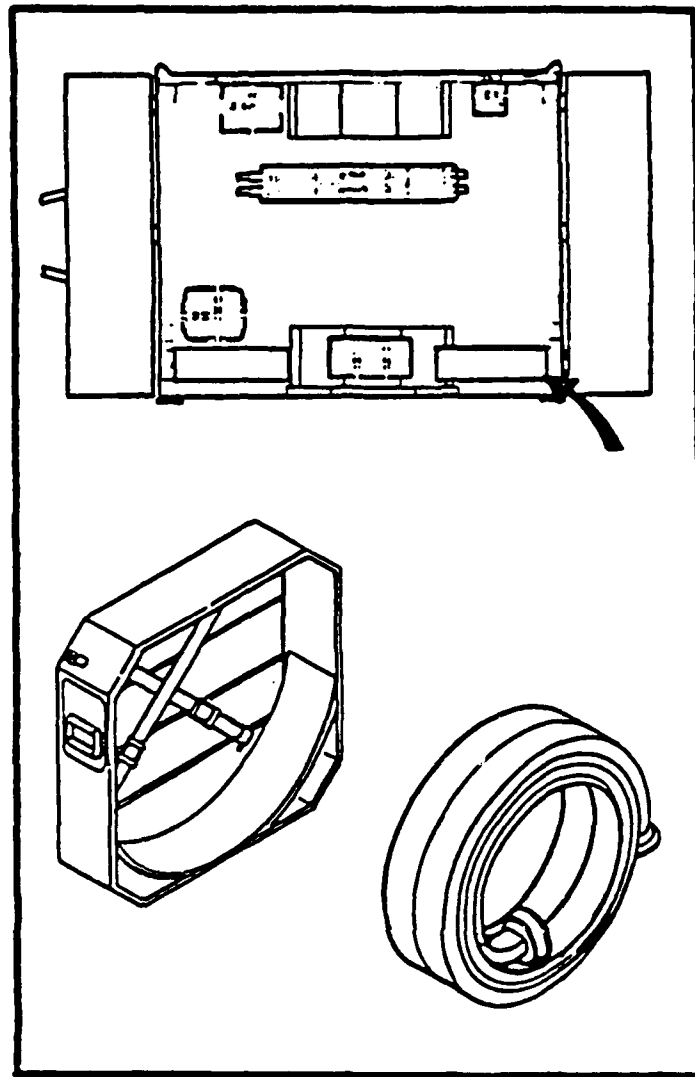
Figure 12. The waveguide protective container and trailer stowage location.

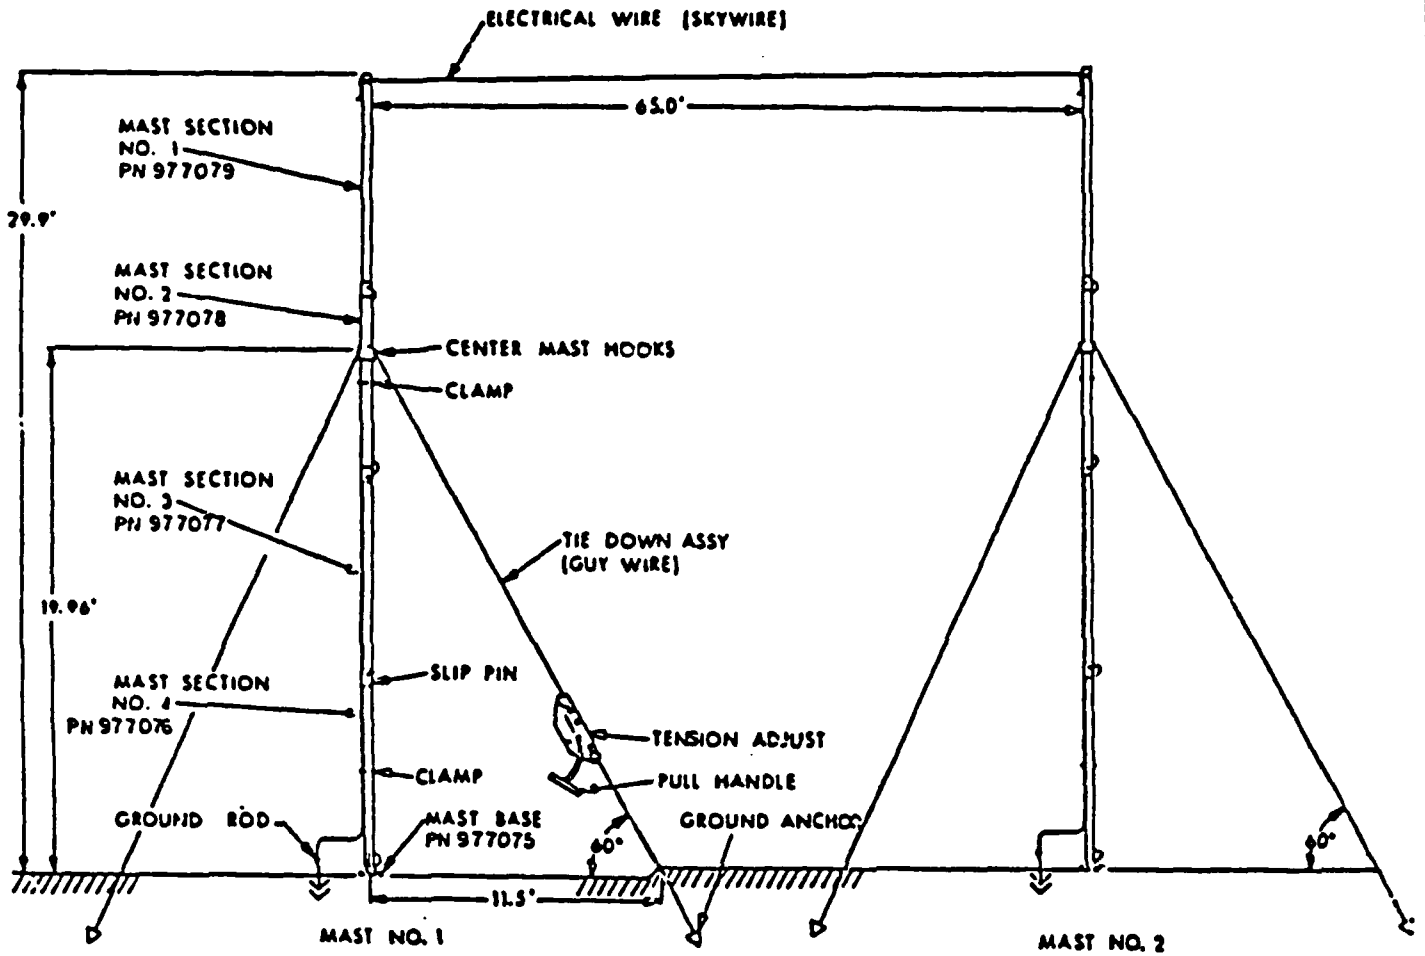
Implications: The LPA is erected next to the AN/TRC-170 antennas and shelter. The collapse of the mast might damage the antennas or shelter. The personnel are also endangered by a collapsing LPA mast.

Data: All the test participants (operators, supervisors, data collectors, and test directorate) recommended four-person crews for LPA erection/lowering tasks. Human Factors personnel observed 10 uncontrolled falls of the masts. In one case, an operator had the mast fall onto his shoulder causing a painful injury.

Figure 14. The lightning protection assembly (LPA) that was erected across the top of the antenna structures.

Potential Solutions: If the current LPA masts continue to be used, using a hinged base plate would make erection easier and safer, but for safety would require four man crews for erection. Alternately, consideration should be given to use of telescopic antenna mast sections which are already in the supply system. The training program should demonstrate correct erection/dis-assembly procedures to all 26QD6 personnel during specialty training.

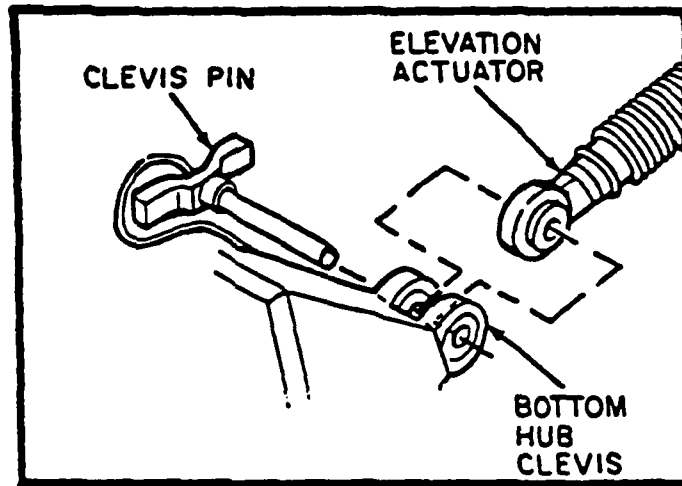
Figure 16. An example of the type of pin that was difficult to insert and remove.

Description of the Problem: Figure 16 shows the type of clevis pins used to secure and assemble equipment. The clevis attachment pins used on the AN/TRC-170 antennas are difficult to handle. The pins are used to hold the antennas together and to secure antenna parts to the low-profile pallet. The pins fit tightly and are difficult to install and remove. The pins have been damaged by attempts to install or remove them using improper tools such as hammers, rocks, and other objects.

Data: Every unit had damaged pins. Replacing the pins was logistically difficult.

Potential Solutions: The pins should be treated with an approved lubricant to control corrosion and facilitate insertion. The holes receiving the pins should be flanged to help insertion/removal. Crewmen suggested that a rubber mallet be issued and used to insert or remove pins.

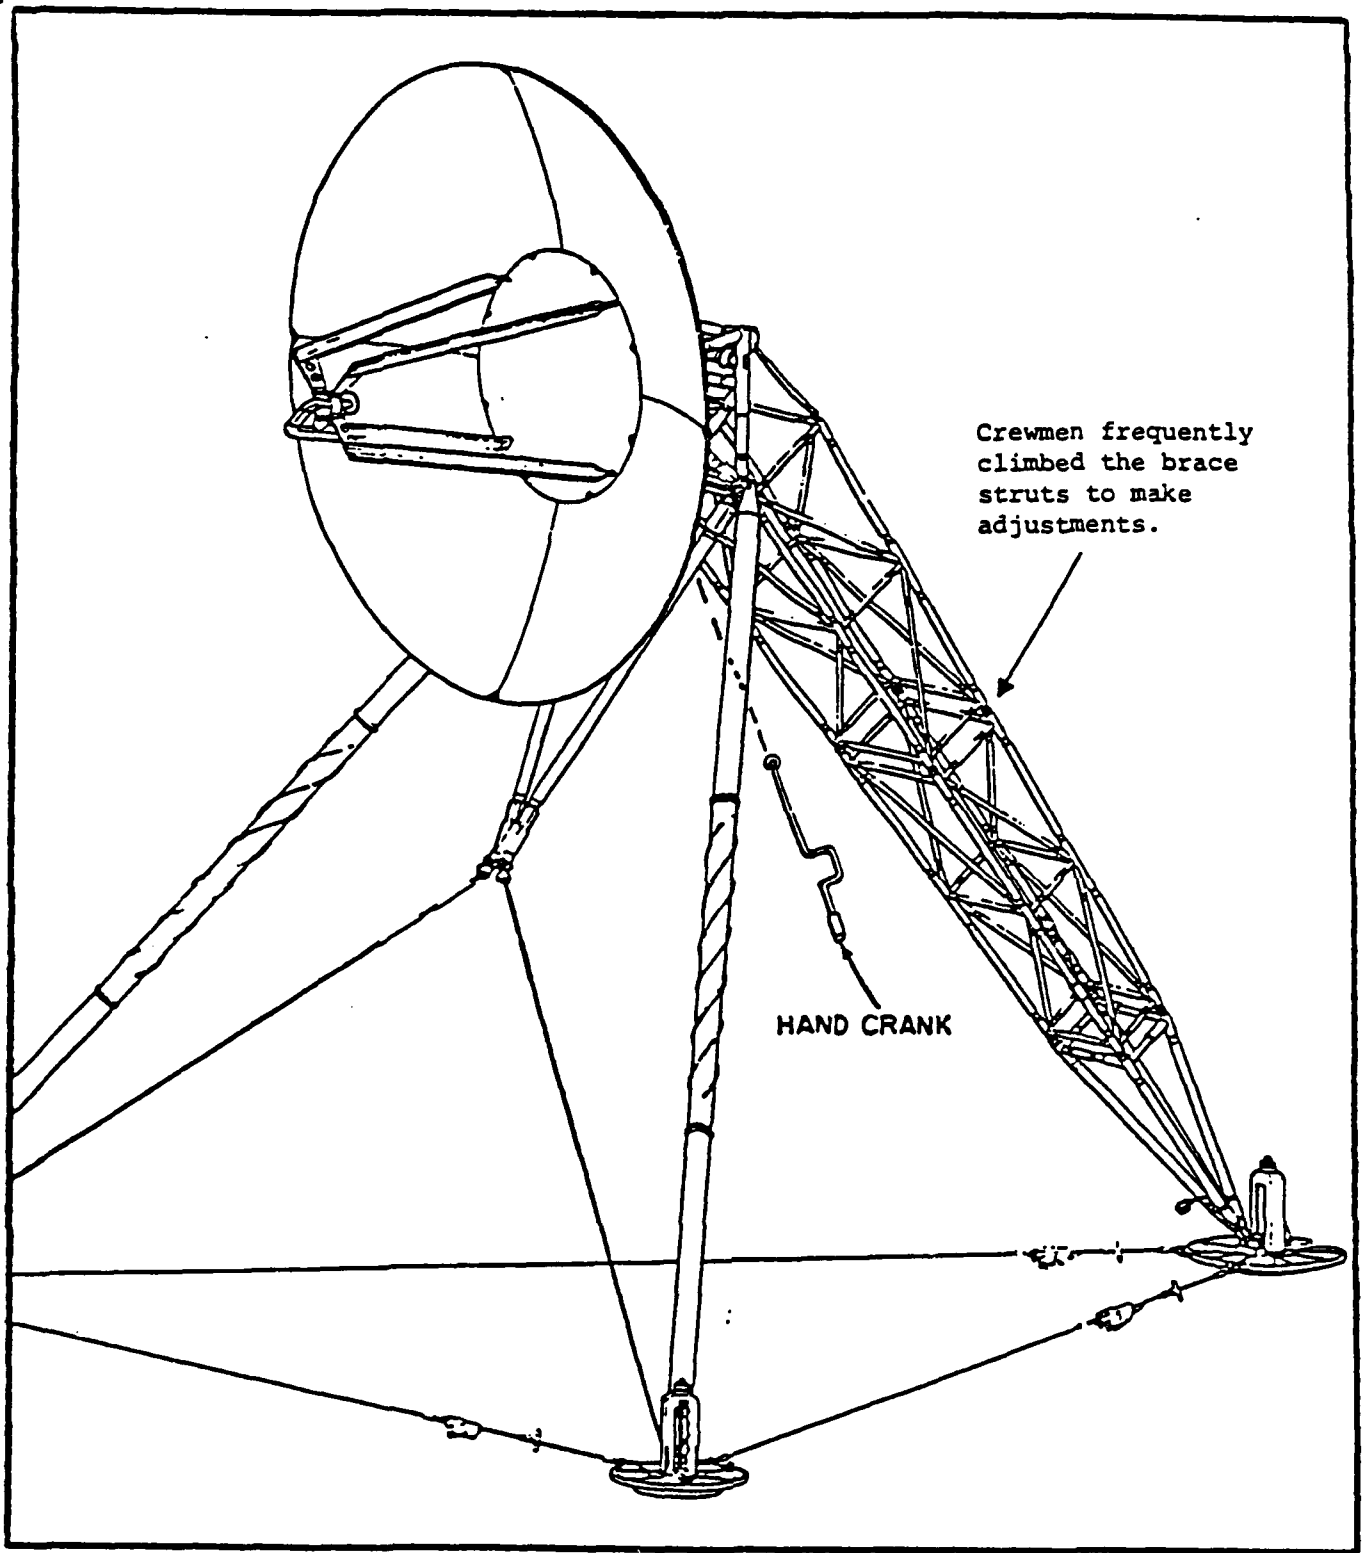
Figure 19. The 9.5-ft. antenna and hand crank that was difficult to use to reach the elevation angle adjustment device.
