Applied Report 84

**RAAF ORION AIRCRAFT A9-300**  
**OXYGEN FIRE(U)**

*This report summarizes the findings of the investigation into the nature and cause of the fire in RAAF Orion aircraft A9-300. This aircraft was destroyed by fire which initiated in the oxygen system as the result of an explosion caused by metal ignition.*

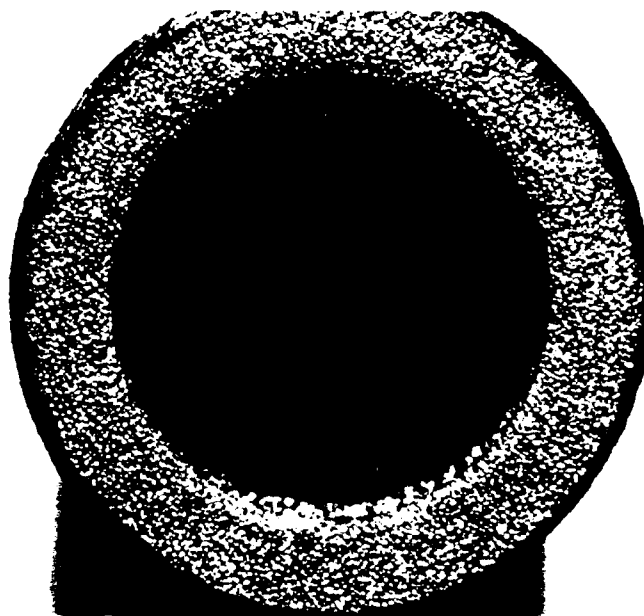
Filters from a number of Orion aircraft were examined. These were taken from the charging valve assemblies, and all showed signs of fretting, indicating that the element was not sealing properly and had oscillated during charging of the oxygen system. This movement had led to damage of the filter body, removal of material from the filter element and an imperfect seal between the filter body and the filter element. As a result the filters were incapable of effectively removing particles and

FIGURE 15 A FINE FILTER FROM AIRCRAFT A9 760 NOTE FRETTING  
AROUND THE EDGE (ARROWED)  
MAGNIFICATION: 9 APPROX

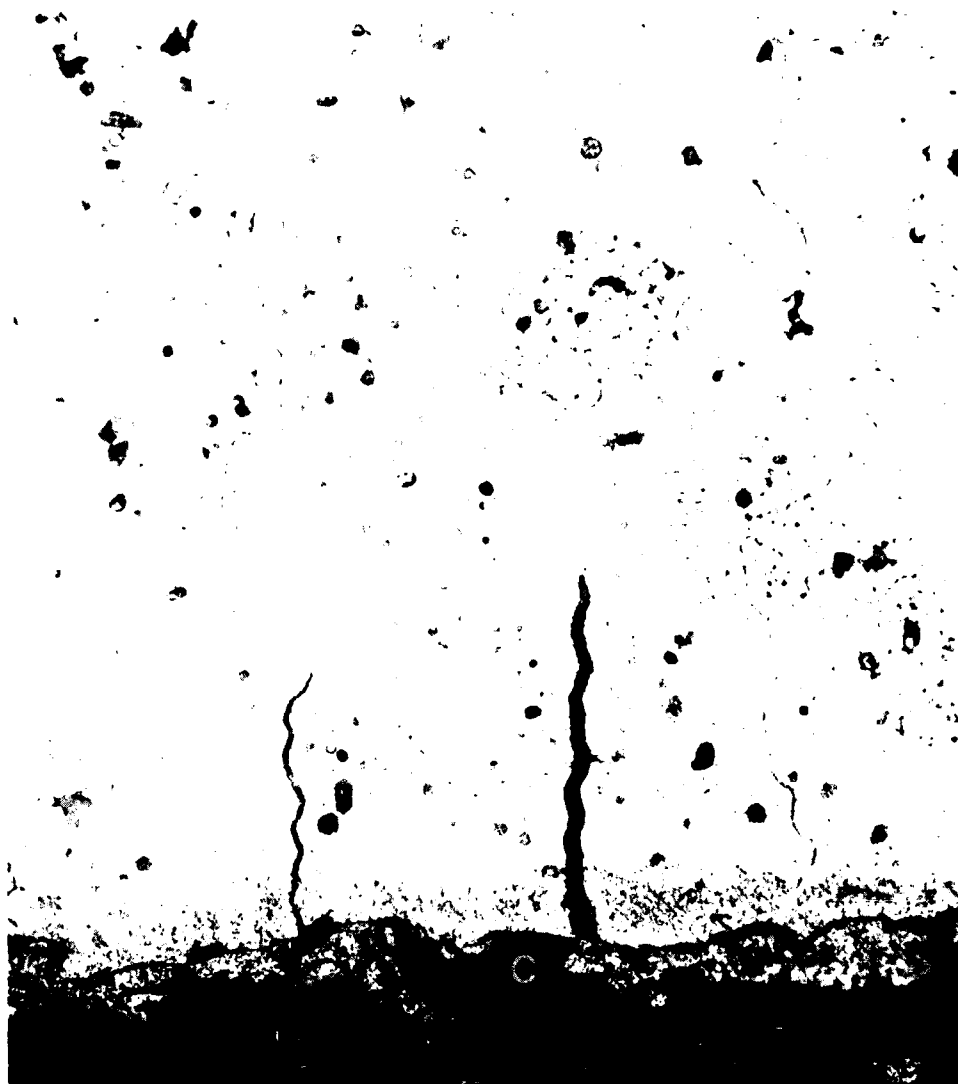
FIGURE 22. SECTION THROUGH THE FIRE DAMAGED BLOCK (A9-300) SHOWING THE COMBUSTION ZONE AREA (AREA C). THE HORIZONTAL LINE JUST ABOVE THE FIRE ZONE MARKS THE LIMIT OF RESOLIDIFIED ALUMINIUM ALLOY (ARROW). THE SHALLOW DEPTH OF THIS ZONE EMPHASISES THAT THE RATE OF COMBUSTION EXCEEDED THE RATE OF HEAT TRANSFER INTO THE INTERIOR OF THE BLOCK.
